Subject: ELECTRICAL DEVICES CANNOT BE CHARGED AT REAR CONSOLE OR TRUNK SIDE TRIM USB POWER OUTLET	Bulletin No.: 09-013/23
	Last Issued : 02/16/2023

2016-2023 CX-9 vehicles with VINs lower than JM3 TC**** ** 630018 (Produced before Aug. 1, 2022)

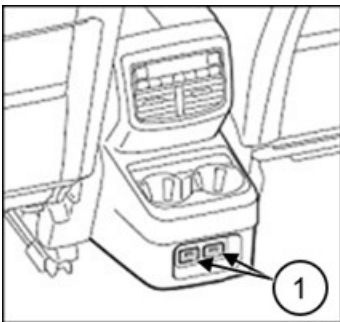
Rear Console

Some customers may experience electrical devices that cannot be charged through the rear console or the trunk side trim USB power outlet. This may be caused by an excessive external force applied to the USB power outlet. To eliminate this concern, the soldering strength of the USB port has been enhanced.

1. Verify the customer concern.
2. Replace the USB power outlet (1) on the rear console or trunk side trim with a modified part according to the instructions on MGSS online: (USB POWER OUTLET REMOVAL/INSTALLATION)
