Technical Service Bulletin

Subject: AMBIENT TEMPERATURE IS DISPLAYED LOWER THAN ACTUAL TEMPERATURE AND A/C DOES NOT WORK SUFFICIENTLY	Bulletin No.: 07-002/23
	Last Issued : 02/01/2023

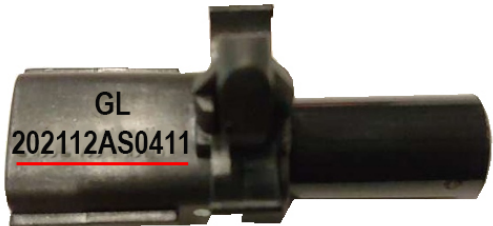
Ambient Temperature Sensor Countermeasure	
LOT Number 202112AS0411

- The ambient temperature sensor countermeasure started in Lot 0411 of 2021/Dec.
- Make sure to disconnect the negative terminal of the battery during the replacement of the sensor, otherwise the sensor may not be reset correctly.

<ul style="list-style-type: none"> • First 4 digits - Year • Digit 5-6 - Month • Digit 7-8 - Production Line Identification Code • Last 4 digits - Product Lot (number assigned to each lot) 	Example: 2021 12 AS 0411 = Dec/2021 Lot Number 411

Is the lot number before Lot 0411 of 2021/Dec?

- **Yes** - Replace the ambient temperature sensor according to the instructions in MGSS.
 - Mazda2 (AMBIENT TEMPERATURE SENSOR REMOVAL/INSTALLATION [FULL-AUTO AIR CONDITIONER])
