Subject: <p style="text-align: center;">MULTIPLE ELECTRICAL MALFUNCTIONS AFTER BODY REPAIR</p>	<p>Service Alert No.: SA-010/23</p> <hr/> <p>Last Issued : 02/09/2023</p>
---	---

APPLICABLE MODEL(S)/VINS

- 2016-~~2023~~ CX-3
- 2013-~~2023~~ CX-5
- 2016-~~2023~~ Mazda2 (Puerto Rico/Mexico spec)
- 2014-2018 Mazda3
- 2014-~~2021~~ Mazda6
- ~~2023~~ CX-50

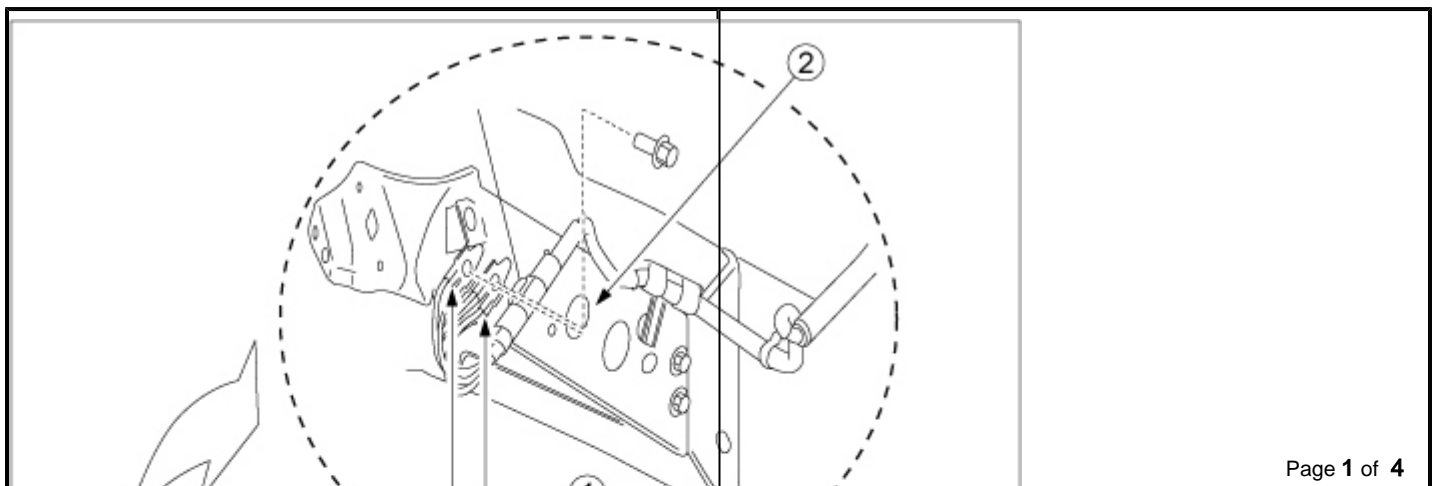
CX-5 shown

Some customers may experience one or more electrical malfunctions after a vehicle body repair. The newly painted fender stay (2) may be causing a poor front harness (1) ground connection.

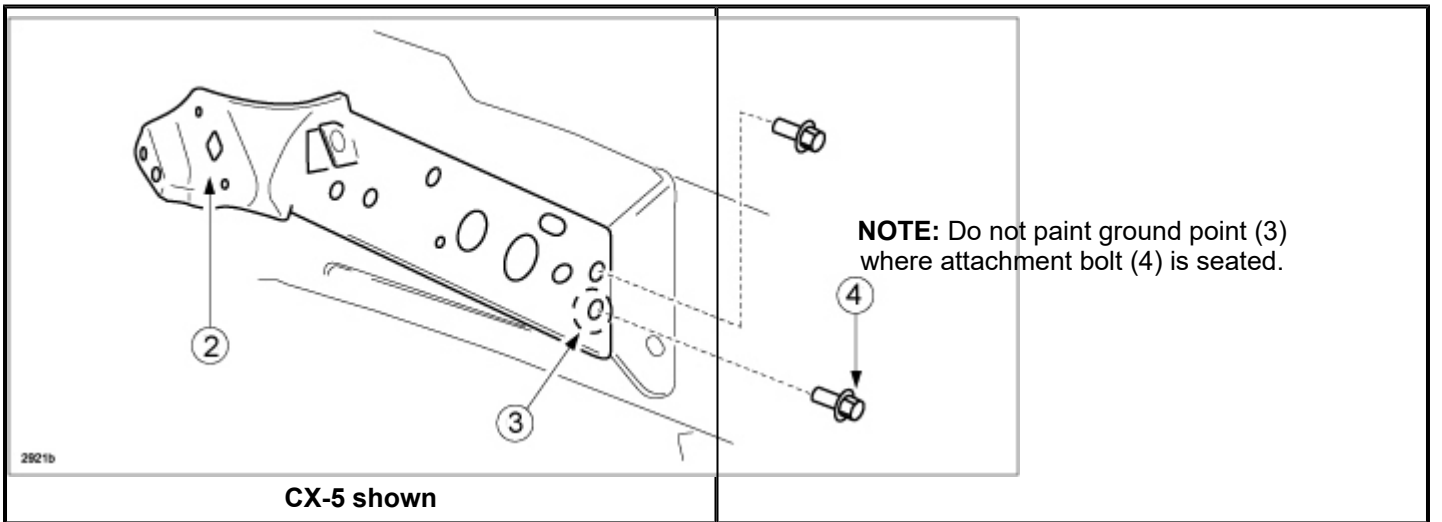
The front fender stay (2) newly painted surface at ground point (3), where attachment bolt (4) is seated, may create a poor front harness ground connection.

Customers concern can be resolved by sanding off paint at ground point (3) where attachment bolt (4) is seated. After installing the bolt (4), apply touch-up paint to the exposed base material area of the front fender stay.

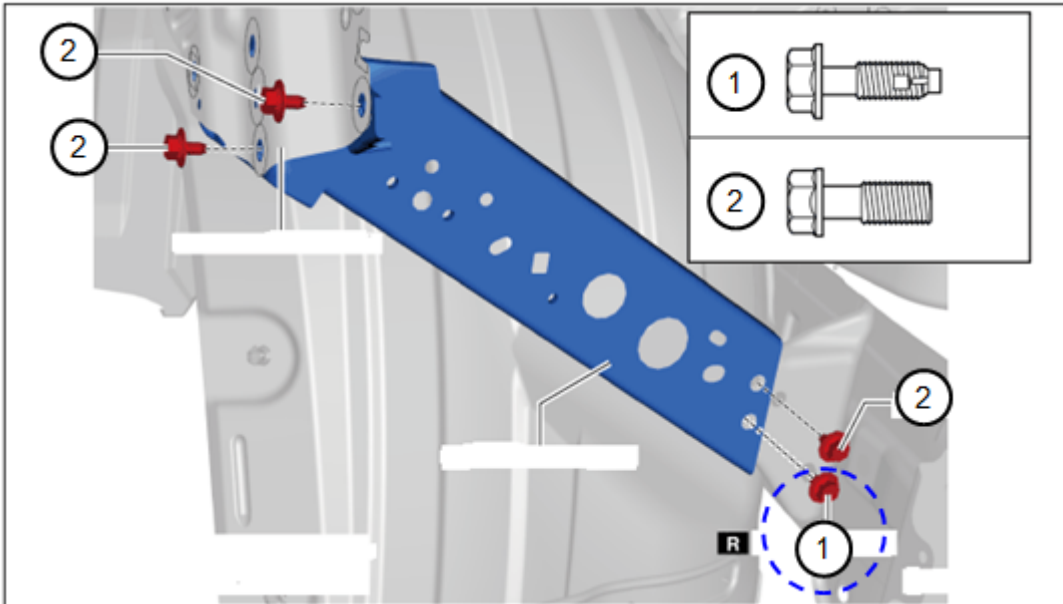
Ground bolt (1)

Mounting bolt (2)

NOTE: Always replace the ground bolt (1) if the Workshop Manual or Bodyshop Manual instructs to use the ground bolt for proper grounding.
