## Replace Cap for Coolant Expansion Reservoir

| Topic number | LI08.10-P-075956 |
| Validity | Model 243 |

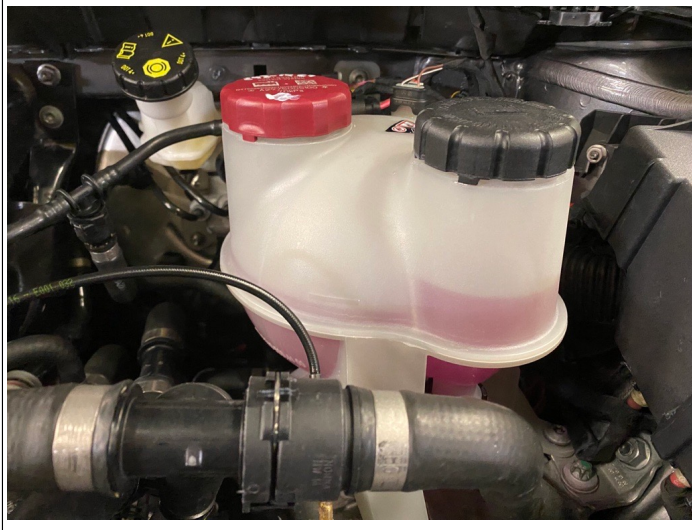
243\_Verschlussdeckel.png

The black cap on the small chamber must not be replaced.

The correct caps are shown in the picture.

Coolant Expansion Reservoir Cap (model243, EQB)

If a black cap is installed on the large chamber of the coolant expansion reservoir, replace it with a red cap with part number (A 297 500 51 00).
