CAL FTL 01-004b

**Subject: New Cascadia Vehicles Equipped with Cummins Engines—
Inspection for Properly Torqued Engine Mounting Bolts**

**Models Affected: New Cascadia export vehicles built between August
24, 2022 and December 13, 2022.**

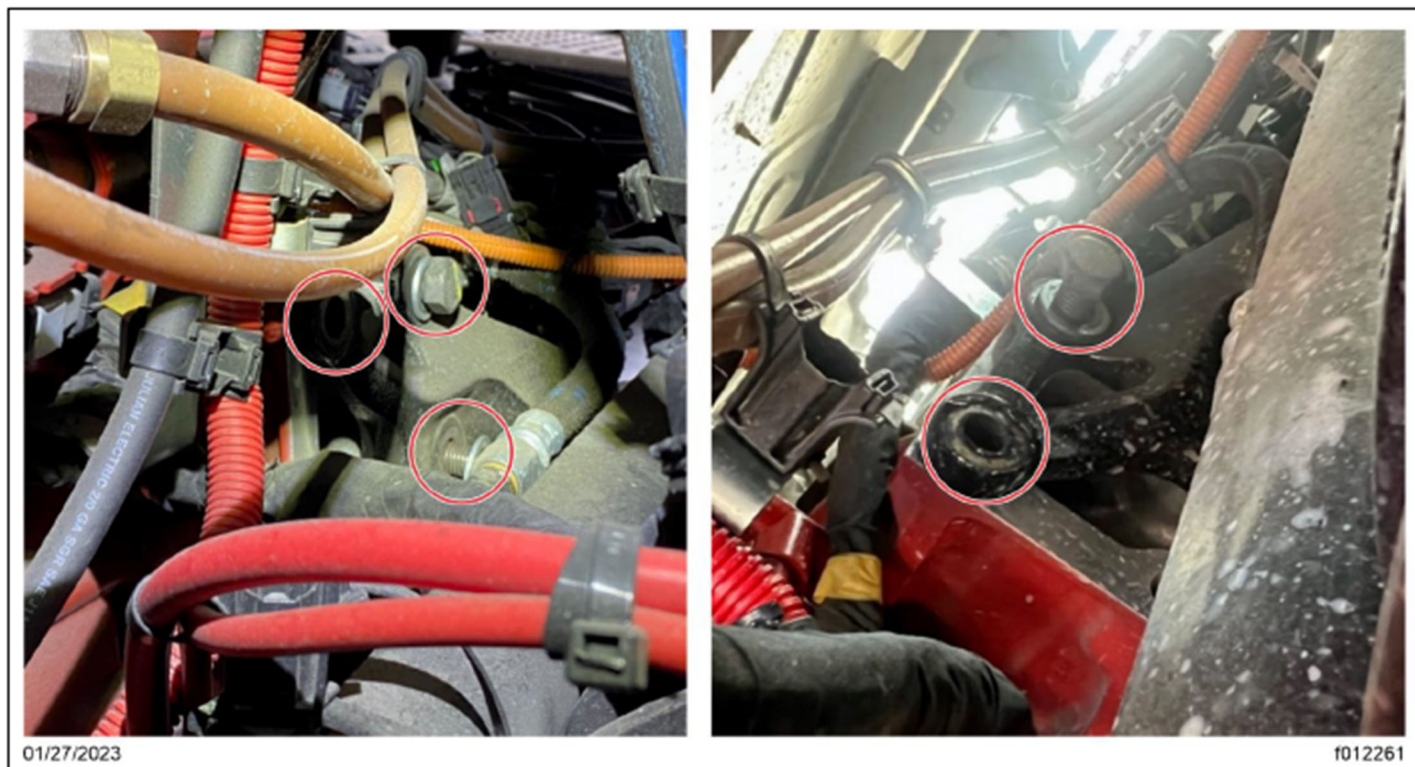
Fig. 1, Loose or Missing Rear Engine Mounting Bolts

5. Remove the splash shield by pulling it forward until it clears the rocker panel, then pull it to the side.
6. Inspect the rear engine mounting for missing or loose bolts. See [Fig. 1](#).
7. If the bolts are present and do not appear to be loose, attach ½-inch Drive 1-1/8 12-point torque adaptor (SRDH361). See [Fig. 2](#).
8. Connect a ½-inch drive torque wrench to the torque adaptor, then tighten all five engine bolts 213 to 269 lbf-ft (289 to 365 N·m). See [Fig. 3](#) for the correct bolts to tighten.

9. If bolts are loose, remove to apply red loctite, install the bolt and attach the ½-inch Drive 1-1/8 12-point torque adaptor (SRDH361). See [Fig. 2](#).
10. Connect a ½-inch drive torque wrench to the torque adaptor, tighten the five engine bolts 213 to 269 lbf·ft (289 to 365 N·m). See [Fig. 3](#) for the correct bolts to tighten. See [Fig. 4](#) for torque adaptor calculations.
11. If bolts are missing, replace the bolts as needed following steps 9 and 10. See [Fig. 5](#) for the bolt identification.
12. Position the splash shield so that the cab studs align with the splash shield holes. Install the two backing plates and the four nuts on the studs. Tighten the nuts 15 lbf·ft (21 N·m).
13. Install the screw that attaches the splash shield to the front-wall mounted bracket.

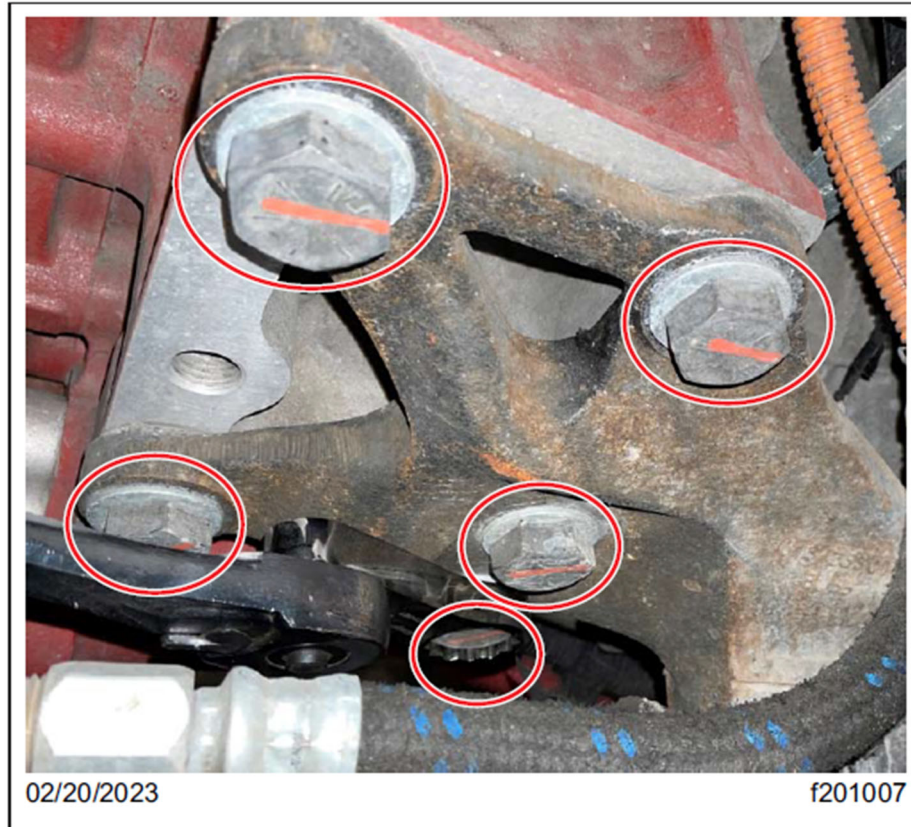
Fig. 3, Five Bolts with Torque Tool Attached
