WNQ3 – Checking Windshield and Re-Bonding if Necessary (Workshop Campaign)

Vehicle Type: **Macan (95B)**

Model Year: **2021**

Concerns: **Windshield**

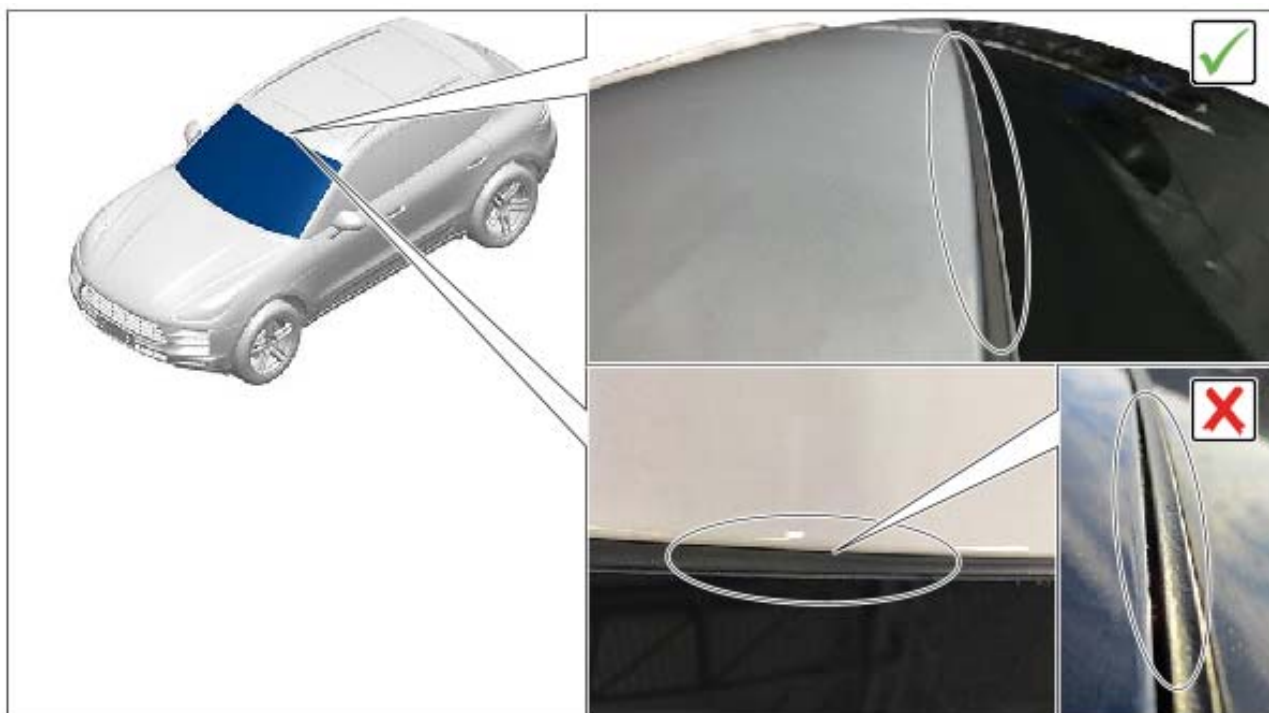
Checking windshield

Work Procedure: 1 Check for gaps between windshield and seal.

The seal must **always** contact the roof over the entire area.
Please note that even a small gap can cause wind noise.

Assessment		Action
(✓)	There is no windshield gap.	- End of action - Continue with Step 3. [Scope 1]
(✗)	There is a windshield gap.	Continue with Step 2. [Scope 2]

- 2 Remove and re-bond windshield. ⇒ *Workshop Manual '641219 Removing and installing windscreen'*
- 3 Enter the campaign in the Warranty and Maintenance booklet.
