Noise Symptom - Creaking Noise from Body Front Area of the Vehicle: Replacing Upper Trailing Arm (SY 265/22)

Model Line: **Taycan (Y1A/Y1B/Y1C)**

Model Year: **As of 2020 up to 2023**

Concerns: **Upper trailing arm**

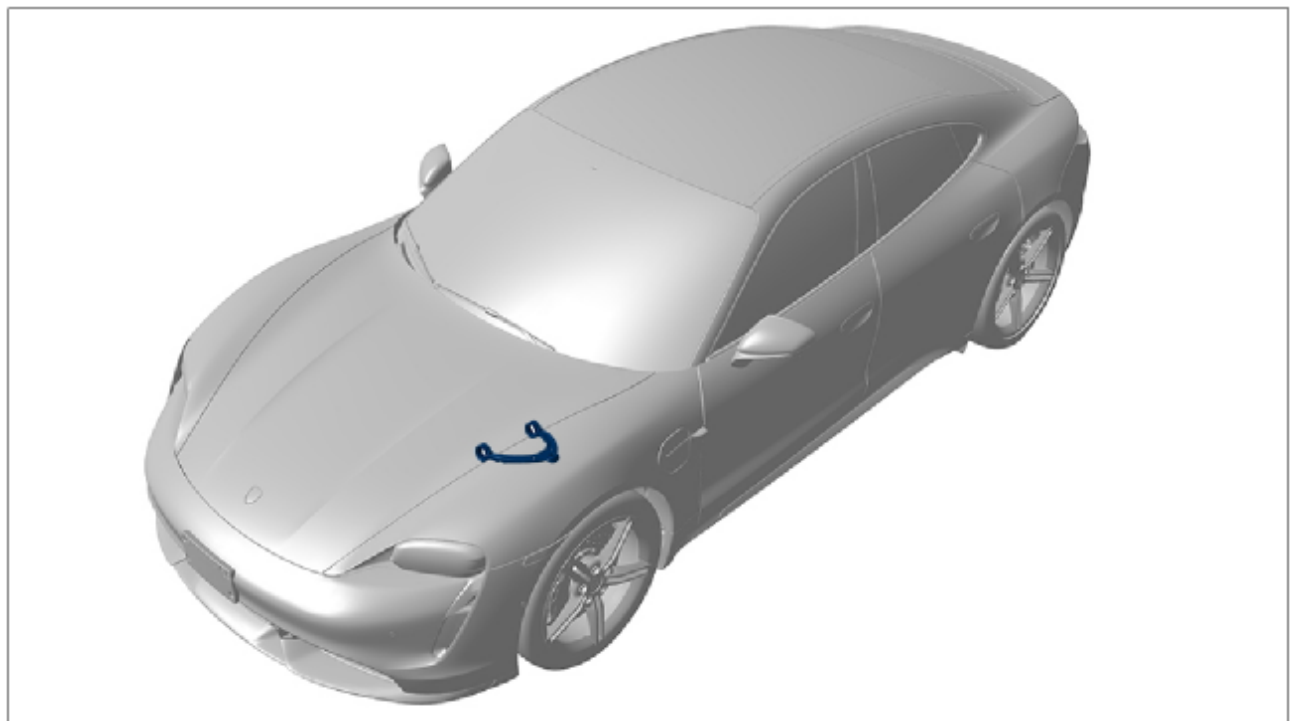
Installation position of upper trailing arm

Symptom: **Creaking noise from body front section area at temperatures below -5 °C (23 °F).**

Cause: Under certain conditions, the arrangement of the upper trailing arm rubber bearings with respect to the body side can cause creaking noises.
Temperatures below -5 °C can increase these noises.

Remedial Action: A new component status is available for the upper left and right trailing arms on the front axle.
In the event of a comprehensible customer complaint, replace the upper left and right trailing arms on the front axle.
