Technical Service Bulletin

Mazda North American Operations
Irvine, CA 92618-2922

Subject: BATTERY DISCHARGED DUE TO SEAT VENTILATION MALFUNCTION	Bulletin No.: 09-008/23
	Last Issued : 02/07/2023

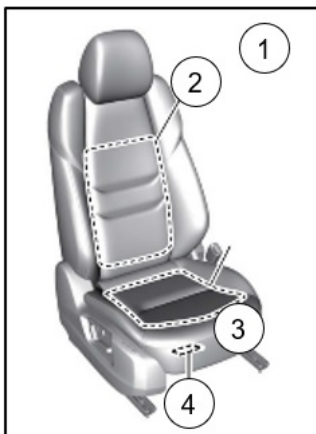
Some vehicles may experience the seat ventilation system still on after the engine has been turned off, in some cases this causes the battery to be completely discharged and not rechargeable. This is caused by a deterioration in the seat ventilation control unit. To eliminate this concern, the material for the circuit of the seat ventilation control unit has been modified.

- (1) Passenger side
- (2) Seat ventilation unit (Seat back side)
- (3) Seat ventilation unit (Seat cushion side)
- (4) Seat ventilation control unit

2. Replace the front seat warmer control unit according to the instructions on MGSS (FRONT SEAT WARMER CONTROL UNIT REMOVAL/INSTALLATION).

NOTE: The front seat ventilation control unit is integrated with the front seat warmer control unit located on the bottom of the passenger side front seat.
