Technical Service Bulletin

WRINKLES ON LEATHER SEAT SURFACE OF NEW (UNSOLD)
VEHICLE

Bulletin No.: 09-007/23 Last Issued : 02/01/2023

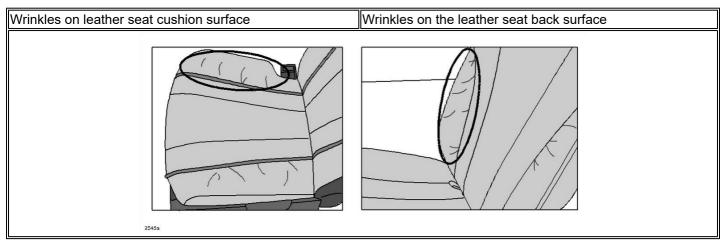
At PDI or when new vehicle is delivered, some customers may complain about wrinkles on the leather seat cushion and/or seat back surface.

Customers having this concern should have their vehicle repaired by a qualified upholstery repair specialist using the following repair procedure.

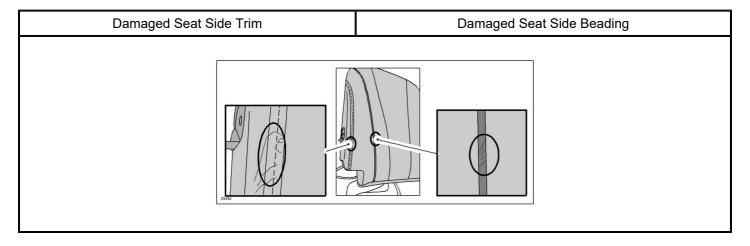
- DO NOT keep the steamer head at the same place for a long time.
- DO NOT run the steamer head without a water-soaked cloth especially over seat trim beading and seat side trim
 area.
- Seat damage may occur if the caution points above are not followed as shown below.
