WNQ2 - Checking Rear Lid and Reworking it if Necessary (Workshop Campaign)

Vehicle Type: **Taycan 4S (Y1A) / Taycan Turbo (Y1A) / Taycan Turbo S (Y1A)**

Model Year: **2020**

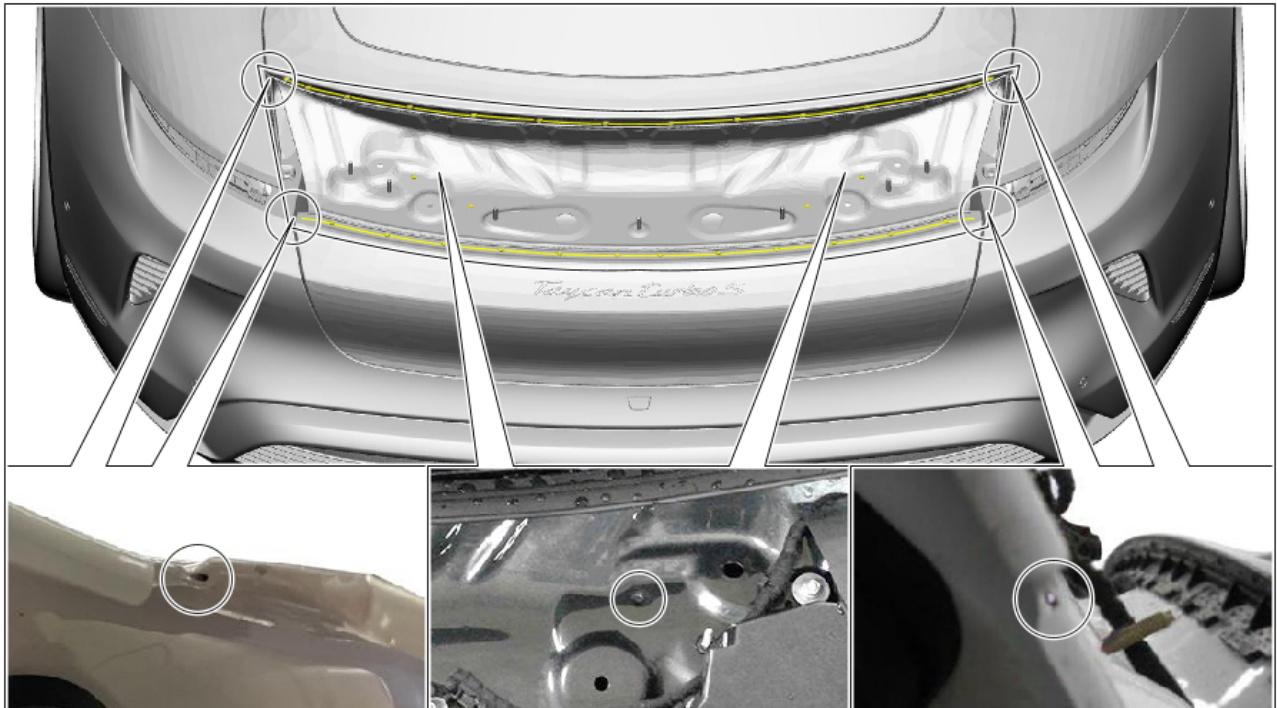
Cleaning the rear lid

The cleaning and leak test must generally be carried out on the entire rear lid. The following points in particular must be observed:

- Clinch points
- Transitions from connecting plates
- Key points

Work Procedure: 1 Clean rear lid at ⇒ *Cleaning the rear lid* -**Marked areas**- with isopropanol.

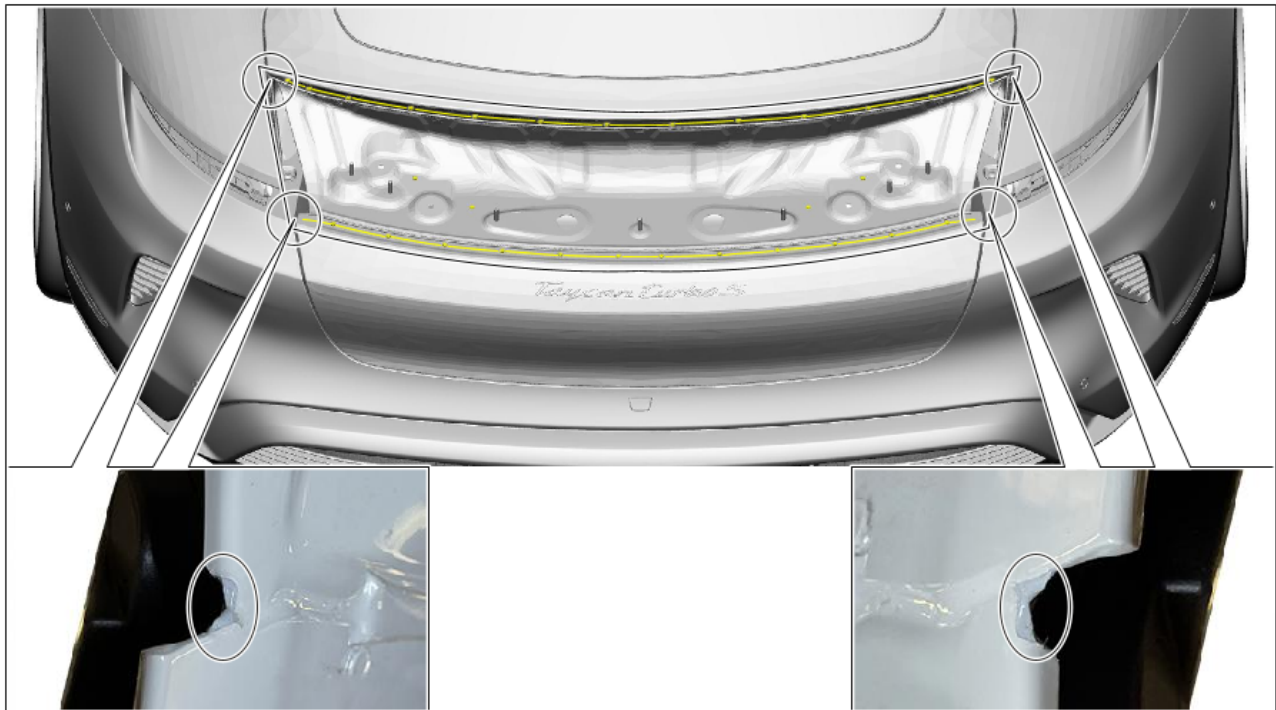
Area to be reworked (example shown at corners)

- Before starting sealing work, mask or cover all adjacent areas, especially the exterior panelling. Make sure that all residual moisture was removed completely before applying a new seal.
- The surfaces to be sealed must be free of grease and dirt before applying body sealant. For this purpose, clean all affected areas with cleaning solution and a lint-free cloth.
- Apply body sealant directly on the paint surface.

Work Procedure: 1 Seal off affected areas with body sealant and rework with touch-up stick in vehicle color.
