# Service Bulletin

Bulletin No.: 22-NA-127

**Subject: Radio Software Version V160 Update**

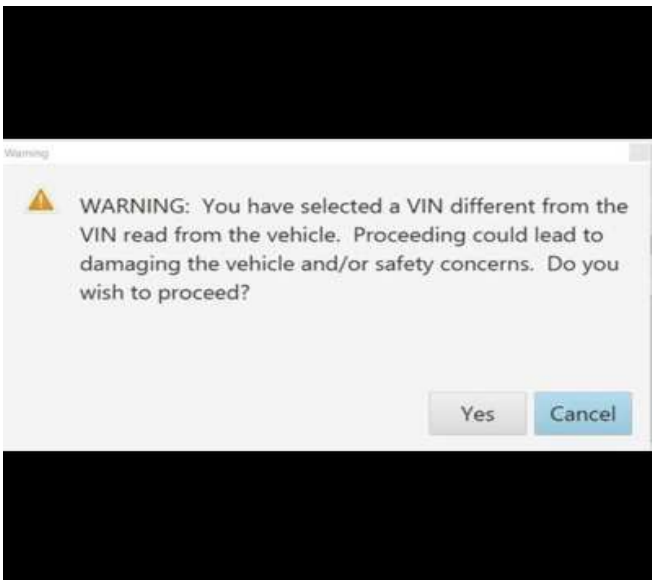
5877000

**Important:** If the vehicle VIN DOES NOT match, the message below will be shown.

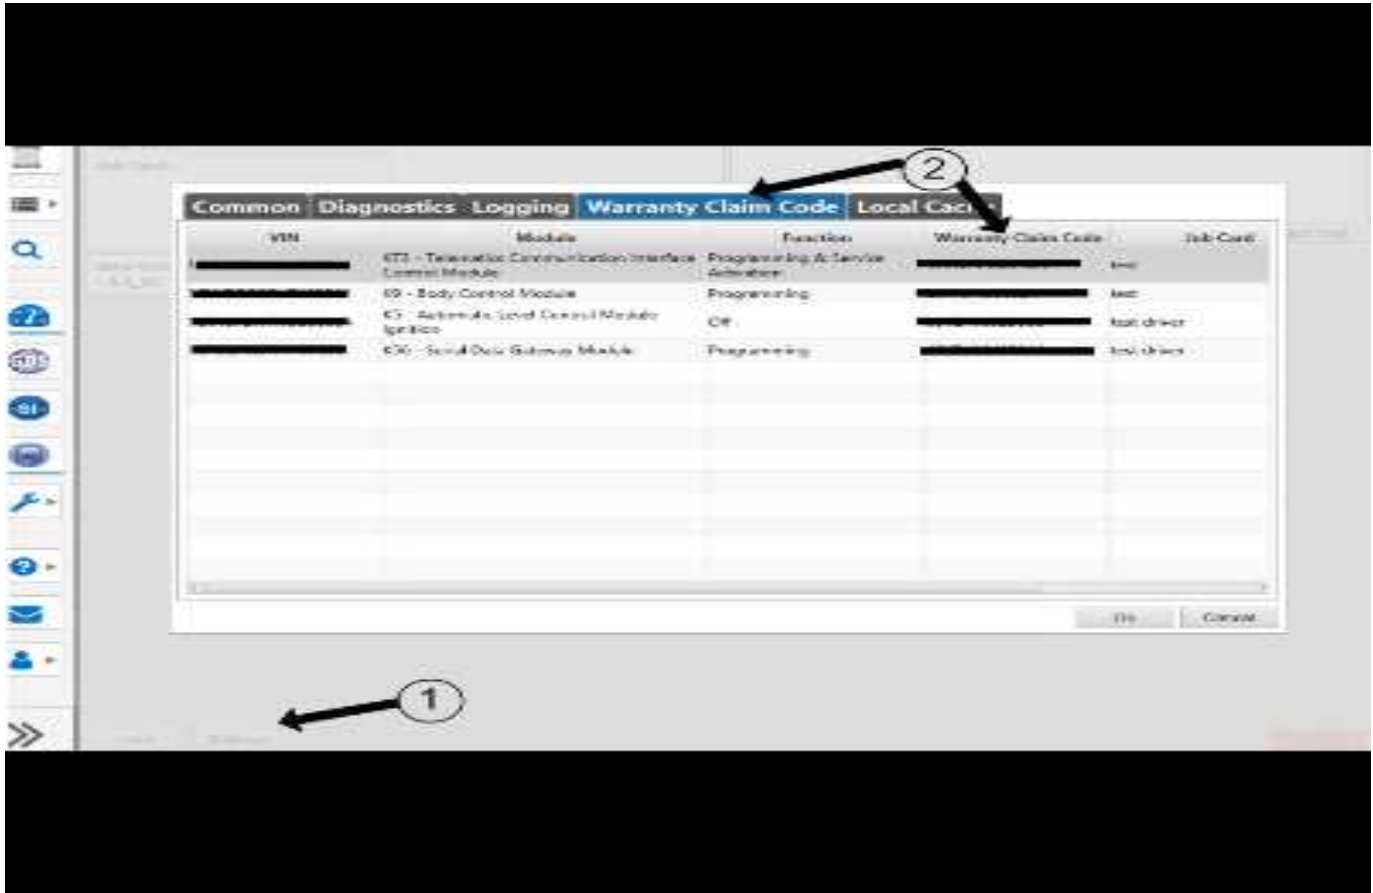
6125774

If the Warranty Claim Code was not recorded on the Job Card, the code can be retrieved in the SPS2 system as follows:

1. Open TLC on the computer used to program the vehicle.
2. Select and start SPS2.
3. Select Settings (1).
4. Select the Warranty Claim Code tab (2).
