Service Bulletin

Bulletin No.: 17-NA-106

Subject: Interior Cabin Boom, Vibration and/or Rumbling/Droning Noise Heard While Driving Low Speeds in High Gear

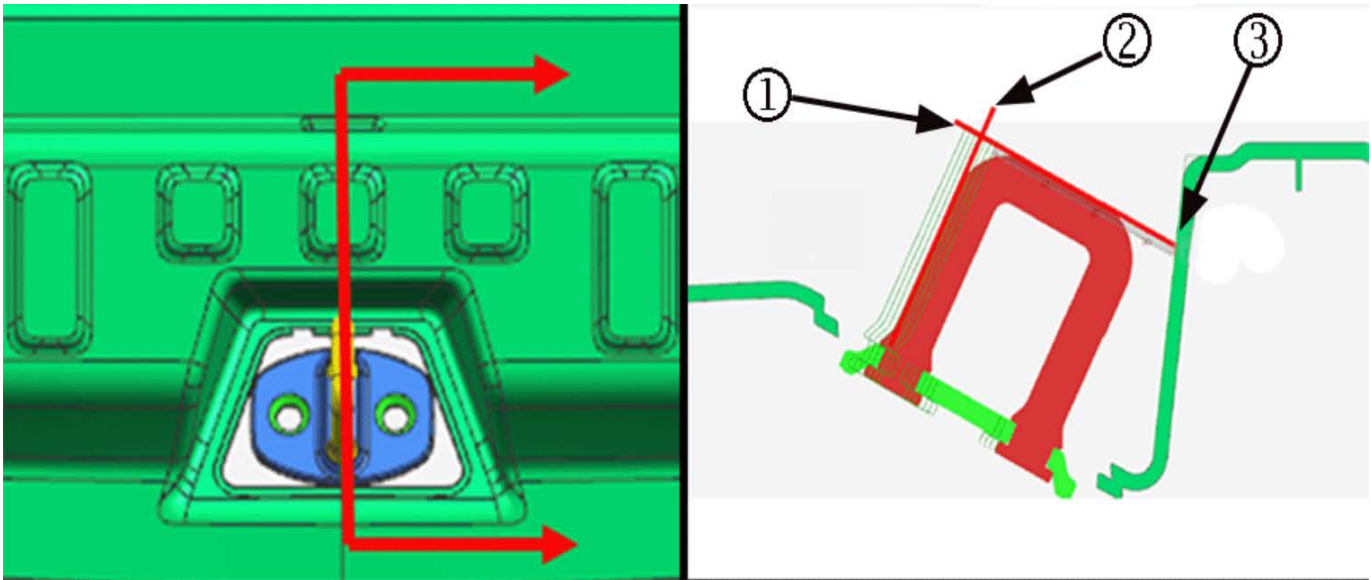
4772397

1. Verify the condition by road testing the vehicle:
 - 1.1. Increase the vehicle speed above 38 mph (61 km/h), then allow the vehicle to shift into a high gear to bring engine speed below 1500 rpm.
 - 1.2. Slow the vehicle down to the minimum speed that holds high gear (typically 35-36 mph (56-57 km/h) for FWD, 32-33 mph (51-53 km/h) for AWD, and evaluate boom noise during steady speed driving.
 - 1.3. Then lightly apply throttle to slowly accelerate and evaluate boom noise under engine load.
2. Once the condition is verified, open the liftgate.

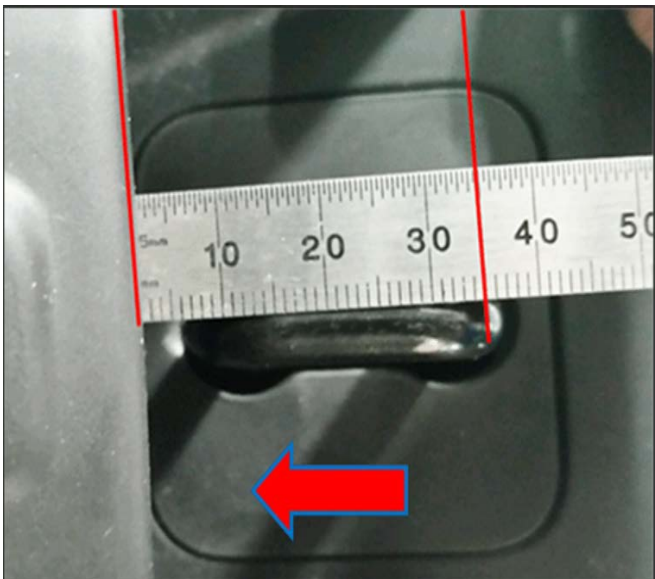
4772398

3. Lay a scale/ruler (1) on top of the liftgate striker and measure the striker position from the rear most edge (2), to the trim panel (3).

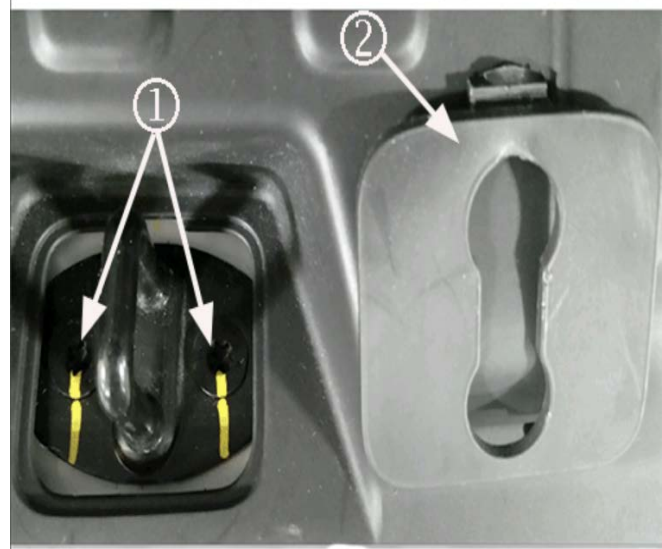
4772399

- If the striker position measures different than 38 mm (1.50 in), as shown in the graphic example above, continue to the striker adjustment in step # 4.
- If the striker position measurement is 38 mm (1.50 in), the positioning is correct. Jump ahead to the liftgate bumper adjustment in step # 7.

4. Remove the striker trim cover (2) and loosen the striker bolts (1).
5. Reposition the striker to the proper 38 mm (1.50 in) distance and re-torque the bolts to 22 N•m (16 lb ft).
6. Reinstall the trim cover.
