# TECHNICAL SERVICE BULLETIN

## Second Row Seat Back Does Not Fold Down Or Recline

**23-2036**

<b>Ford</b> 2018-2023 Expedition
<b>Lincoln</b> 2018-2023 Navigator

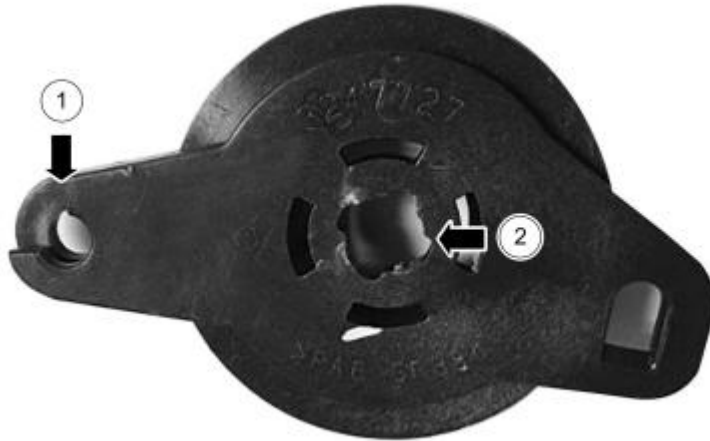
Figure 1

**Issue:** Some 2018-2023 Navigator and Expedition vehicles may exhibit a concern where the second row seat back does not fold down or recline when the recline handle is pulled upward or the second row single seat easy entry seat fold switch is pressed. This concern may occur with vehicles equipped with two or three second row seats. This may be due to a broken recliner release lever. To correct this concern, replace the recliner release lever.

Possible locations for damage on the recline release lever. (Figure 1)

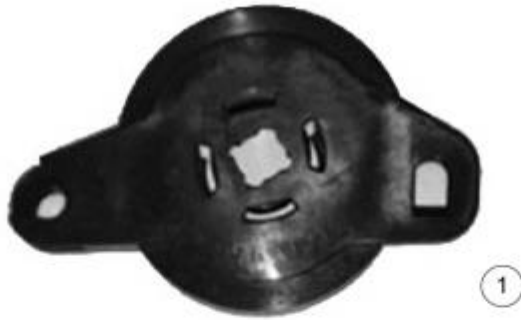
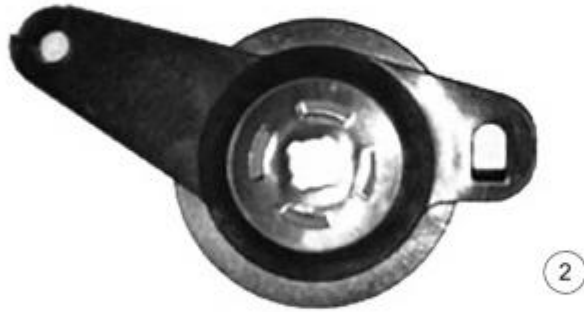
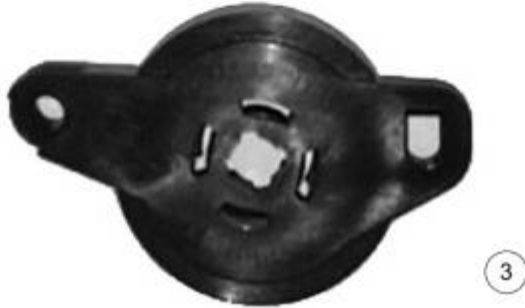
Figure 2

There are three different recline release levers based on the seat repair. (Figure 2)

Item	Description
1	Right seat release lever
2	Middle seat release lever
3	Left seat release lever

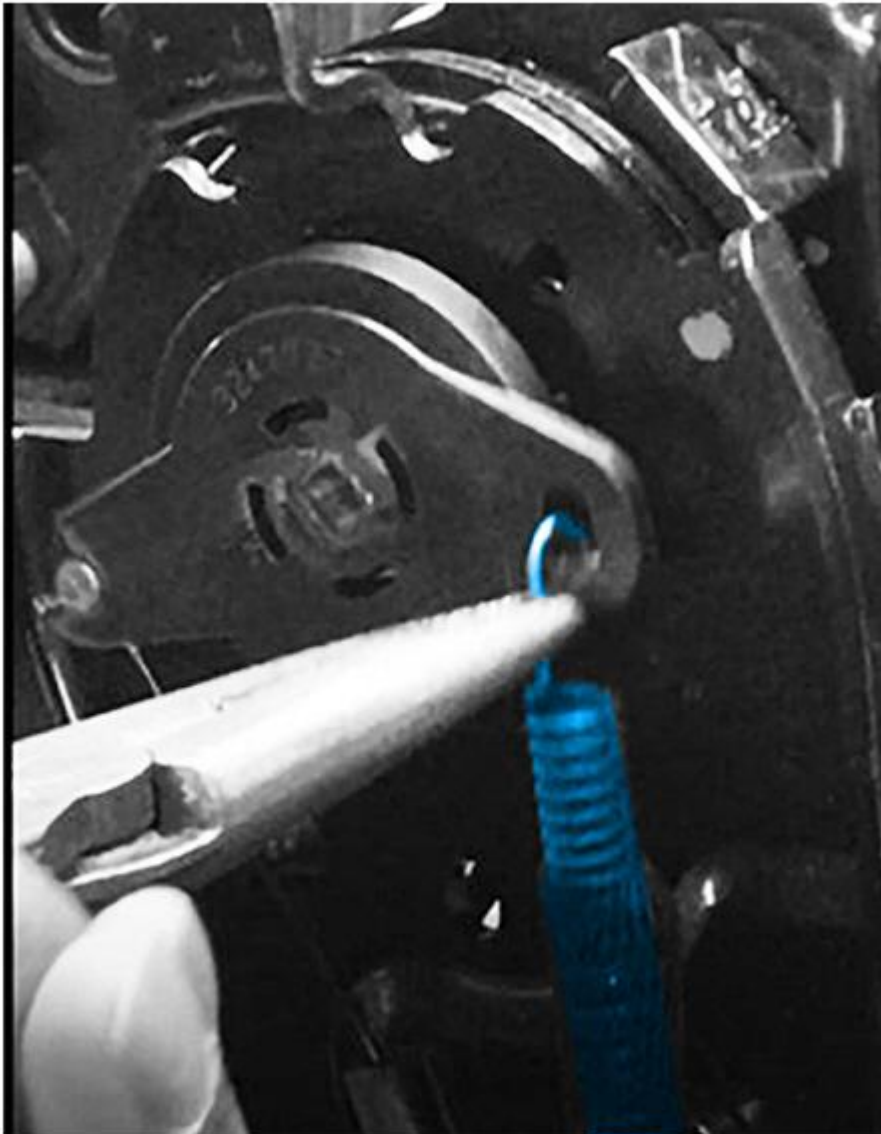
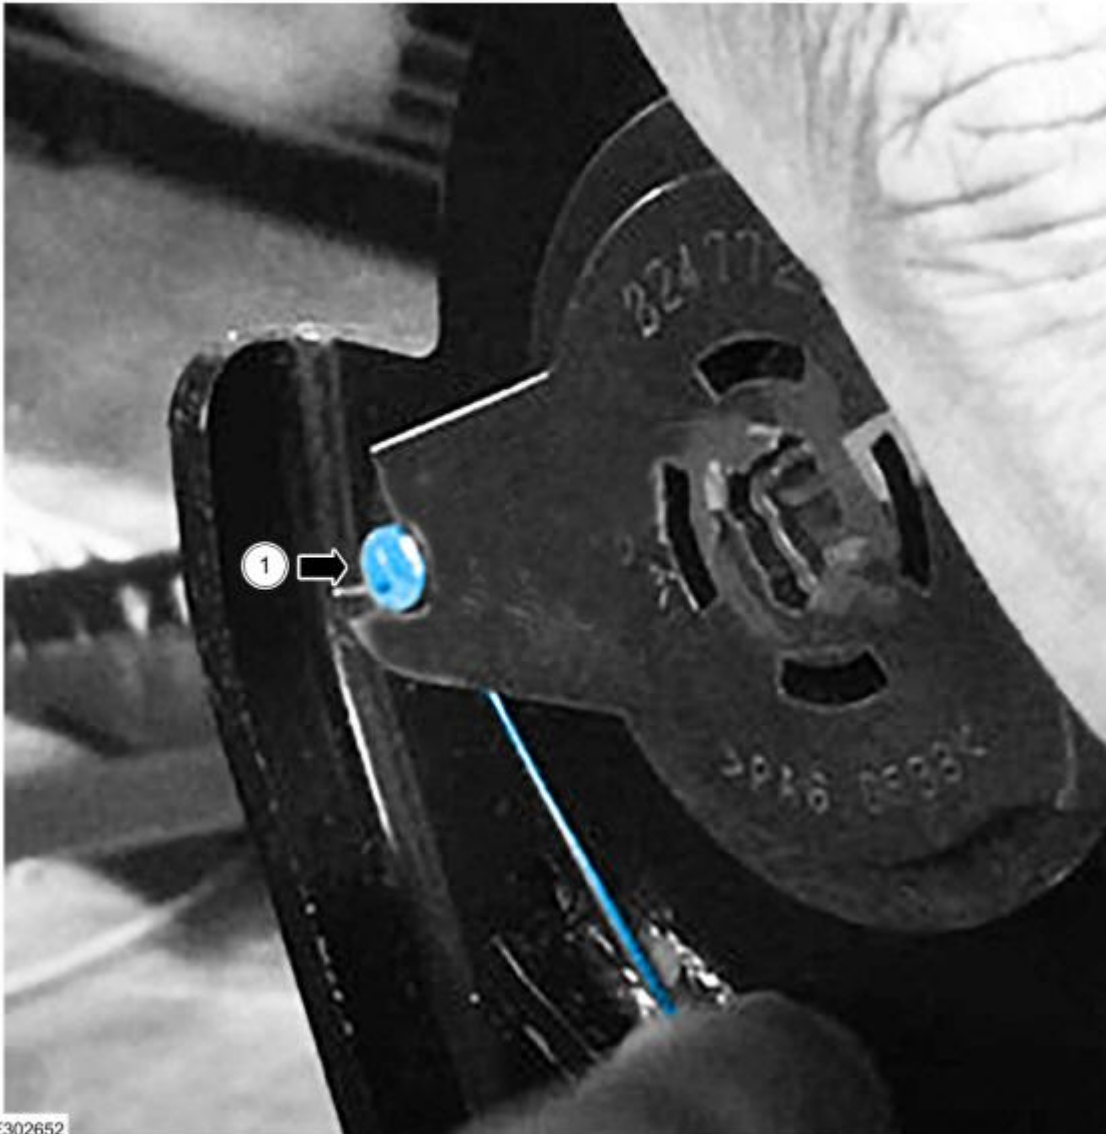
- If either of these attachment points on the recline release lever are damaged, the replacement recline release lever will need both the spring and release cable reattached. (Figures 11-12)

(1). Carefully unhook the spring and unhook the seat lever cable.

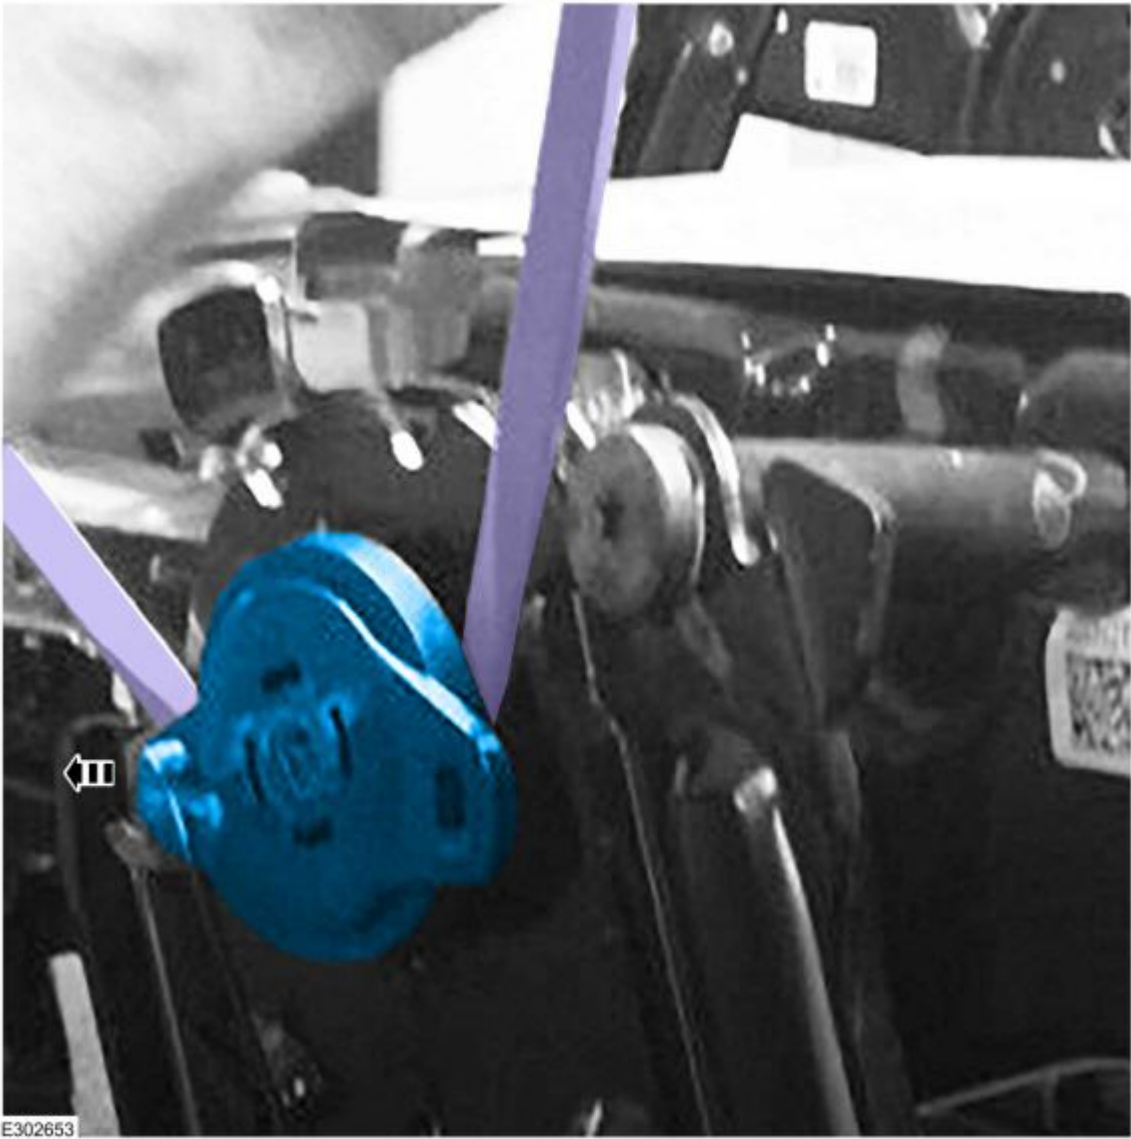
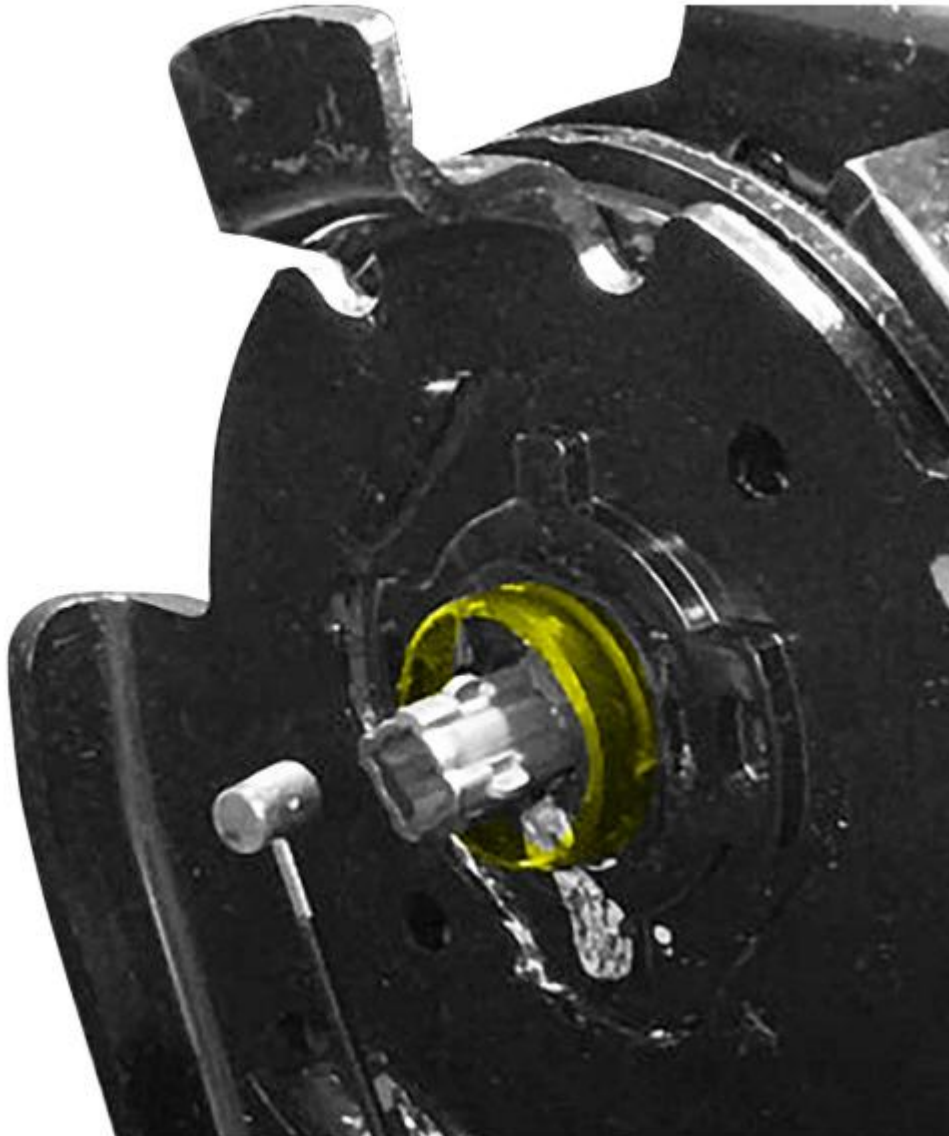
**NOTE: When prying on the backside of the recline release lever, be careful not to remove the inner mounting ring. If the inner mounting ring is removed, seat assembly replacement is required. (Figures 13-14)**

(2). Once both the spring and release cable are free of the recline release lever, gently pry on the backside of the recline release lever to remove it.

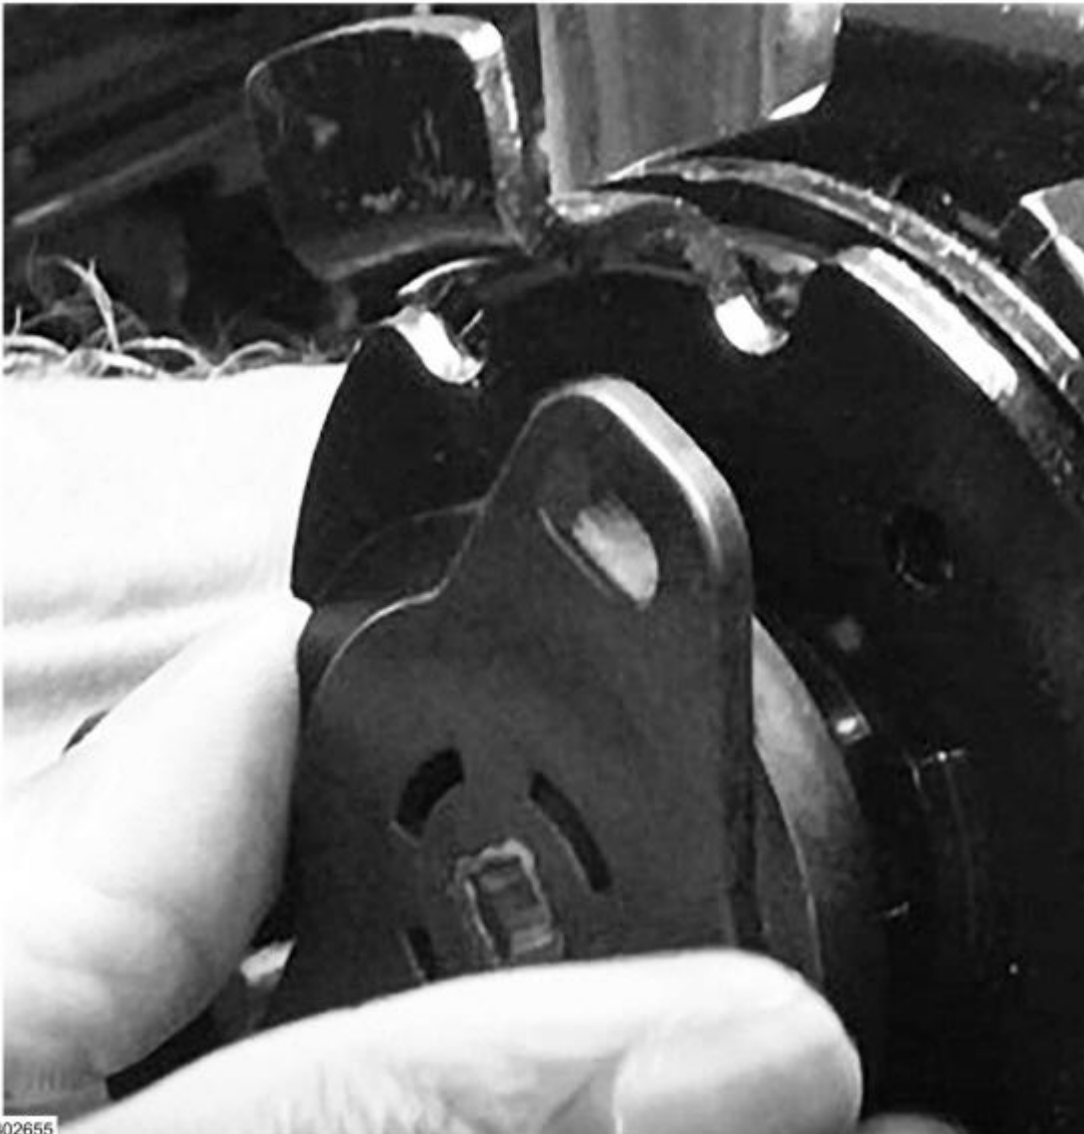
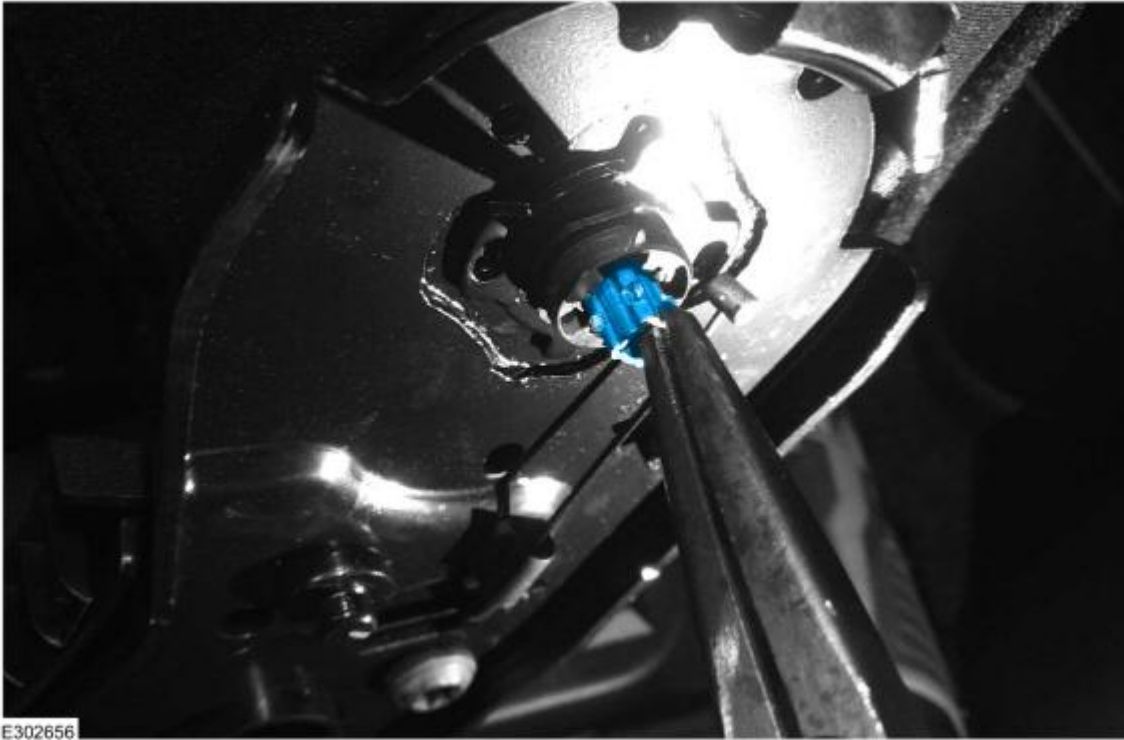
**NOTE: The square tube that holds the recline release lever in place may need to be pulled out to seat the new part. Do not pull the tube more than a few millimeters as this tube runs the entire length of the chair. Pulling out too far will unseat the opposite side of the chair and will require seat assembly replacement. (Figures 15-16)**

(1). Install the new recline release lever by pressing the new part into place.
