# INSTRUCTION TO SERVICE

| ITS: 60637 | | DATE: February 16, 2023 |
| SUBJECT: | Inspection – Precharge Circuit resistors | |
| ISSUE: | Possible damage to pre charge resistors | |

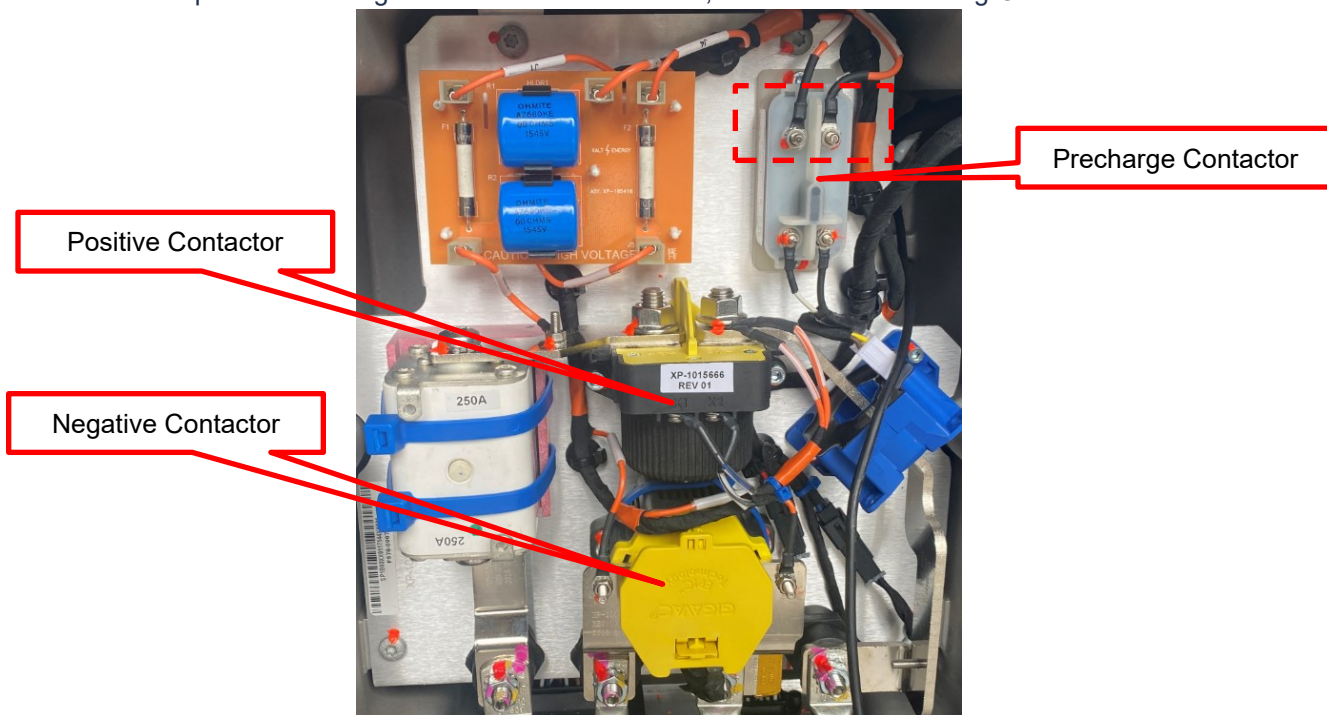
3.4. Measure the positive and negative contactors resistance, should be above 1Meg Ohm.

3.5. Measure the precharge contactor resistance between the marked terminals shown above. Resistance should be above 1 Meg Ohm.

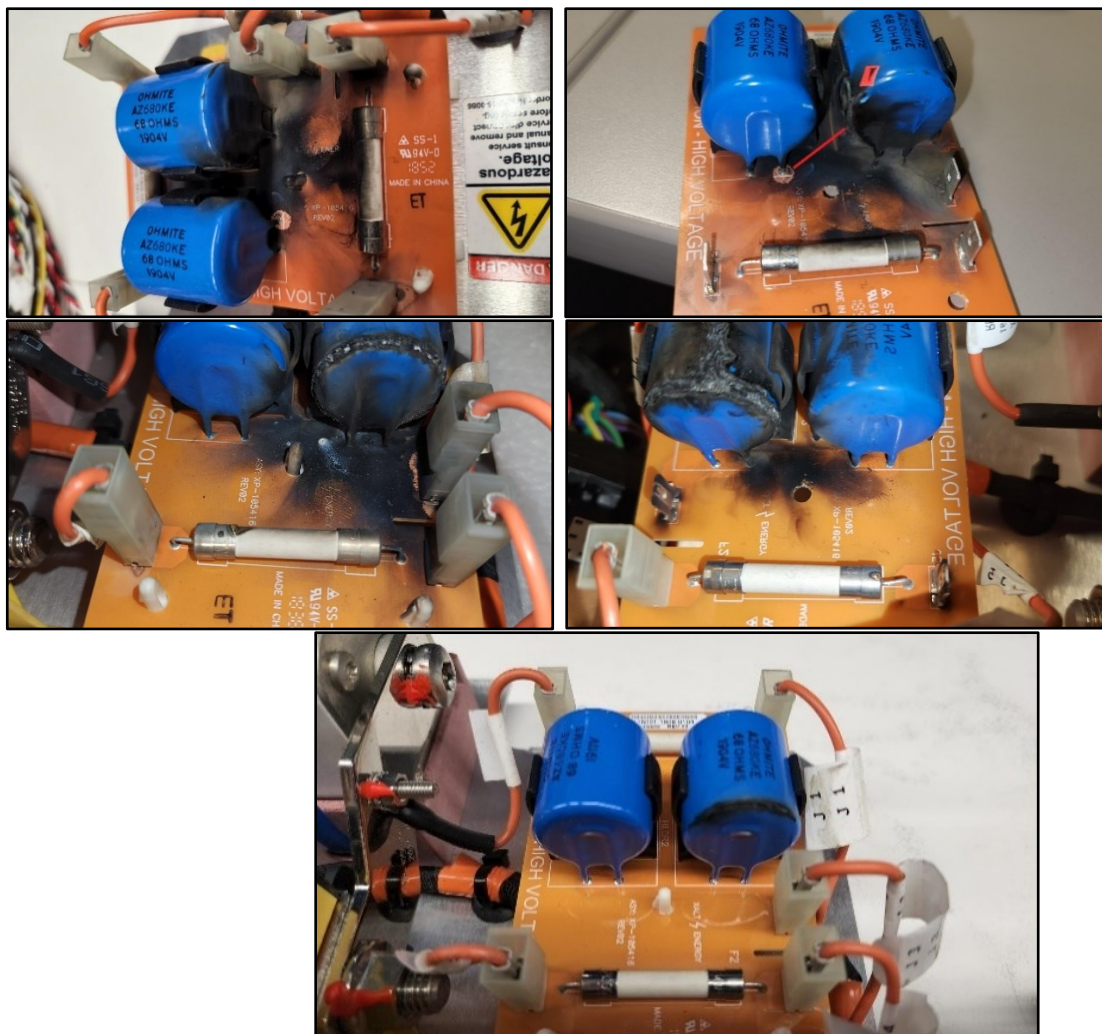
## Appendix A – Examples of damaged precharge resistors

- The following ITS provides inspection instruction following field reports of damaged precharge circuit on the BDU's.
- The following ITS will only apply to SR numbers: 2212, 2213 and 2315
- Inspection will be done only on the roof ESS

- 3.6. Inspect the precharge circuit resistors for any sign of discoloration or heat damage. Refer to Appendix A for examples of damaged precharge resistors.
- 3.7. Repeat the same for Mid and Rear ESS enclosures.
- 3.8. If any of the precharge circuits show similarity to the pictures in Appendix A please email TSS:
