Allison Reduced Engine Load At A Stop (RELS) Diagnostic Trouble Code P071a Or P07ce - GR/TE Models Built, With The Split Shaft Package, June 2022 to October 2022

It is possible for GR/TE models built June 2022 to October 2022 to have Diagnostic Trouble Code P071a or P07ce along with complaints of the transmission not going in to neutral when coming to a stop and/or the transmission will go in to 4th gear lock up when applying the service brake.

This solution has been created for Concrete Pump and Vacuum Truck Applications with Split Box PTO

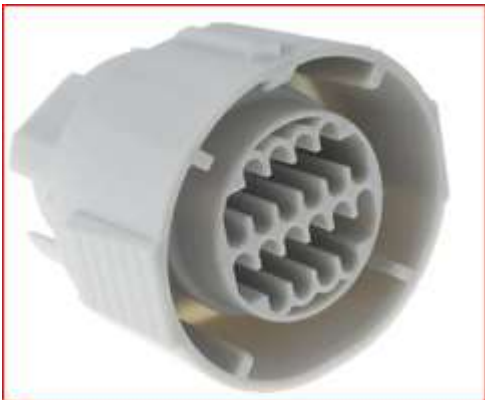
Round Gray Connector:

Look near this connector for a single wire connector marked Z11 RELS (Reduce Engine Load Stop) (See image below) If body builder has wire connected to that connector remove and install that wire in cavity U wire ID N143 on the body builder side of the connector.

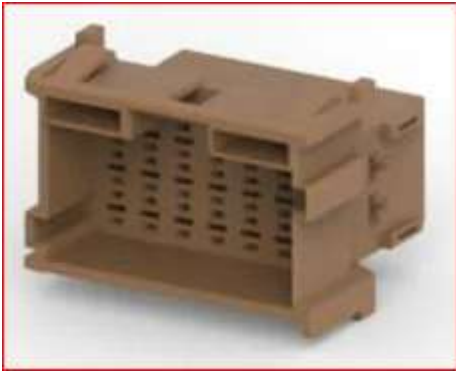
Rectangular Brown Connector: Look near this connector for a single wire connector marked Z11 RELS (Reduce Engine Load Stop) (See image below) If body builder has wire connected to that connector remove and install that wire in cavity 18 Body Builder side of the Brown Connector. If a new terminal is needed please use p/n 978295.

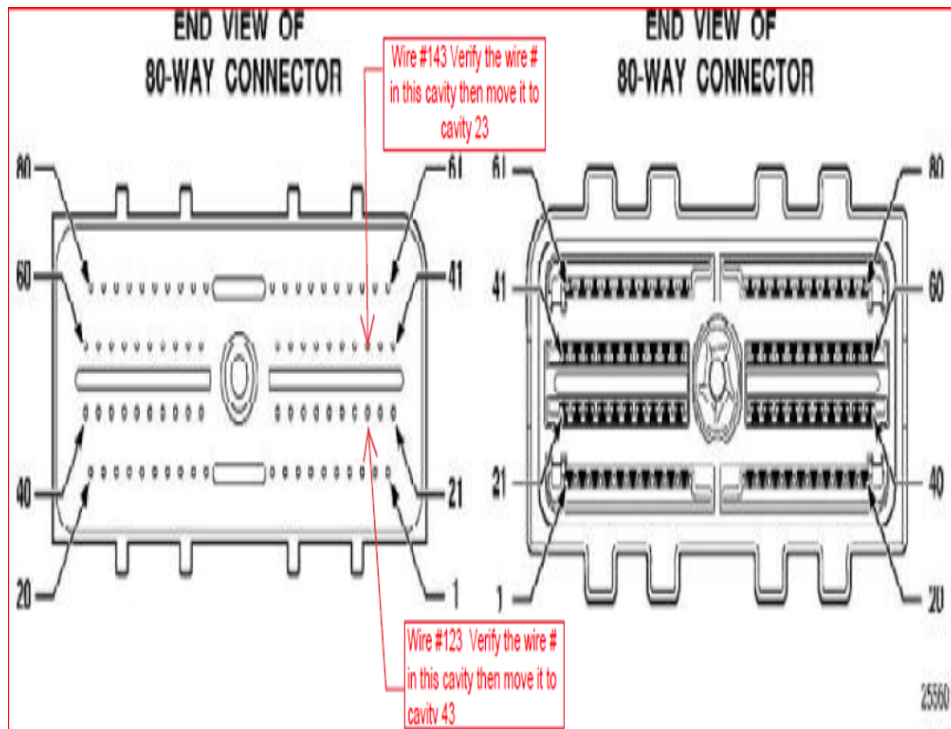
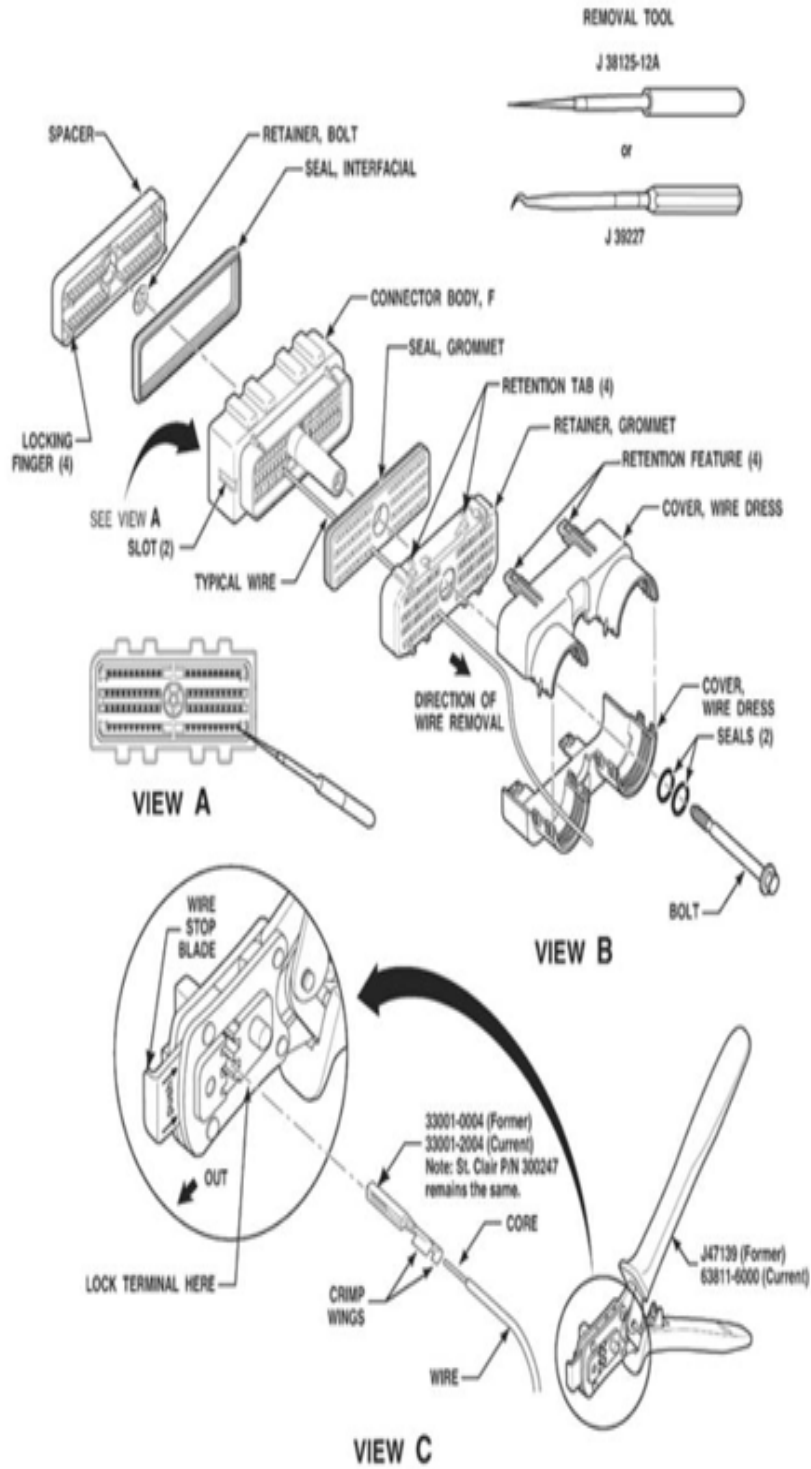
AFL 80F Bolt-Assist Transmission Control Module (TCM Connector)

Move the 2 wires on the transmission ECU connector located behind the D panel (Allison 80 pin connector) (See Below)

- Move wire N143 move to Cavity 23
- Move wire N123 to Cavity 43

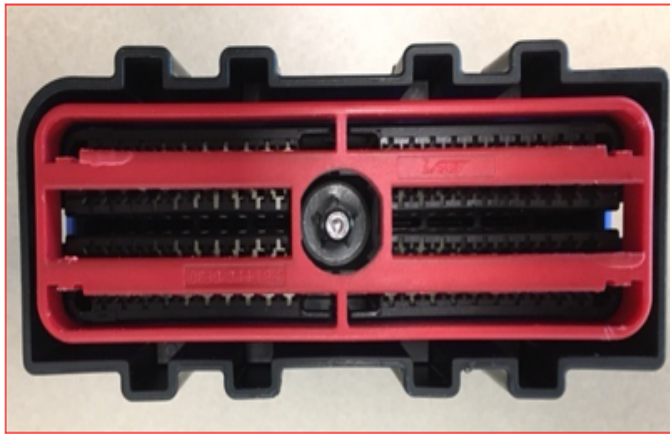
Cavity 43

Cavity 23

After you have swapped the wires in cavity 23 and 43, assemble the connector and plug it back in to the TECU and tighten the bolt. (DO NOT OVER TORQUE)

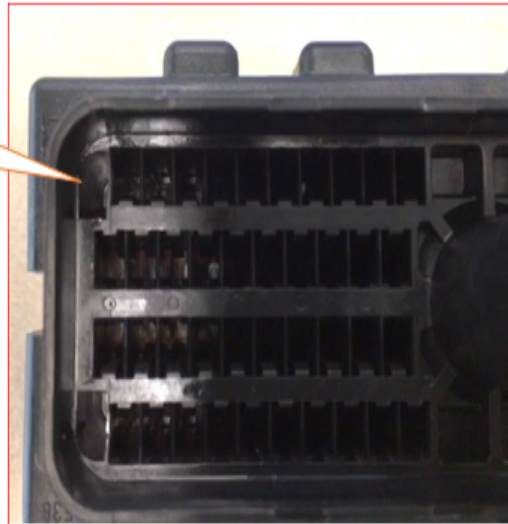
- After removing the 80-way connector, you will need to remove the red terminal lock terminal part #25193072 if needed

Locking fingers are located in each corner of the connector on the opposite side of the connector

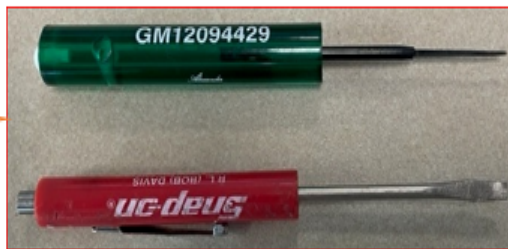
Use these tools or similar, to unlock the red terminal lock

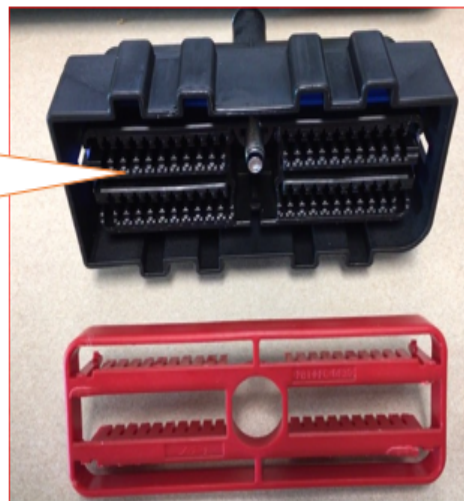
After lock has been removed you can use the terminal unlocking tool to unlock the wire terminal and slide the wire and terminal out the back side of the connector.

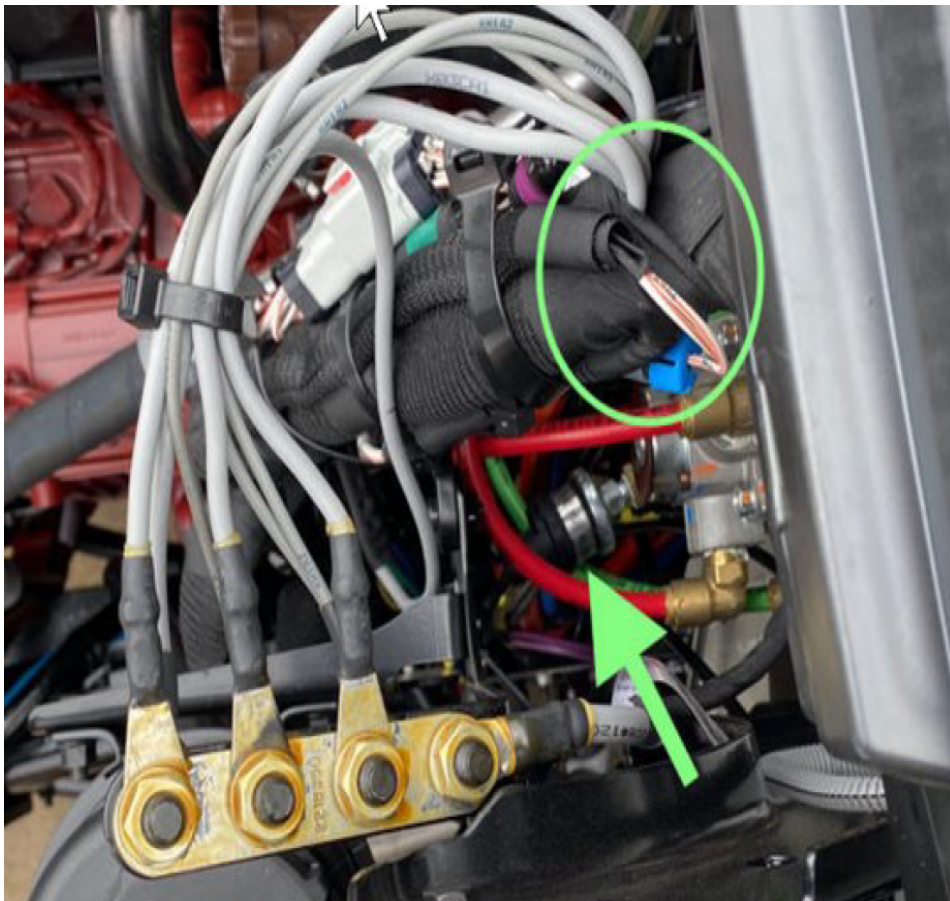
Visually inspect the service brake switch and verify that it is installed and the harness is connected.

If the service brake switch has not been installed refer to the p/n below.

Description	P/N
Allison Brake Switch	29511309
NOTE: The Mack brake switch listed below should only be used if the Allison switch is unavailable	
Mack Brake Switch	25165995

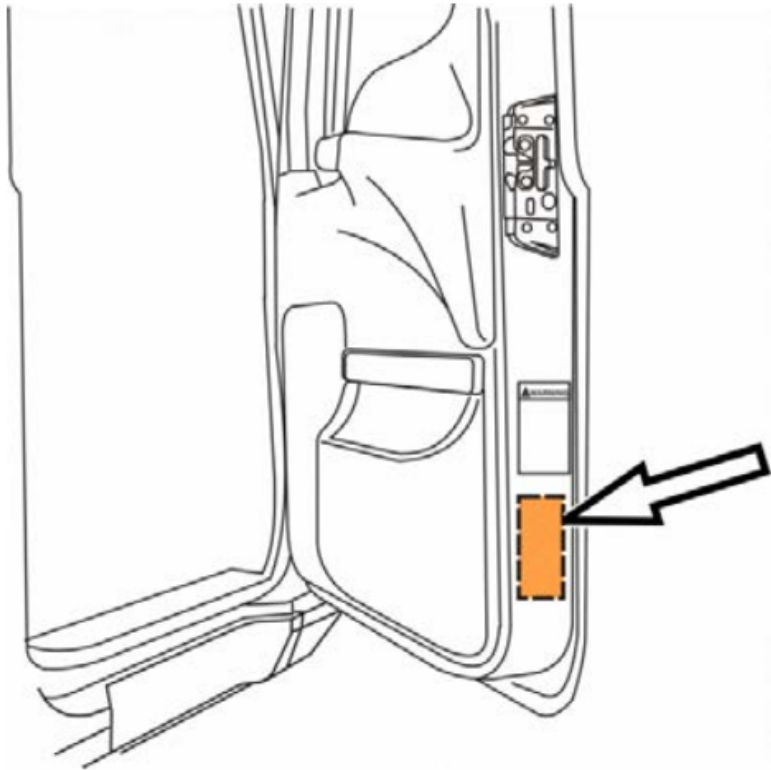
After this repair has been completed please install a Campaign Completion Label (**P/N 85152363**). Fill out the label and use **CBR-2240** for the recall number. See illustrations below.

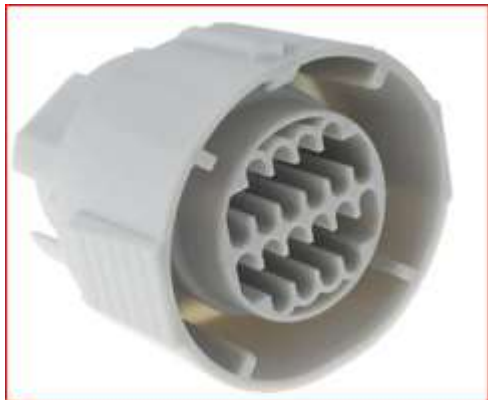
Round Gray Connector: Install the wire from the Stiebel box engagement in cavity U wire ID N143.

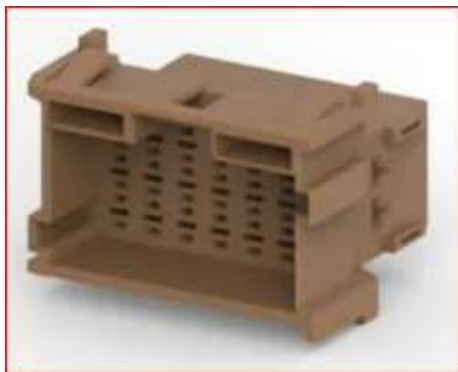
Rectangular Brown Connector: Install the wire from the Stiebel box engagement wire in cavity 18 ID N143 Body Builder side of the Brown Connector. If a new terminal is needed please use p/n 978295.

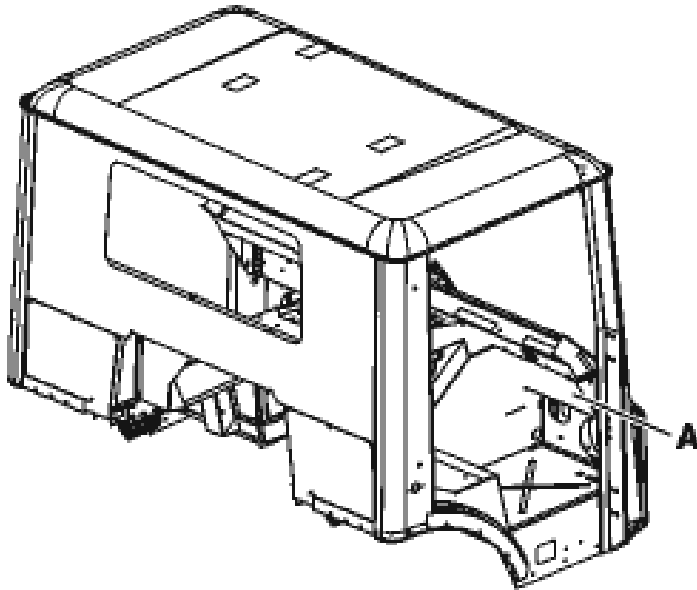
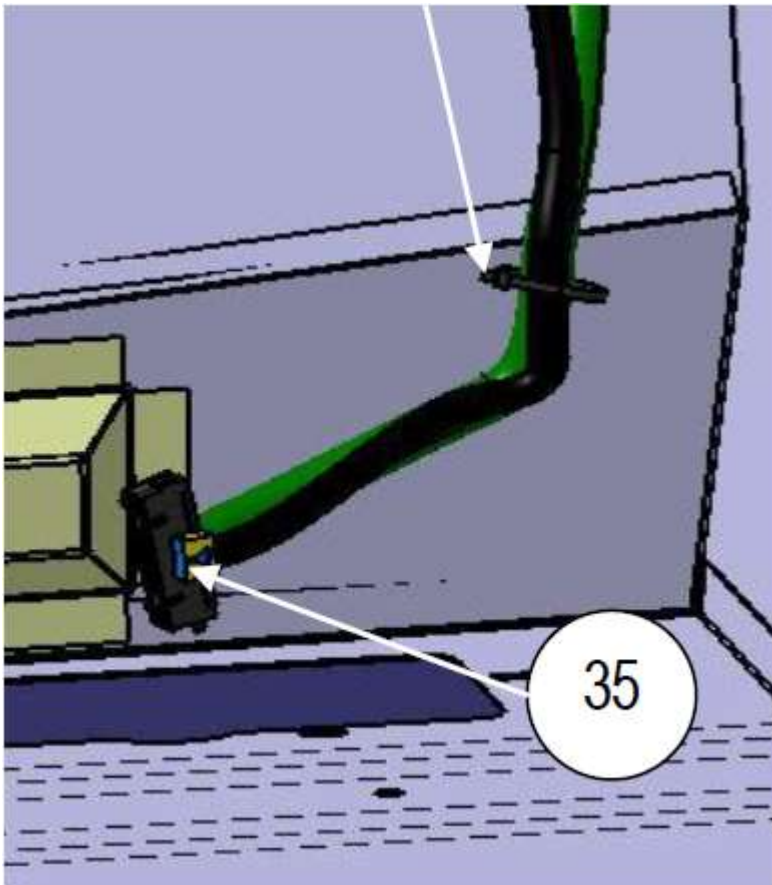
move the 2 wires on the TECU (Allison 80 pin connector)

- Move wire N143 move to Cavity 23
- Move wire N123 to Cavity 43

TECU is located on right side of cab (A)

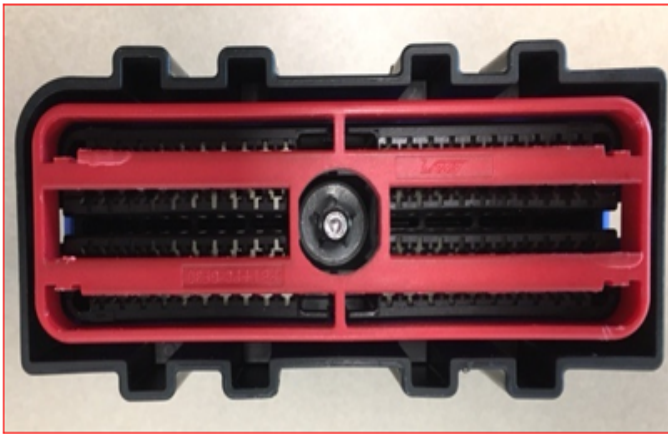
Cavity 43

Cavity 23

After you have swapped the wires in cavity 23 and 43, assemble the connector and plug it back in to the TECU and tighten the bolt. (DO NOT OVER TORQUE)

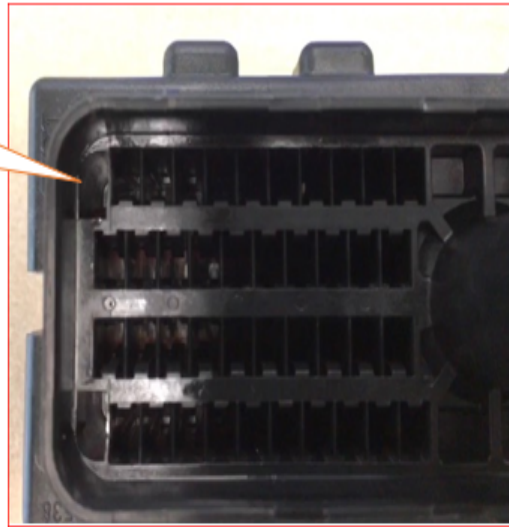
- After removing the 80-way connector, you will need to remove the red terminal lock terminal part #25193072 if needed

Locking fingers are located in each corner of the connector on the opposite side of the connector

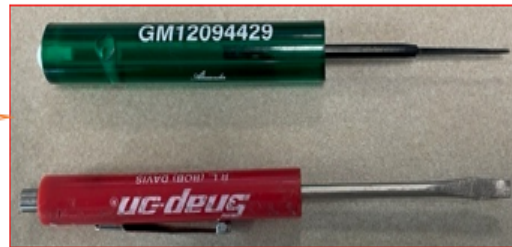
Use these tools or similar, to unlock the red terminal lock

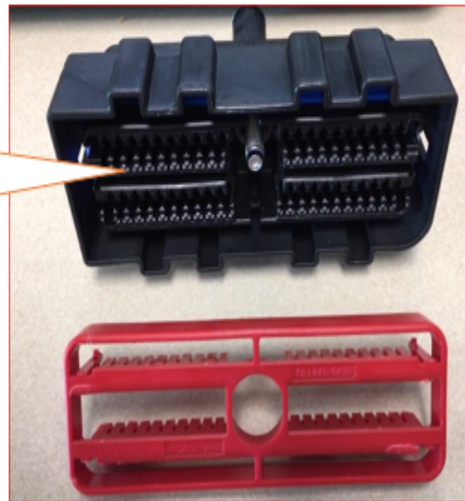
After lock has been removed you can use the terminal unlocking tool to unlock the wire terminal and slide the wire and terminal out the back side of the connector.

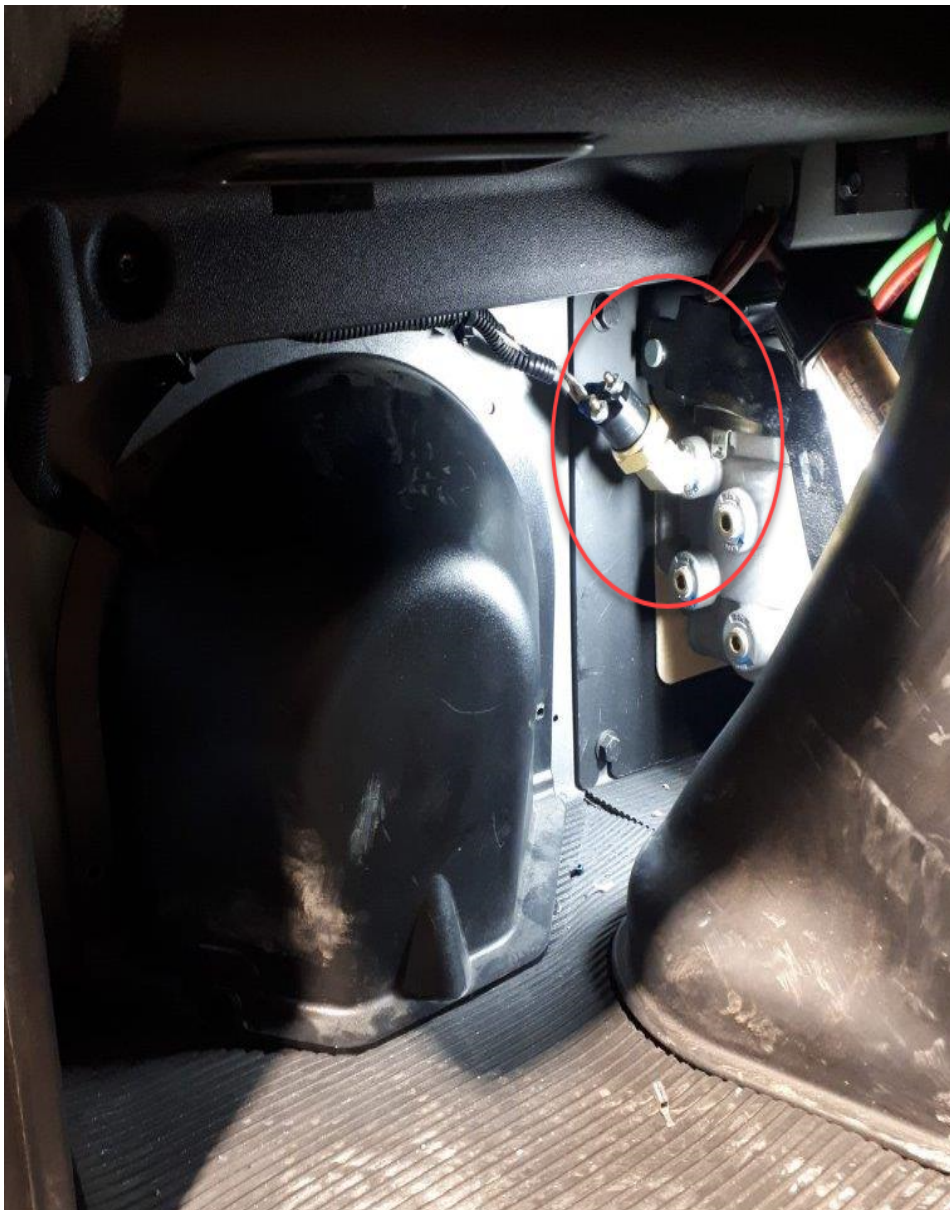
Visually inspect the service brake switch to verify that it is installed and the harness is connected. See image below.

If the service brake switch has not been installed refer to the p/n below.

Description	P/N
Allison Brake Switch	29511309
NOTE: The Mack brake switch listed below should only be used if the Allison switch is unavailable	
Mack Brake Switch	25165995

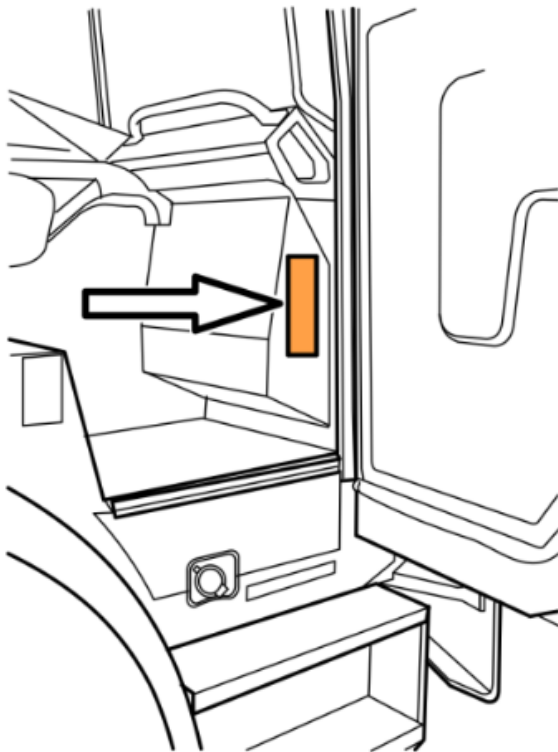
After this repair has been completed please install a Campaign Completion Label (**P/N 85152363**). Fill out the label and use **CBR-2240** for the recall number. See illustrations below.
