## Mack MMD Alternator Pulley

**Section** Function Group 321

Model Years	Models
2020 - 2022	MD6, MD7

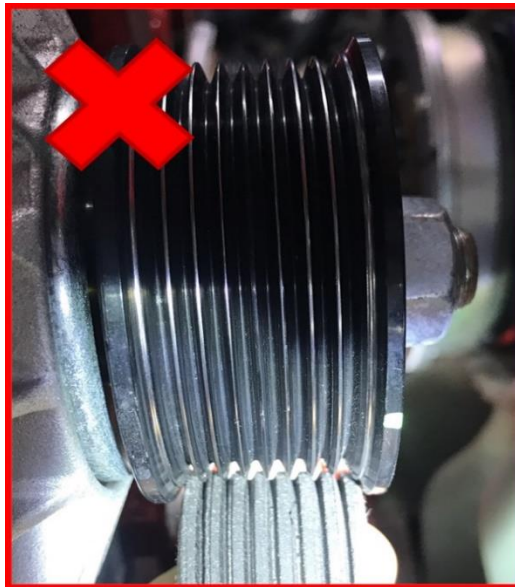
Incorrect

Mack Trucks has determined that certain Medium Duty Trucks may have an incorrect Alternator Pulley. On affected vehicles the alternator pulley has the incorrect groove pitch which may cause premature belt wear and in some instances the belt can slip off. To correct this issue the alternator pulley will need to be replaced with an updated part and a new alternator belt installed.

6. Remove alternator pulley and install new pulley part# **78635625**.
7. Install pulley retaining nut and hand tighten and ensure the pulley is fully seated.
