TECHNICAL SERVICE BULLETIN

Classification: EL23-001	Reference: ITB23-007	Date: February 17, 2023
-----------------------------	-------------------------	----------------------------

WIRELESS CHARGER DOES NOT CHARGE IPHONE 12 OR NEWER

APPLIED VEHICLES:	2022-2023 QX60 (L51) 2022-2023 QX80 (Z62)
APPLIED GRADES:	2022 QX60 – Except Pure and Luxe 2023 QX60 – All QX80 – All

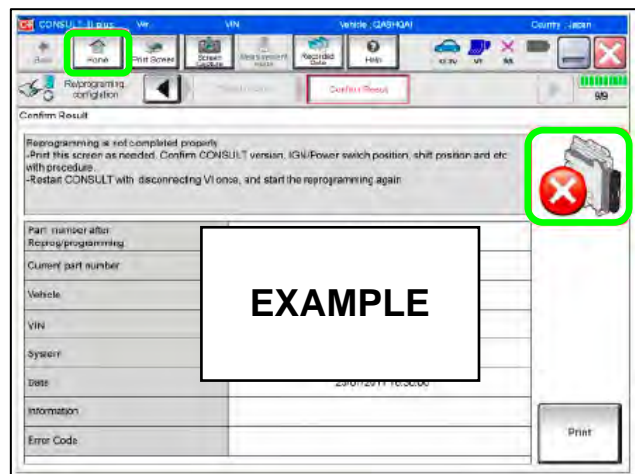
Figure 19

If reprogramming does not complete and the “X” icon displays, as shown in Figure 19:

- Check battery voltage (12.0 - 15.5 V).
- CONSULT A/C adapter is plugged in.
- Ignition is ON, engine OFF. Or if EV in Ready Mode.
- Transmission is in Park.
- All CONSULT VI cables are securely connected.
- All C-III plus updates are installed.
- Select **Home**, and restart the reprogram procedure from the beginning.
