# TECHNICAL SERVICE BULLETIN

Classification: BT09-052J	Reference: NTB09-081J	Date: February 27, 2023
------------------------------	--------------------------	----------------------------

## WINDSHIELD CRACKING

**APPLIED VEHICLES:** All Nissan

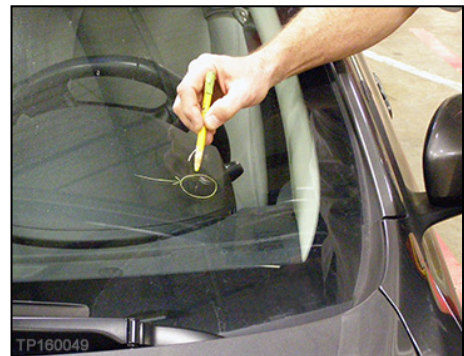
**Prior to removal, dealers must take at least two (2) digital photographs of the damaged area. Dealers are required to mark glass and other components returned that have “visible issues” using masking tape or appropriate means (grease pen, etc.) to identify and highlight the area damaged.**

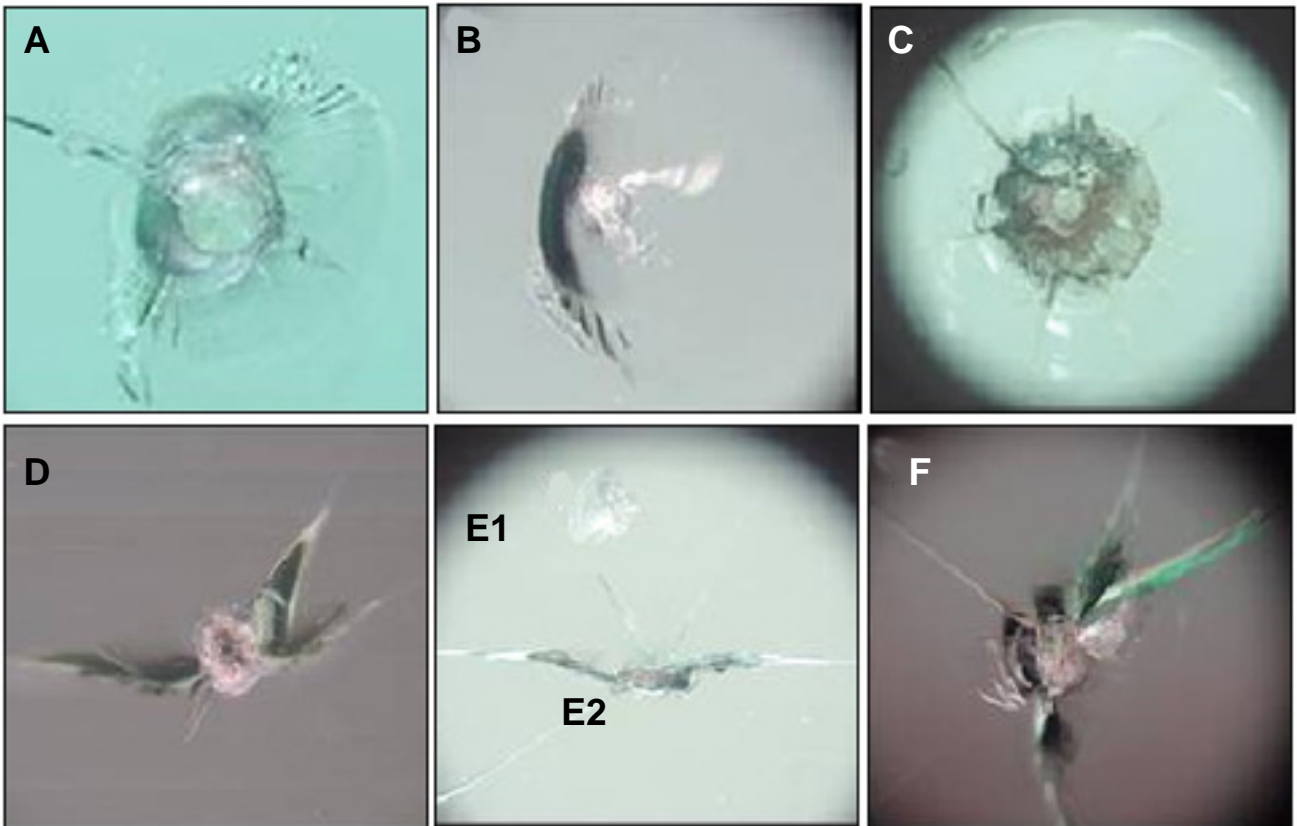
Most windshield damage that occurs due to impact is easily identified as shown below:

- Cone shaped break (A, B, C)
- Crush mark (D, E1, F)
- Star shape crack (C, D, E2, F).

Cracks can spread and become larger from the original strike point or crush mark due to:

- Thermal stresses caused by temperature fluctuation.
- External physical stresses, such as hand touch, wind force, or vehicle vibration during driving (pot holes).

A lead, or crack from one of the star cracked impact points can run to the edge of the glass and **appear** to be a low stress crack starting from the glass outside edge.

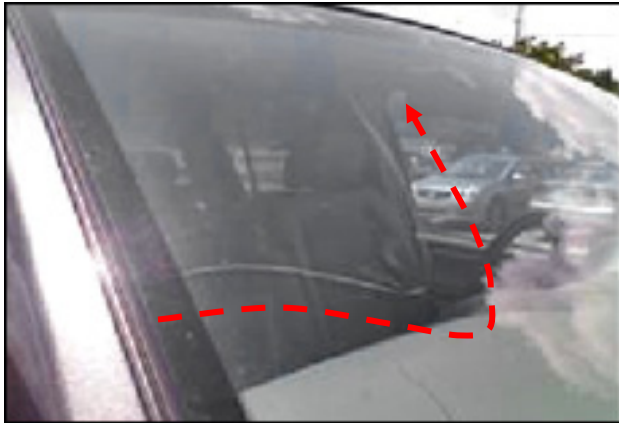
Single crack with **no** impact mark:  
**Warranty**

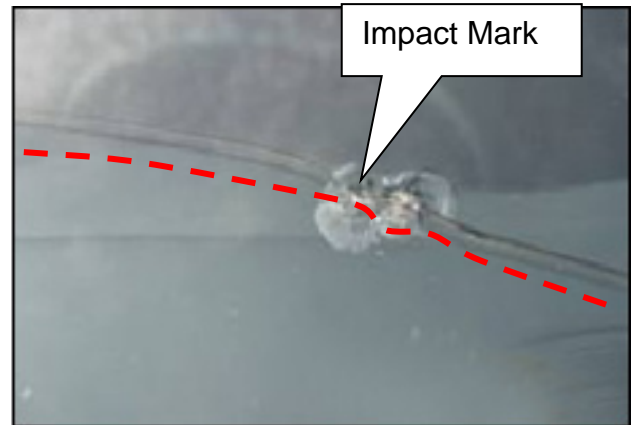
Single crack with impact mark:  
**Not Warranty**

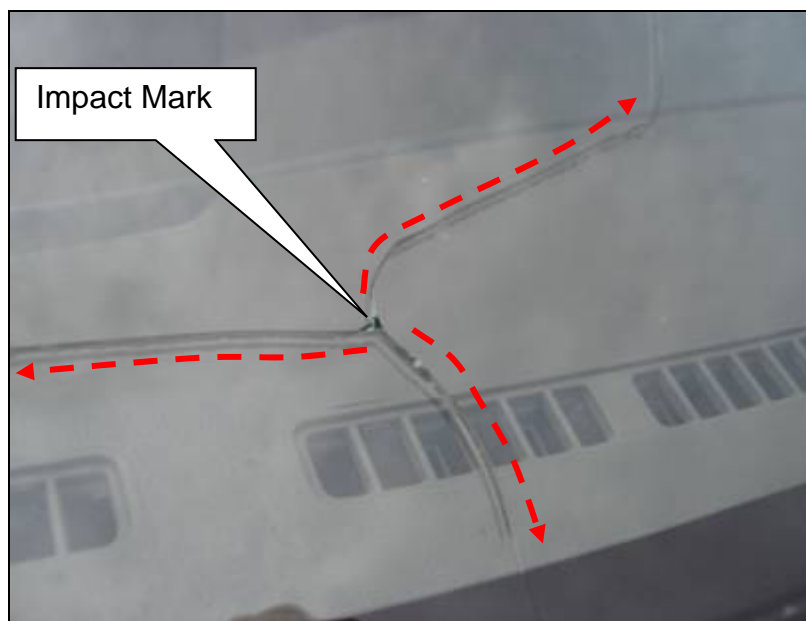
This type of crack is always caused by impact to the glass. The point of impact is located where the crack “branches out”.

Compound crack: **Not Warranty**

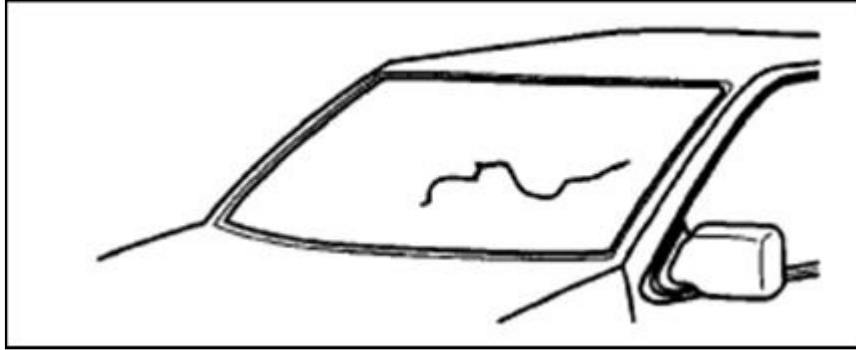
This type of crack does not begin or end at the edge of the glass.

- These cracks are always caused by an impact to the glass and are not covered under warranty.

Cracks not reaching the edge: **Not Warranty**

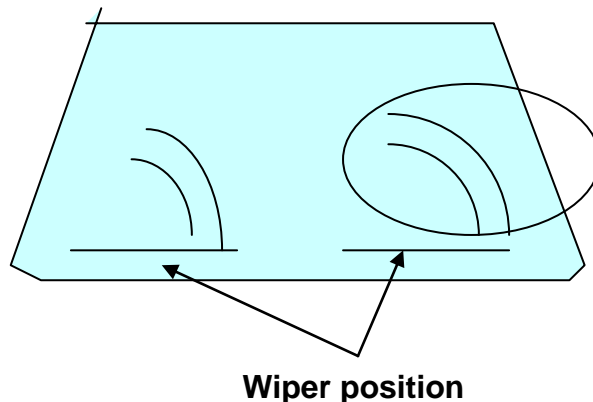
- Inspect the wiper paths (may be a single scratch of a group of scratches).
- Small scratches can cause a small rupture in the outer glass surface, which can lead to a crack from thermal conditions, vehicle vibration during driving, or wind pressure.

Scratch from sand/stone: **Not Warranty**

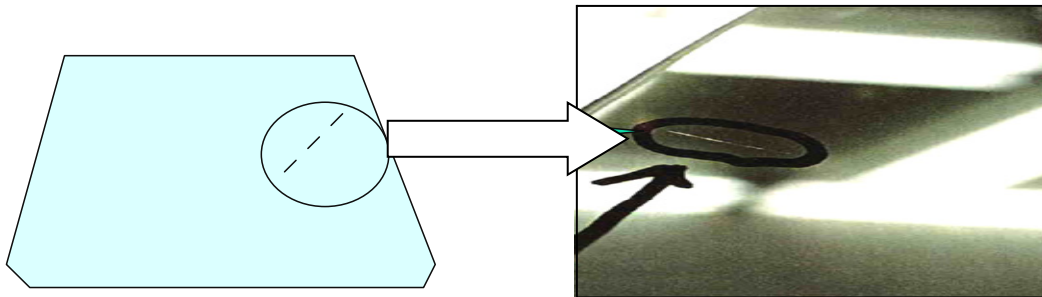
- Scratches can occur from metal objects such as keys and metal buttons. These scratches are typically sharp and can be found anywhere on the glass surface.
- Thoroughly examine the entire length of the crack to identify any scratch as a start point.
- Small scratches can cause a small rupture in the outer glass surface, which can lead to a crack from thermal conditions, vehicle vibration during driving, or wind pressure.

Scratch from metal objects: **Not Warranty**

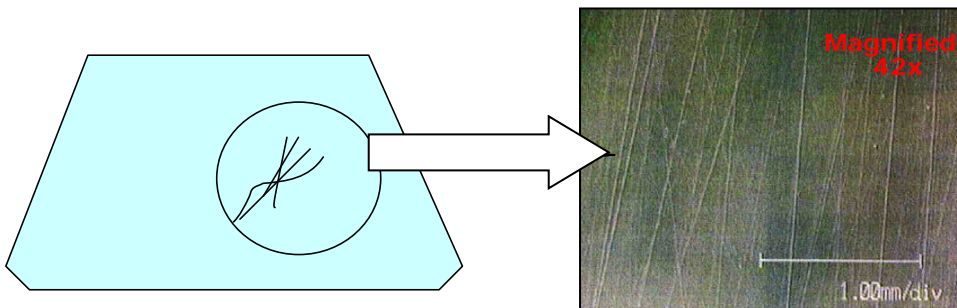
- Scratches can occur from wiping the glass with a towel that has sand particles or dirt on it.
- These scratches are typically long and have several scratches concentrated together.
- These scratches can be found anywhere on the glass surface.
- Thoroughly examine the entire length of the crack to identify any scratch as a start point.

Scratch from dirty towel/cloth: **Not Warranty**

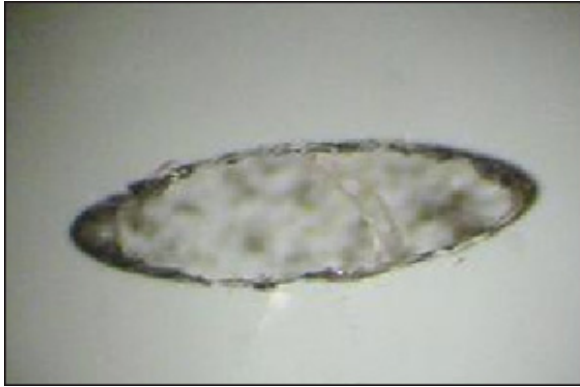
Open bubble – **Warranty**

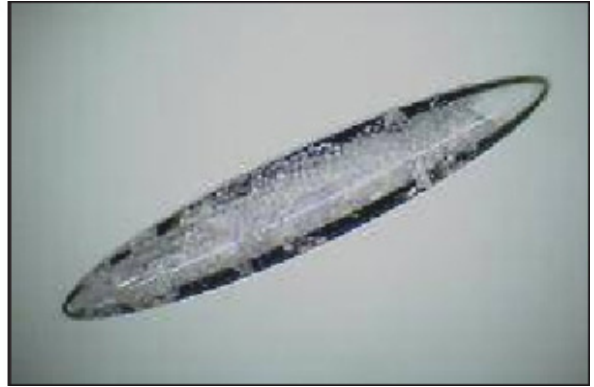
Surface blister - **Warranty**

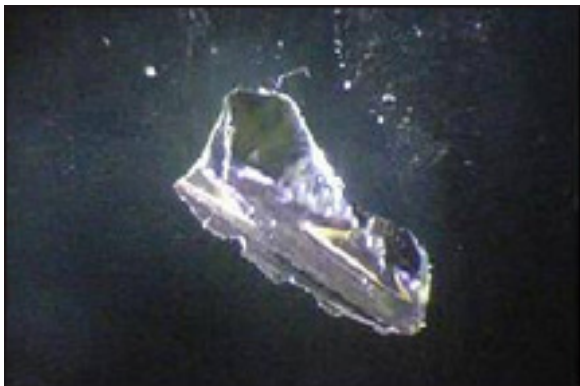
Adhesion chip – **Warranty**  
(Can occur from a manufacturing issue such as adhesion of molding to the glass surface along the glass edge.)

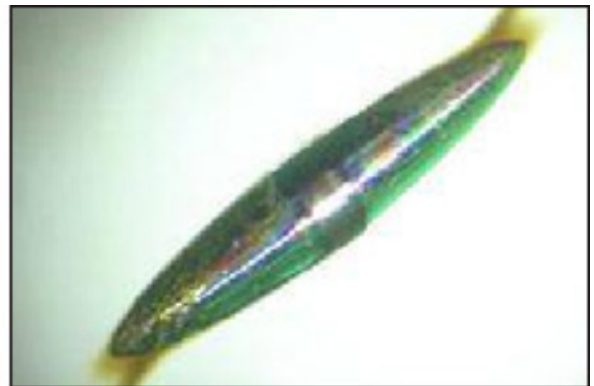
Surface blister – **Warranty**

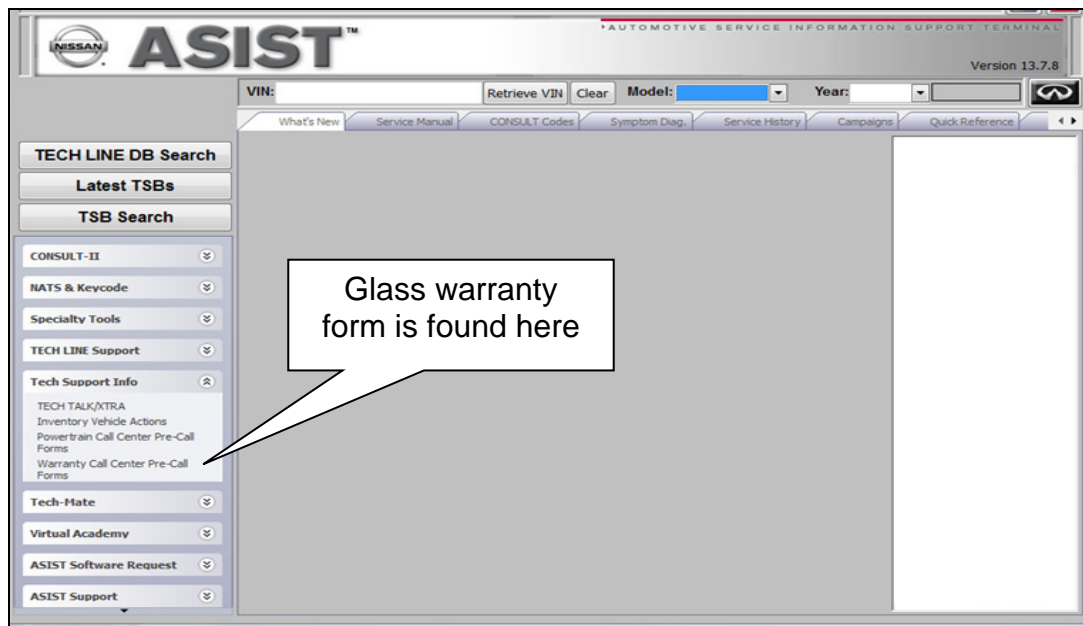
- Dealers are required to take at least two (2) digital photographs that clearly identify the alleged glass defect prior to removing the glass from the vehicle.
- Digital photographs must be kept in dealer records.
- Dealers are required to mark glass and other components returned that have “visible issues” using masking tape or appropriate means (grease pen, etc.) to identify and highlight the area damaged.
- The new glass warranty form must be completed and digital photograph files attached through ASIST for:
  1. Over DCAL Warranty Call Center pre-authorization
  2. Glass Part Return requests
- **The claim will be subject to a claim debit if the part is not marked properly and/or missing the required digital photographs (via ASIST) to support identification of a warrantable defect.**
