TECHNICAL SERVICE BULLETIN

Classification: FA10-006C	Reference: NTB10-126C	Date: February 22, 2023
------------------------------	--------------------------	----------------------------

WHEEL BEARING COLLISION DAMAGE

APPLIED VEHICLES: All Nissan

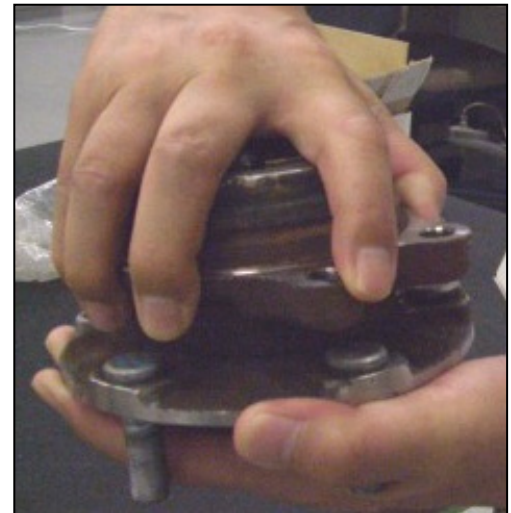
Figure 1

Impacts to wheel bearings (such as a collision or other suspension damage) may create slight indents in the bearing surfaces. These indents may not be visible but can cause bearing noise.

1. Remove the hub/bearing assembly from the vehicle.
2. Hold the hub/bearing assembly with both hands.
3. Rotate the hub/bearing assembly in both directions (clockwise and counterclockwise).
4. If any gritty or rough feeling is detected in the bearing, replace it with a new one.
