POWERTRAIN – LONG CRANK/ HARD START/ NO START DURING PDI-16- 3.0L

Refer to SSM 75912

23MY Land Rover Defender, Discovery

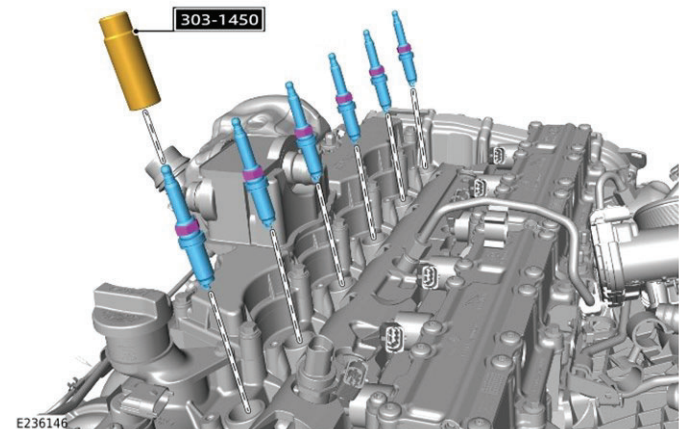
- Spark plugs may be found to be fuel fouled.
- In some circumstances Diagnostic Trouble Code (DTC) for misfire is also stored within the Powertrain control module (PCM).

- Please raise an TA with the following information.
 - Reference this SSM number
 - Evidence of any fuel on spark plugs and in combustion chamber
 - Any other observations that will help with the investigation of the failure
- If the customer concern has been rectified, attach all the information identified to the EPQR, quoting this SSM, along with the confirmation of concern/verbatim:
 - Vehicle Cranks longer than normal.
 - After a long crank, the vehicle starts, but runs rough.
 - Vehicle cranks and will not start.
 - Detail of diagnostic steps performed for hard starting condition.
