TECHNICAL SERVICE BULLETIN

Classification: EL22-018	Reference: NTB23-014	Date: February 17, 2023
-----------------------------	-------------------------	----------------------------

WIRELESS CHARGER DOES NOT CHARGE IPHONE 12 OR NEWER

APPLIED VEHICLES: 2021-2023 Rogue (T33)
2021-2023 Frontier (D41)
2021-2023 Armada (Y62)

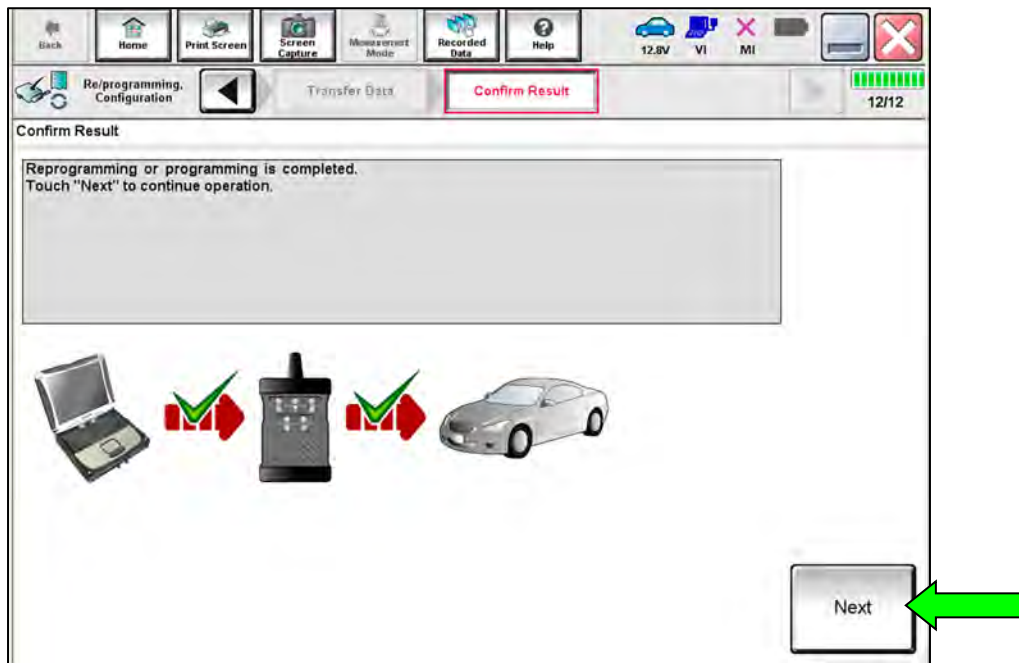
HINT: When the screen in Figure 17 displays, Wireless Charger reprogramming is complete. If the screen in Figure 17 does not display (indicating that reprogramming did not complete), refer to the information on the next page.

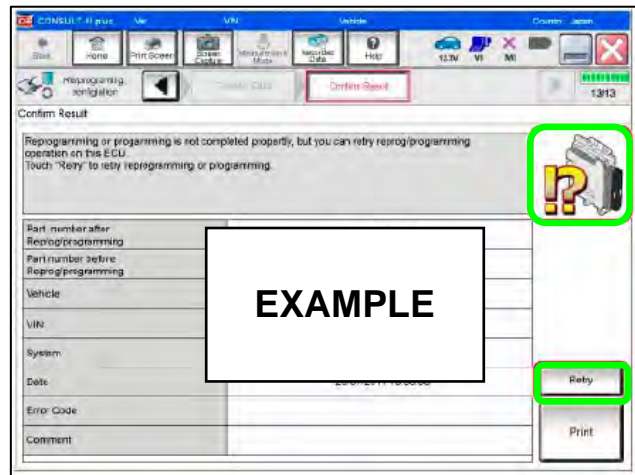
Figure 18

If reprogramming does not complete and the “!?” icon displays, as shown in Figure 18:

- Check battery voltage (12.0 - 15.5 V).
- Ignition is ON, engine OFF. Or if EV in Ready Mode.
- External Bluetooth® devices are OFF.
- **All** electrical loads are OFF.
- Select **Retry** and follow the on screen instructions.
- Retry may not go through on first attempt and can be selected more than once.

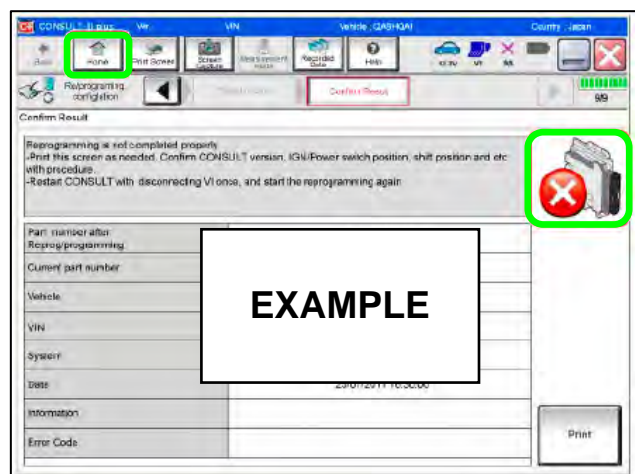
Figure 19

If reprogramming does not complete and the “X” icon displays, as shown in Figure 19:

- Check battery voltage (12.0 - 15.5 V).
- CONSULT A/C adapter is plugged in.
- Ignition is ON, engine OFF. Or if EV in Ready Mode.
- Transmission is in Park.
- All CONSULT VI cables are securely connected.
- All C-III plus updates are installed.
- Select **Home**, and restart the reprogram procedure from the beginning.
