Accessory Raised Air Intake

20-23MY Defender

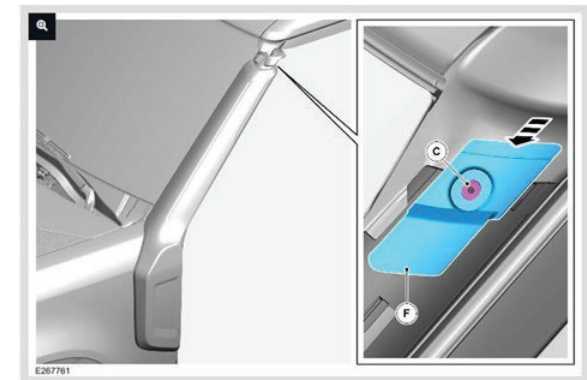
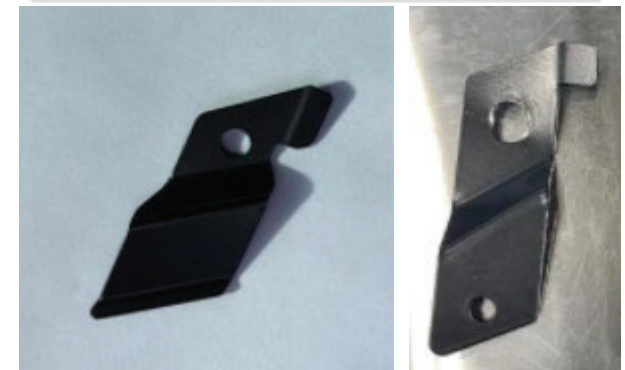
- A customer may complain of a rattling type noise from the accessory fitted raised air intake tube.

- Vehicles may experience loads that exceed that of the upper A-Pillar bracket, causing the plastic bracket to crack.

- A metal upper bracket to retain the air tube has been released for service to address this concern.
- SSM 75865 has been published to provide instructions and part number of the new bracket.
- Should a customer express a concern, please refer to this SSM.
- Some early released parts of the LR180431 bracket had the wrong width bracket (narrower) supplied. Using the narrower upper bracket would cause a rattle concern. All parts have been corrected to include the correct width metal bracket to directly replace the plastic bracket.
