## Body/Chassis – Water Leak From Roof Area

- **SSM 75903** has been published to address a potential water leak path through the roof body seam.
- Roof water leaks should be able to be repaired without the need to remove the complete roof cassette assembly.

22-23MY Range Rover, 23MY Range Rover Sport SVR

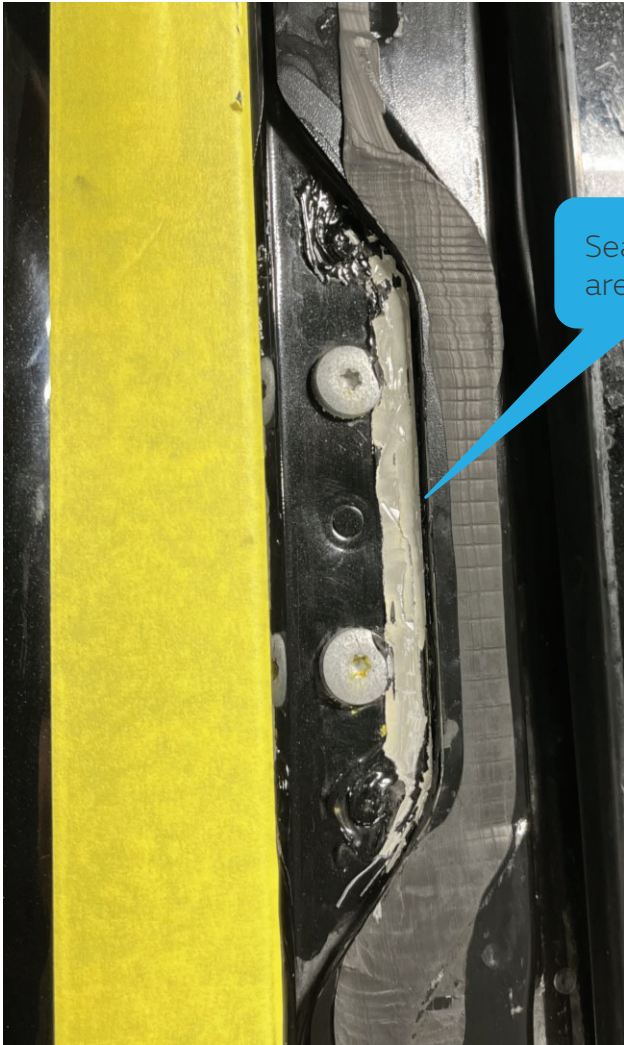
Seal this area

The area must be clean and dry before applying the PU adhesive.
