JLRTB02102NAS2

TECHNICAL BULLETIN

Engine Oil Leak From Cylinder Head

The customer has raised a concern about an engine oil leak evident under the vehicle. Further investigation has found that engine oil is leaking from one or more of the oil gallery ball bearing plugs on rear of the cylinder heads.

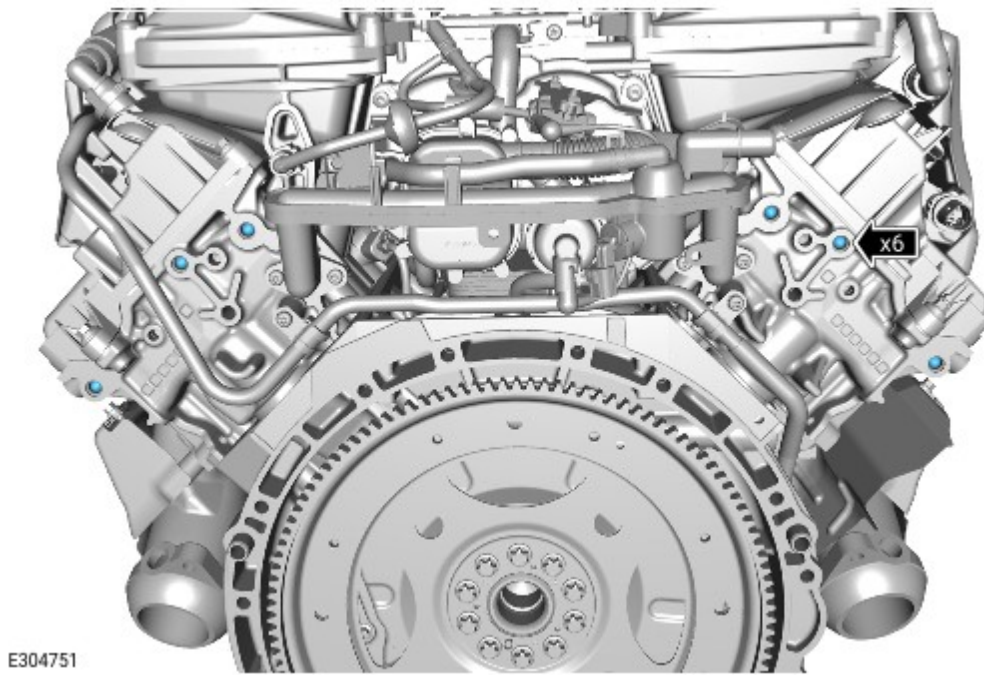
1.

This illustration shows the location of the 6 ball bearing plugs that must be sealed as part of this Technical Bulletin. **The steps 2 to 12 must be completed for each of the 6 ball bearing plugs.**
