Global Service Action  
Number: N750

<b>Subject:</b>  <b>Front shock absorber incorrectly installed</b>	Publication No.: N750
	Model: Range Rover (LK)
	Model Year: 2023
	Model: Range Rover Sport (L1)
	Model Year: 2023
	Date of Issue: 22 February 2023
	Expiry Date: 28 February 2025

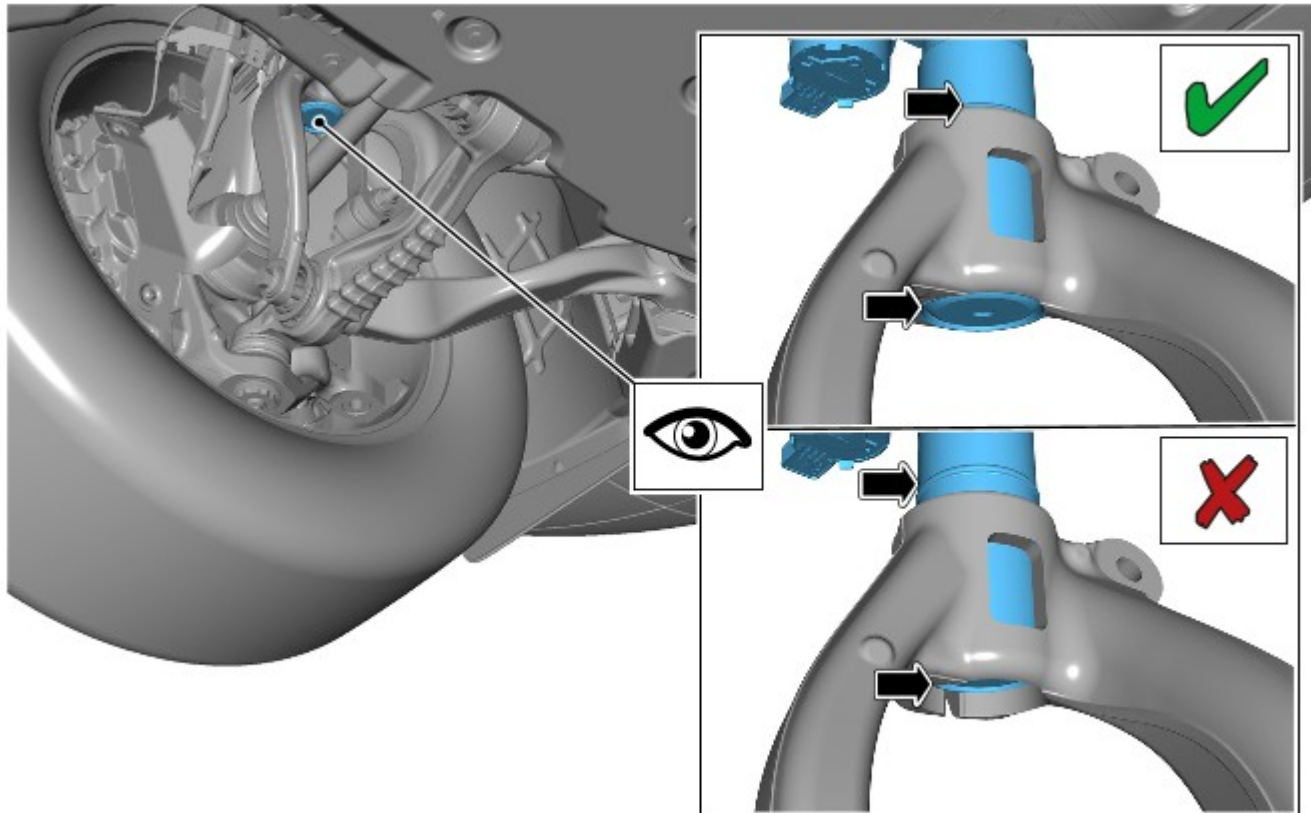
E324428

On certain 2023 model year Range Rover and Range Rover Sport vehicles the front left shock absorber may not be fully installed into the yoke.

2. Visually inspect the installed position of the front left shock absorber into the yolk.

If the front left shock absorber **is** fully installed in the yolk, as shown in the image with a green '✓', no further action is required. Lower the vehicle and release.

If the front left shock absorber **is not** fully installed in the yolk, as shown in the image with a red 'X', continue to the SERVICE INSTRUCTION.
