# UPDATE PRIOR TO SALE NOTICE

Global Service Action  
Number: N763 UPS8522-5

<b>Subject:</b>  <b>Camshaft Carrier Drill Hole</b>	Publication No.: N763 UPS8522-5
	Model: Range Rover (LK)
	Model Year: 2023
	Model: Range Rover Sport (L1)
	Model Year: 2023
	Model: Discovery (LR)
	Model Year: 2023
	Model: Defender (LE)
	Model Year: 2023
	Model: Range Rover Velar (LY)
	Model Year: 2023 - 2024
	Date of Issue: 03 February 2023
	Expiry Date: 09 December 2023

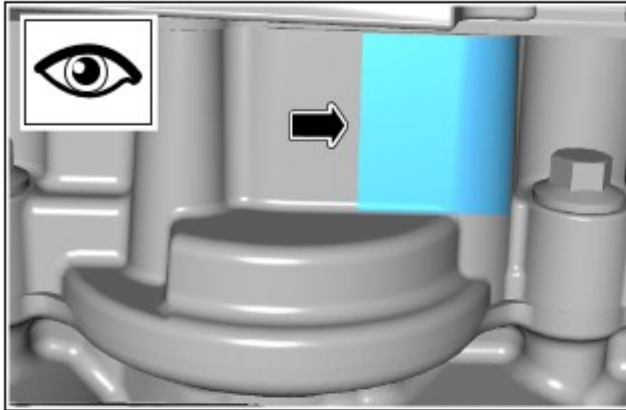
E323282

2. Locate the highlighted area of the camshaft carrier shown in the illustration.

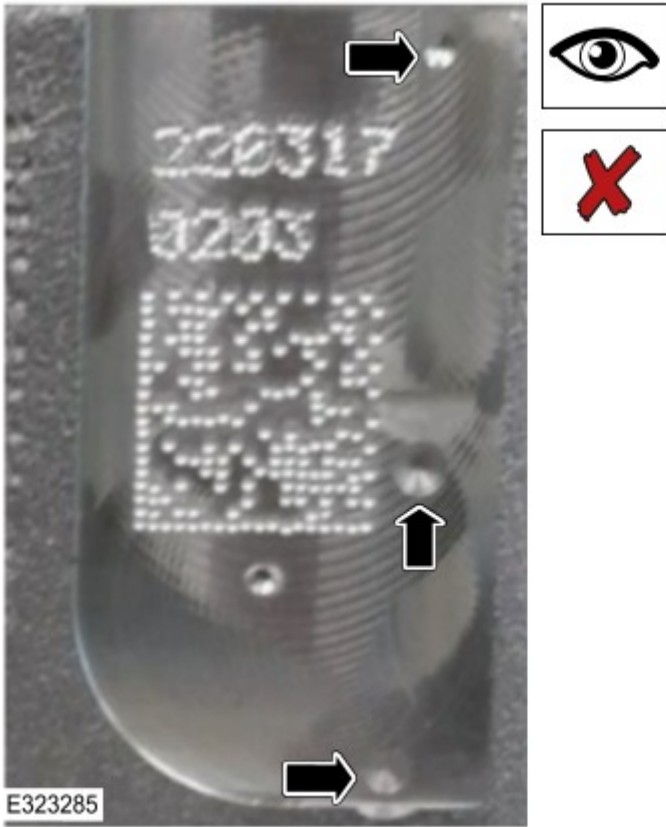
6. The failure condition shown highlights 3 drilled tooling marks in the upper, middle and lower right side of the tooling stamp.

If the 3 drilled tooling marks in the upper, middle and lower right side of the tooling stamp are **ALL** present, then the vehicle has failed the inspection.

1. Renew the camshaft carrier, (see TOPIx Workshop Manual section 303-01: Engine - INGENIUM I6 3.0L PETROL - Removal and Installation - Camshaft Carrier).

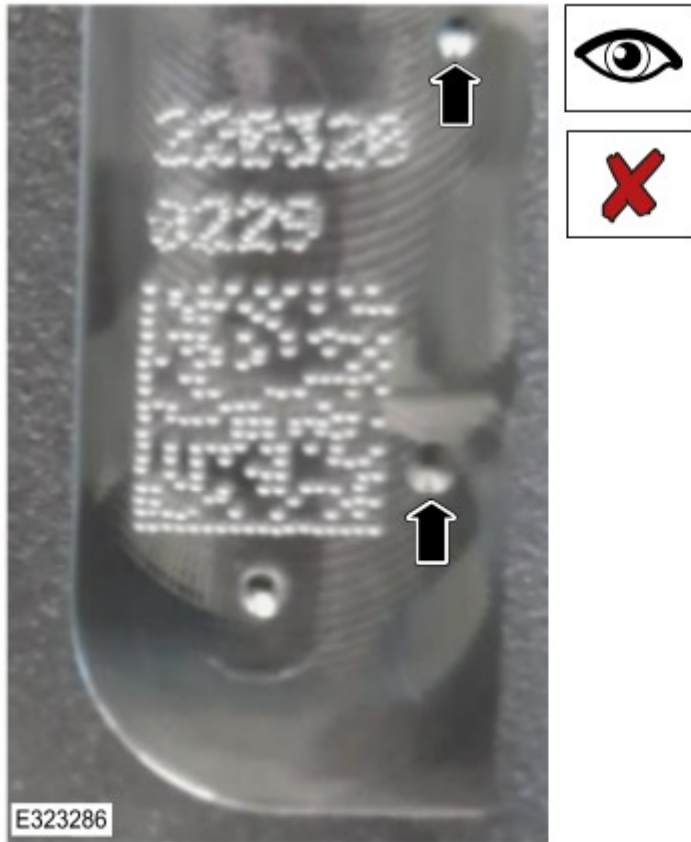
7. The failure condition shown highlights 2 drilled tooling marks in the upper and middle right side of the tooling stamp.

If the 2 drilled tooling marks in the upper and middle right side of the tooling stamp are **BOTH** present, then the vehicle has failed the inspection.
