UPDATE PRIOR TO SALE NOTICE

Global Service Action
Number: N763v6 UPS8522-
6

Subject: Camshaft Carrier Drill Hole	Publication No.: N763v6 UPS8522-6
	Model: Range Rover (LK)
	Model Year: 2023
	Model: Range Rover Sport (L1)
	Model Year: 2023
	Model: Discovery (LR)
	Model Year: 2023
	Model: Defender (LE)
	Model Year: 2023
	Model: Range Rover Velar (LY)
	Model Year: 2023 - 2024
	Date of Issue: 07 February 2023
	Expiry Date: 09 December 2023

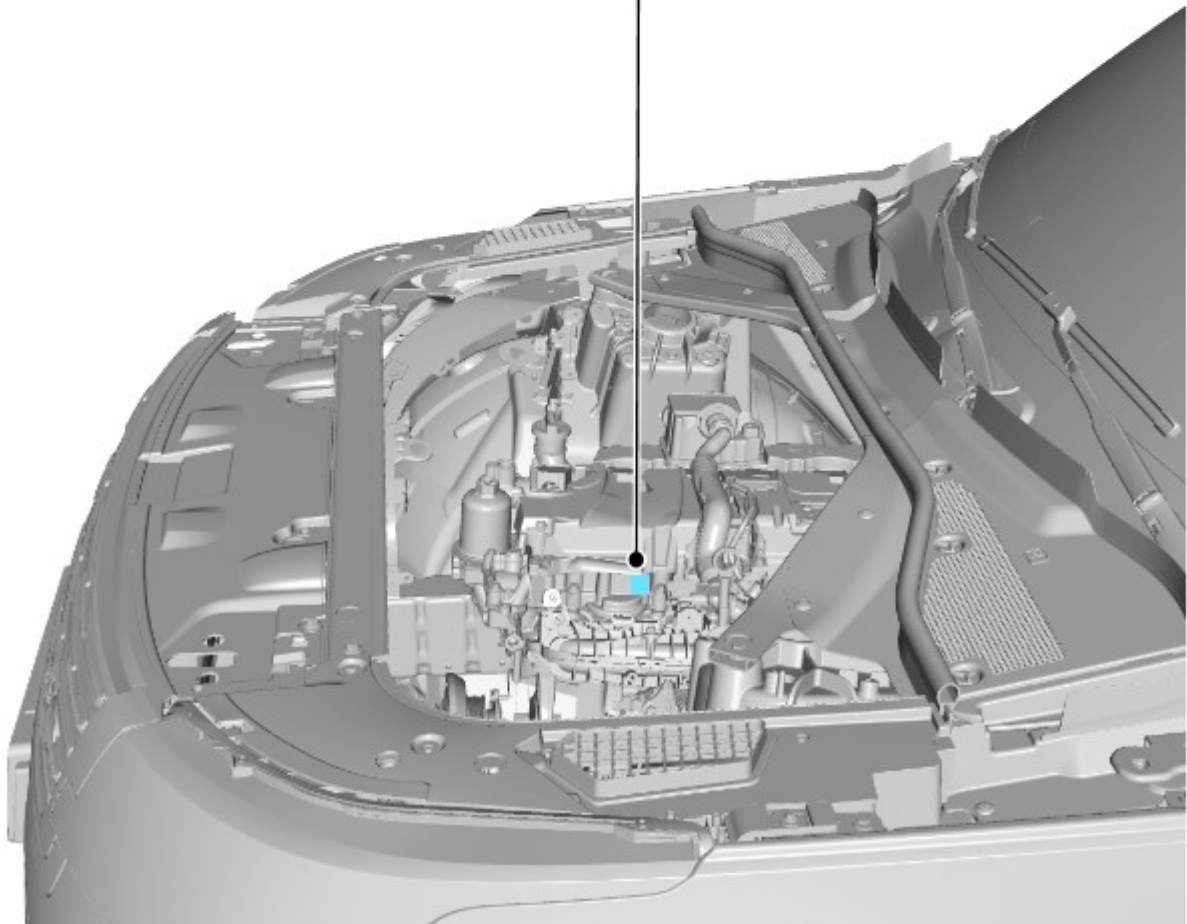
E323282

2. Locate the highlighted area of the camshaft carrier shown in the illustration.

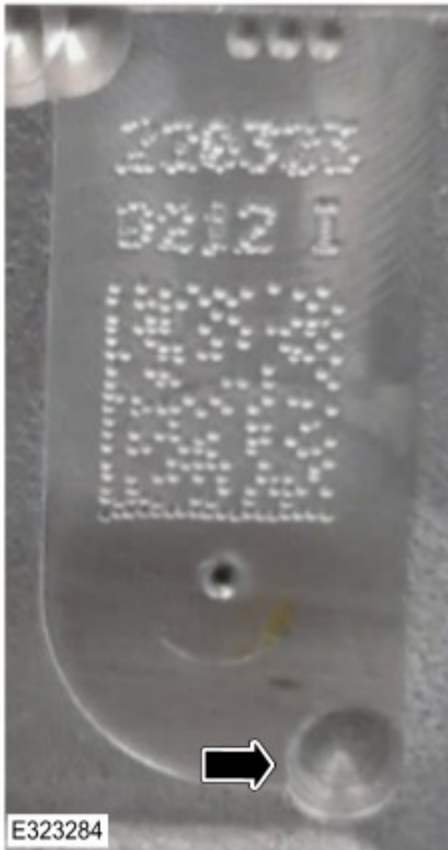
5. The failure condition shown highlights 1 drilled tooling mark in the lower right side of the tooling stamp.

If the 1 drilled tooling mark in the lower right side of the tooling stamp is present, then the vehicle has failed the inspection.

1. Renew the camshaft carrier, (see TOPIx Workshop Manual section 303-01: Engine - INGENIUM I6 3.0L PETROL - Removal and Installation - Camshaft Carrier).

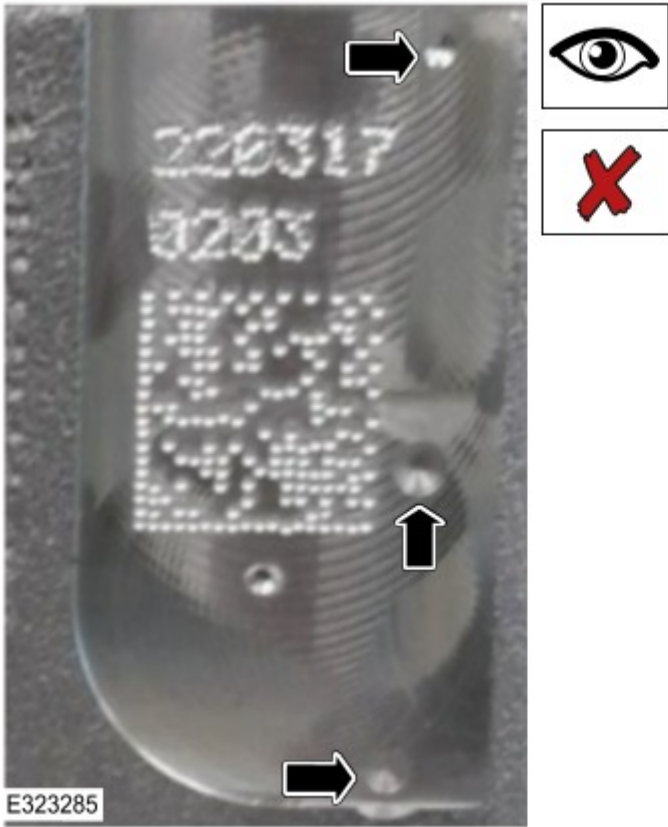
6. The failure condition shown highlights 3 drilled tooling marks in the upper, middle and lower right side of the tooling stamp.

If the 3 drilled tooling marks in the upper, middle and lower right side of the tooling stamp are **ALL** present, then the vehicle has failed the inspection.

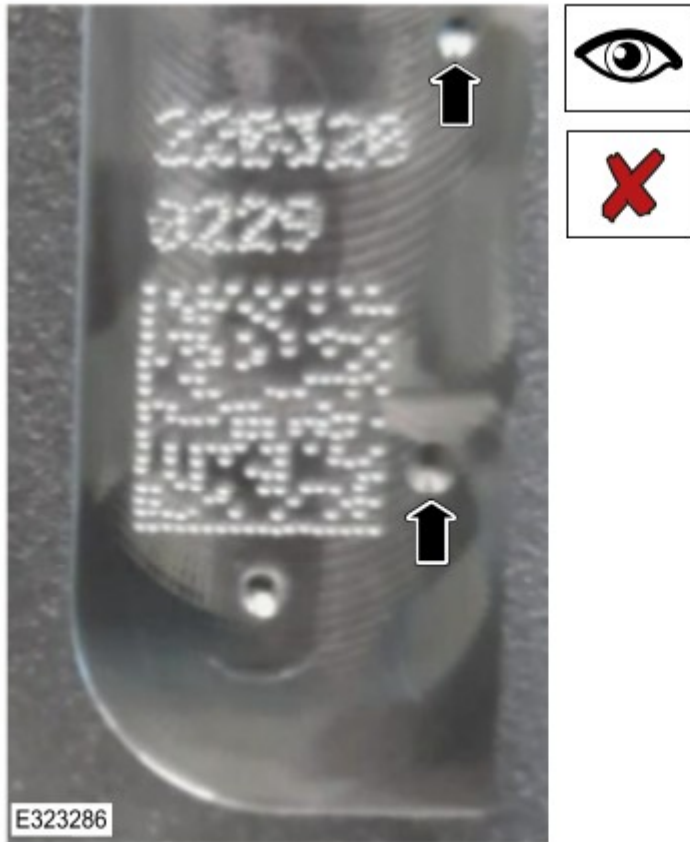
7. The failure condition shown highlights 2 drilled tooling marks in the upper and middle right side of the tooling stamp.

If the 2 drilled tooling marks in the upper and middle right side of the tooling stamp are **BOTH** present, then the vehicle has failed the inspection.
