TECH TIP

**S-SERIES ABS LIGHT ON C2200 (49)
DTC**

**GROUP: 0-GENERAL
TECH TIP NO: TT-23-014
DATE: 2-14-23**

Subject Vehicles: 2022 Model Year through Current S-Series trucks.

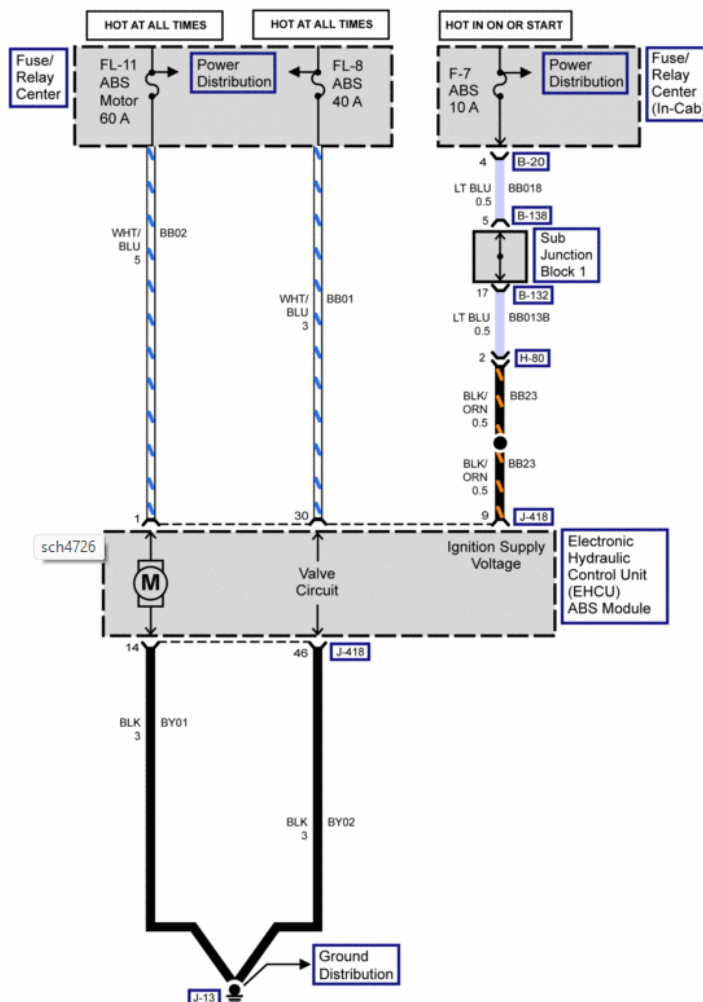
Some 22MY-Current S-Series Trucks may experience an ABS light with DTC C2200 (49) set. When following published diagnosis for this DTC, it may lead to unnecessary replacement of the EHCU (Electronic Hydraulic Control Unit). We have found that addressing a poor ground connection for the EHCU has corrected this DTC. Follow the service procedure prior to replacing any parts.

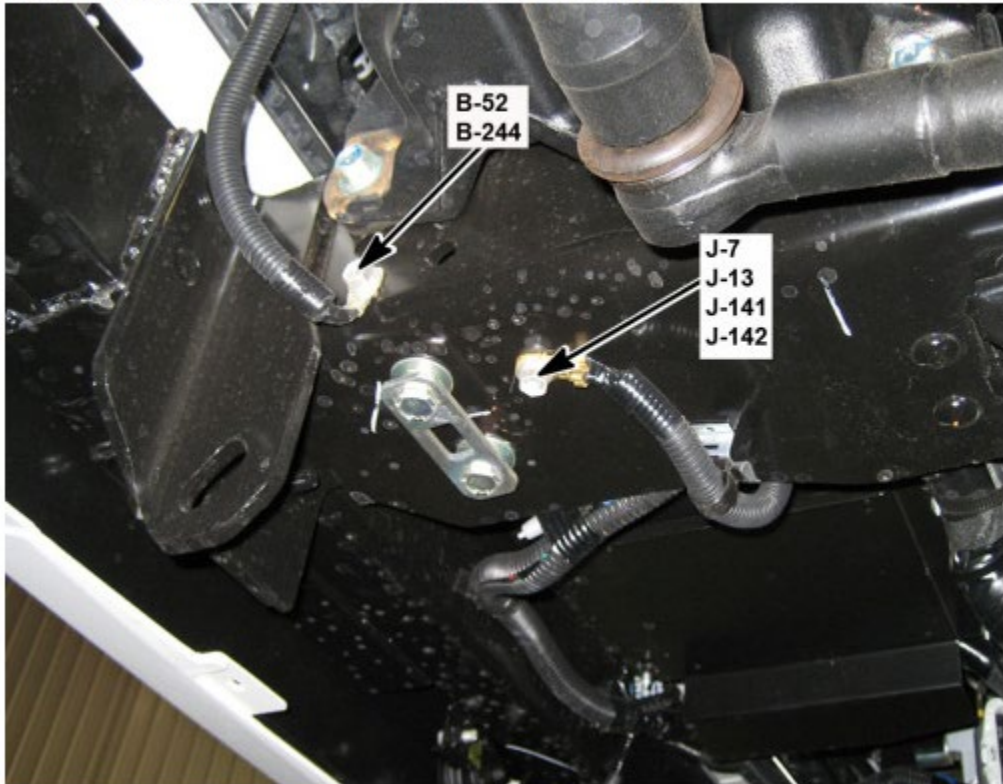
On the Front Left Frame Rail, Behind the Front Bumper

1. Locate ground J-13 for the EHCU (Electronic Hydraulic Control Unit).

2. Remove the fastener securing the ground eyelet, clean the ground eyelet itself and remove paint from the frame around this connection.
3. Secure the eyelet back on to the frame, securing the fastener, ensuring a good and tight connection.
4. If the issue persists after cleaning this ground, follow published diagnosis.
