SERVICE ACTION

Global Service Action
Number: N770

Subject: Transmission Bell Housing Bolt - Torque Check	Publication No.: N770
	Model: Range Rover (LK)
	Model Year: 2023
	Model: Range Rover Sport (L1)
	Model Year: 2023
	Date of Issue: 21 February 2023
	Expiry Date: 28 February 2025

On certain 2023 model year Range Rover and Range Rover Sport vehicles, the transmission bell housing bolts may not have been tightened to the correct torque specification.

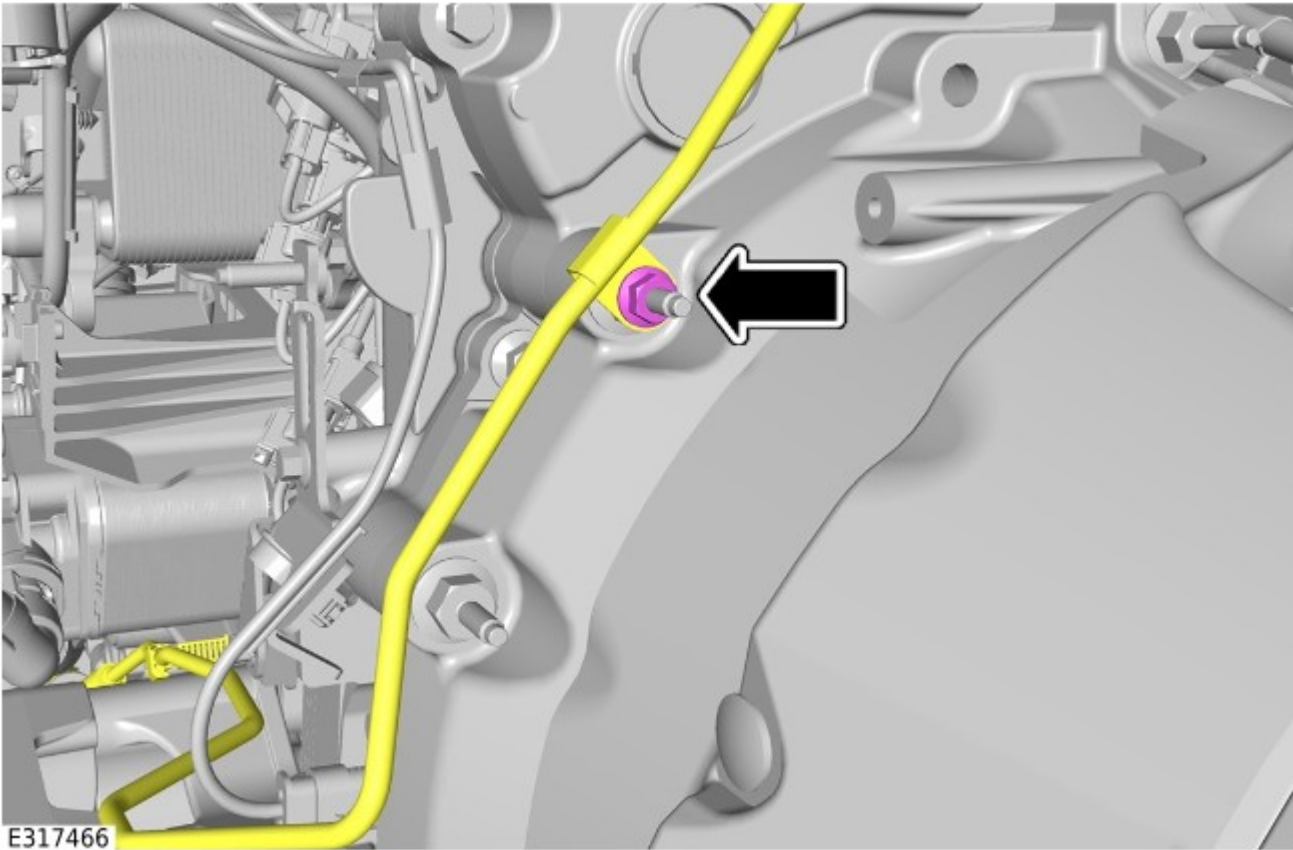
E317466

2. Reposition the front differential breather pipe to access the transmission bell housing bolt.

Remove the nut.

Torque: **22 Nm**

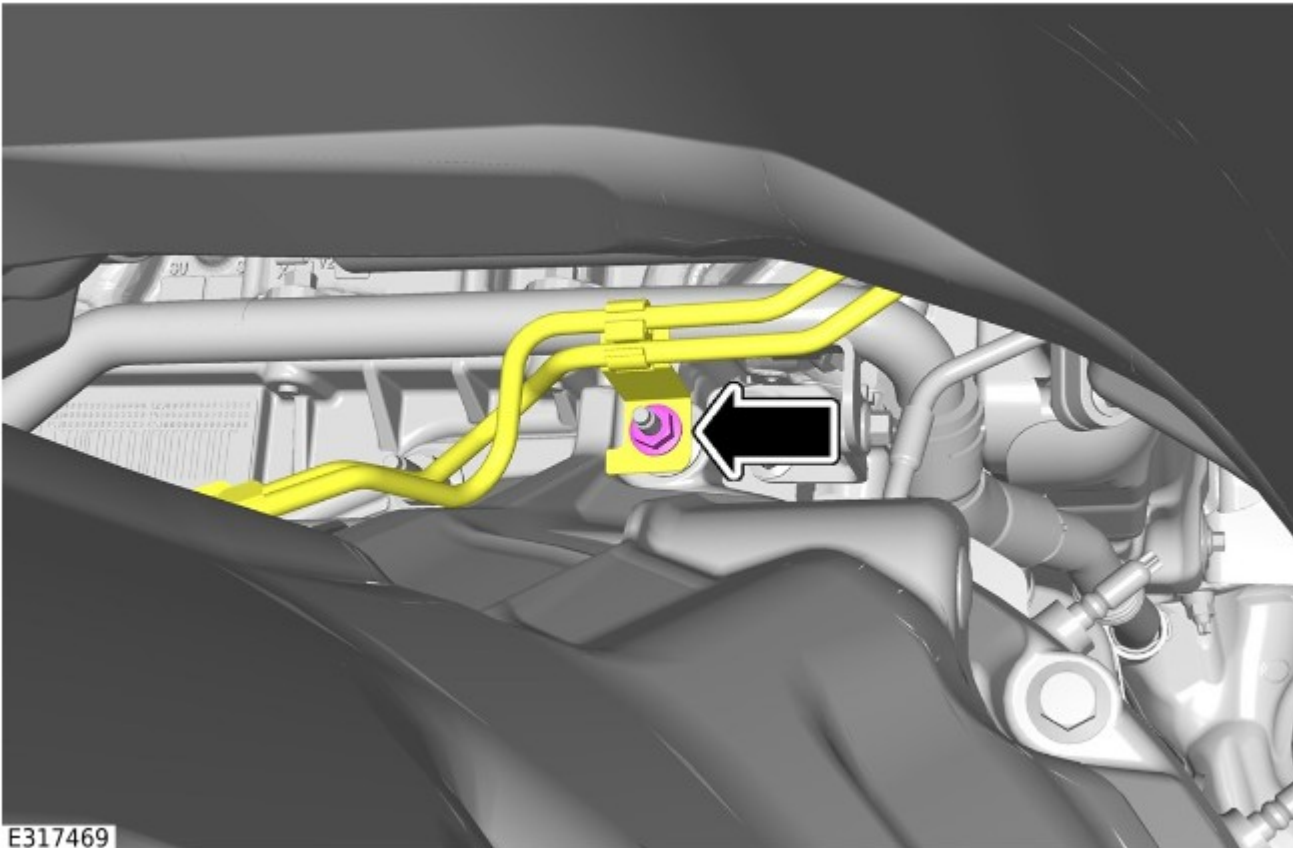
E317469

3. Reposition the transmission breather pipes to access the transmission bell housing bolt.

Using a suitable extension and universal joint, remove the nut.

Torque: **22 Nm**

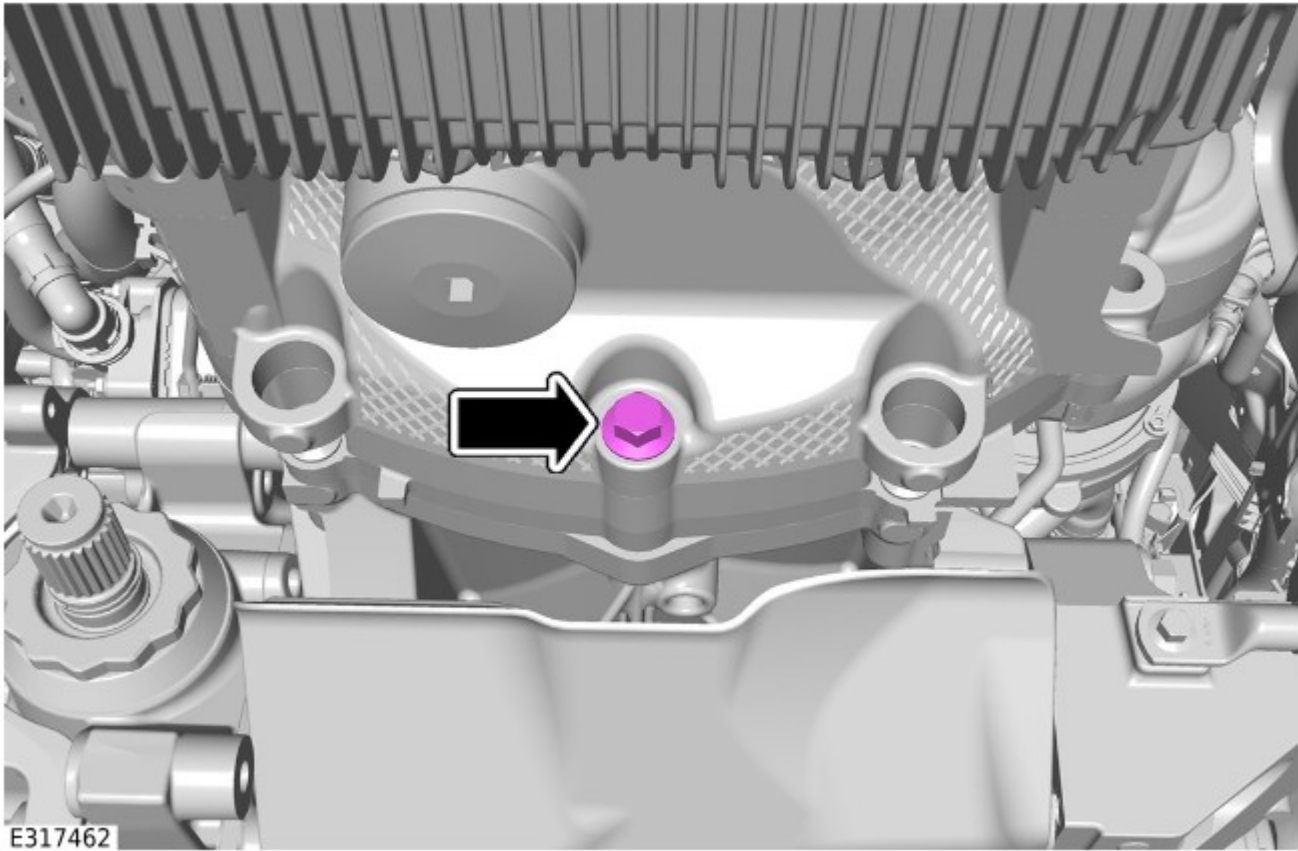
4. Tighten the transmission bell housing bolt.

Torque: **40 Nm**

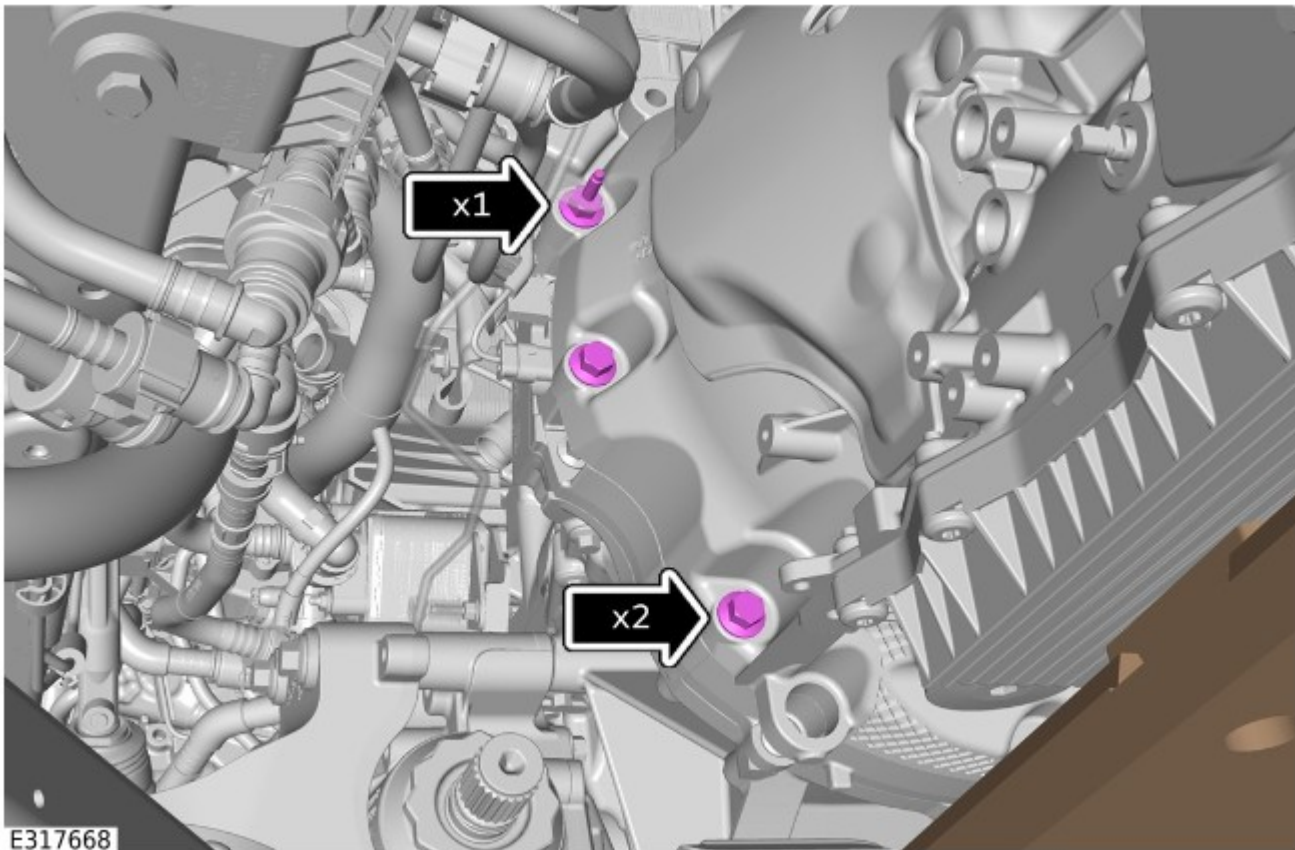
E317668

5. Tighten the 3 transmission bell housing bolts.

Torque: 40 Nm

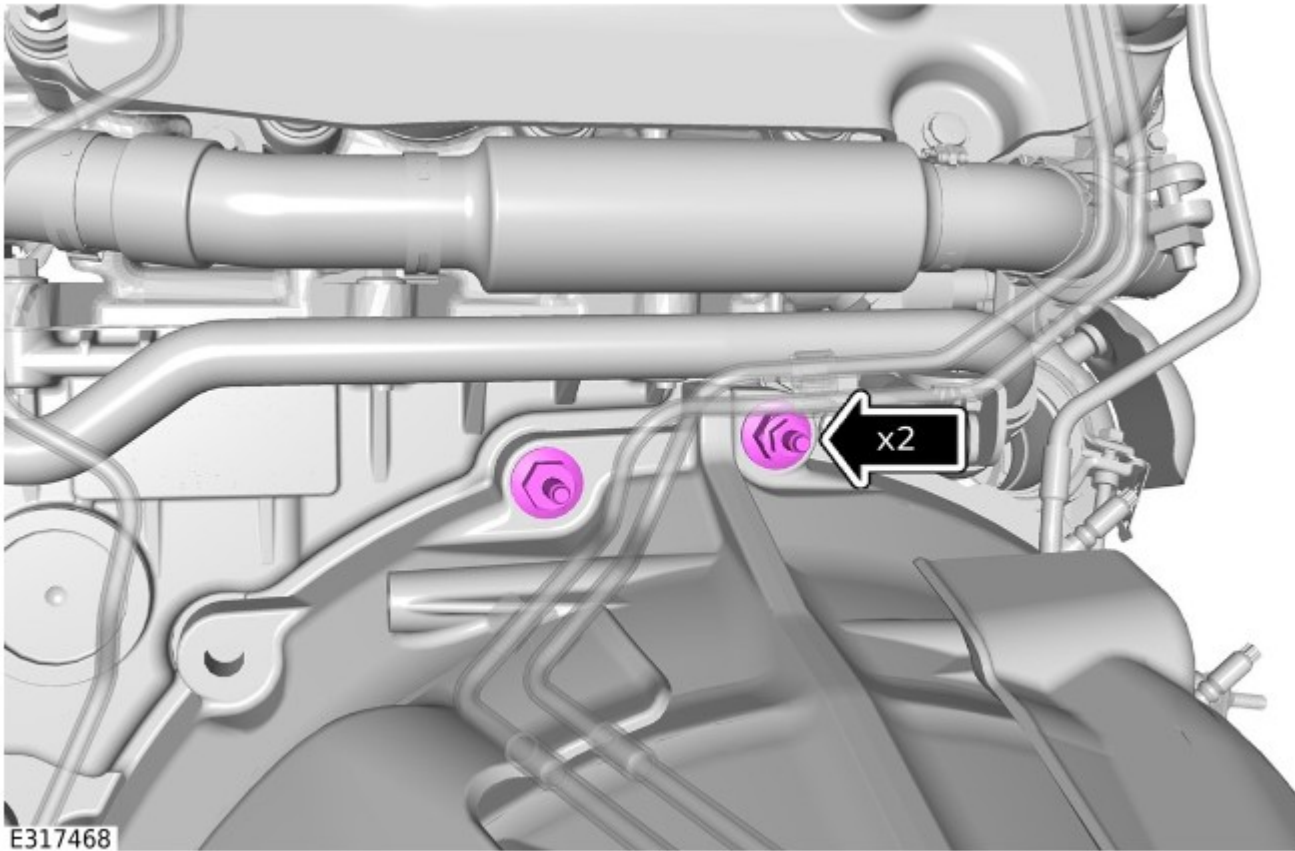
E317468

6. Using a suitable extension and universal joint, tighten the 2 transmission bell housing bolts.

Torque: **40 Nm**

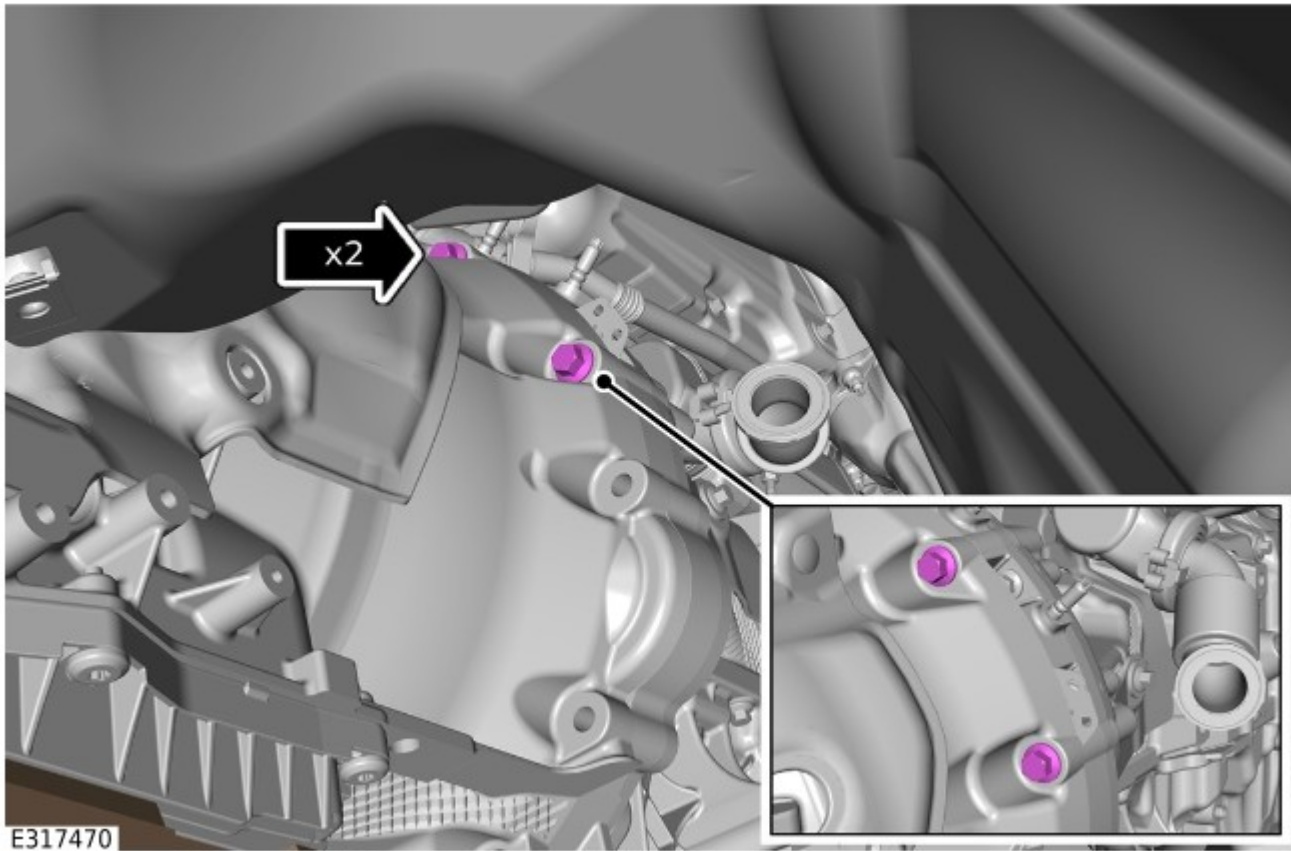
7. Using a suitable extension and universal joint, tighten the 2 transmission bell housing bolts.

Torque: **40 Nm**

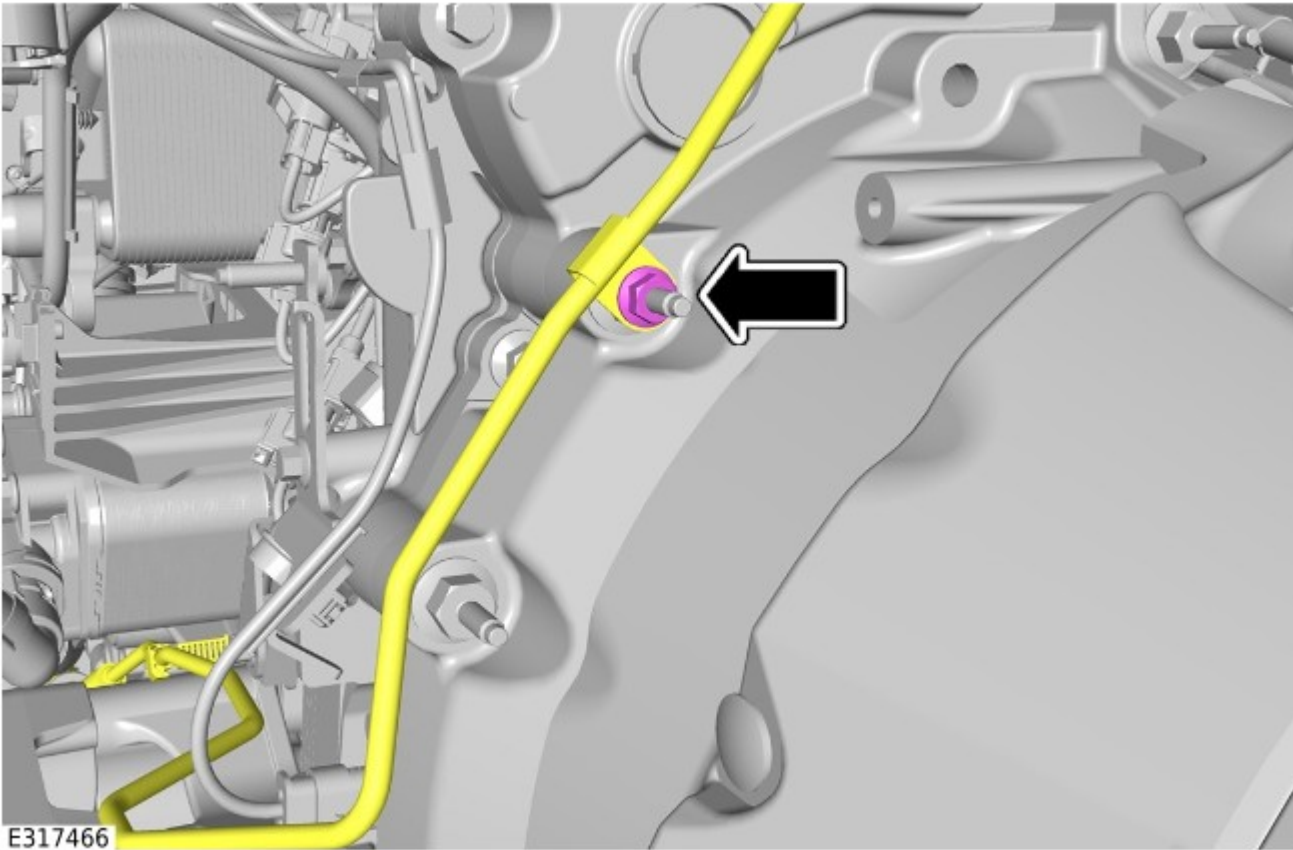
E317466

2. Reposition the front differential breather pipe to access the transmission bell housing bolt.

Remove the nut.

Torque: **22 Nm**

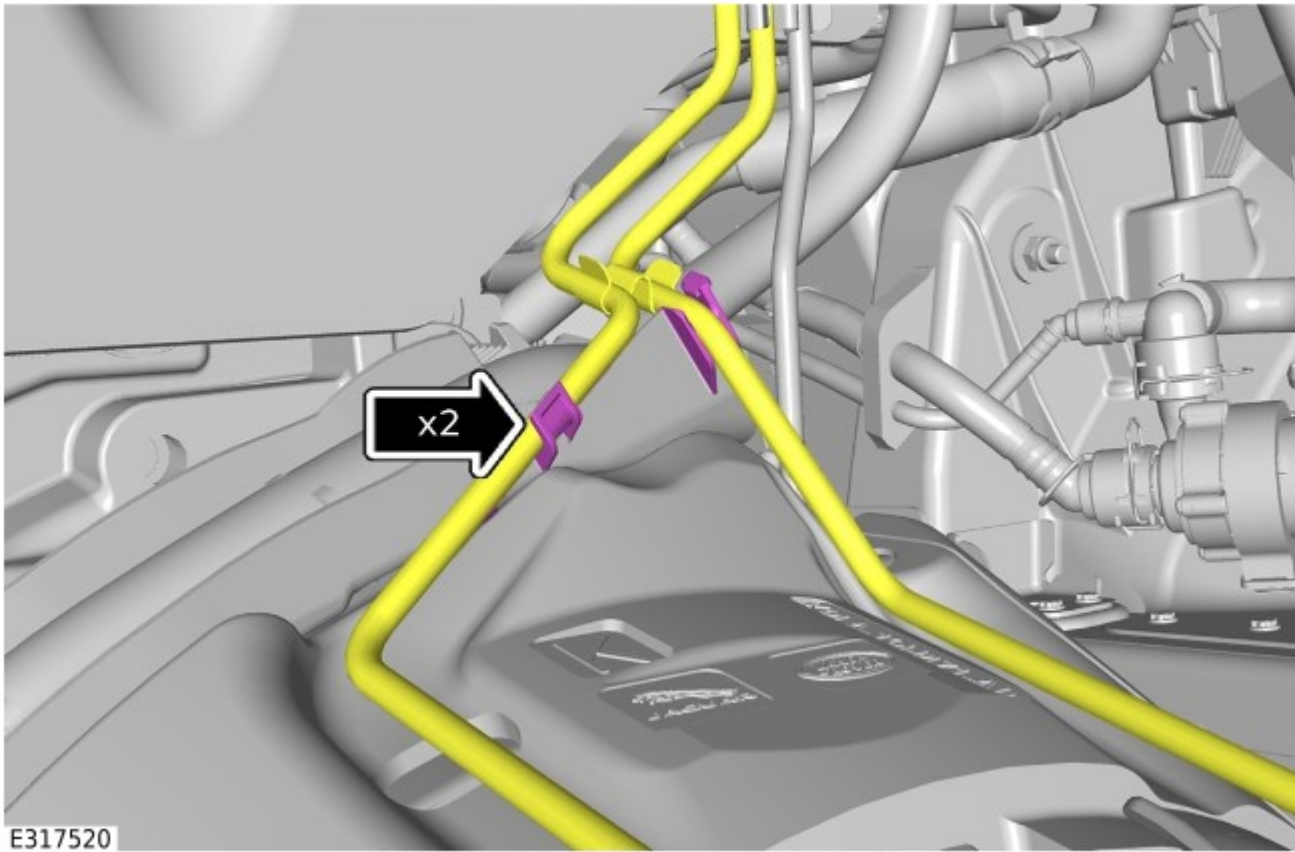
E317520

3. Release the 2 transmission breather pipes from the [Mild Hybrid Electric Vehicle \(MHEV\)](#) cable bracket.

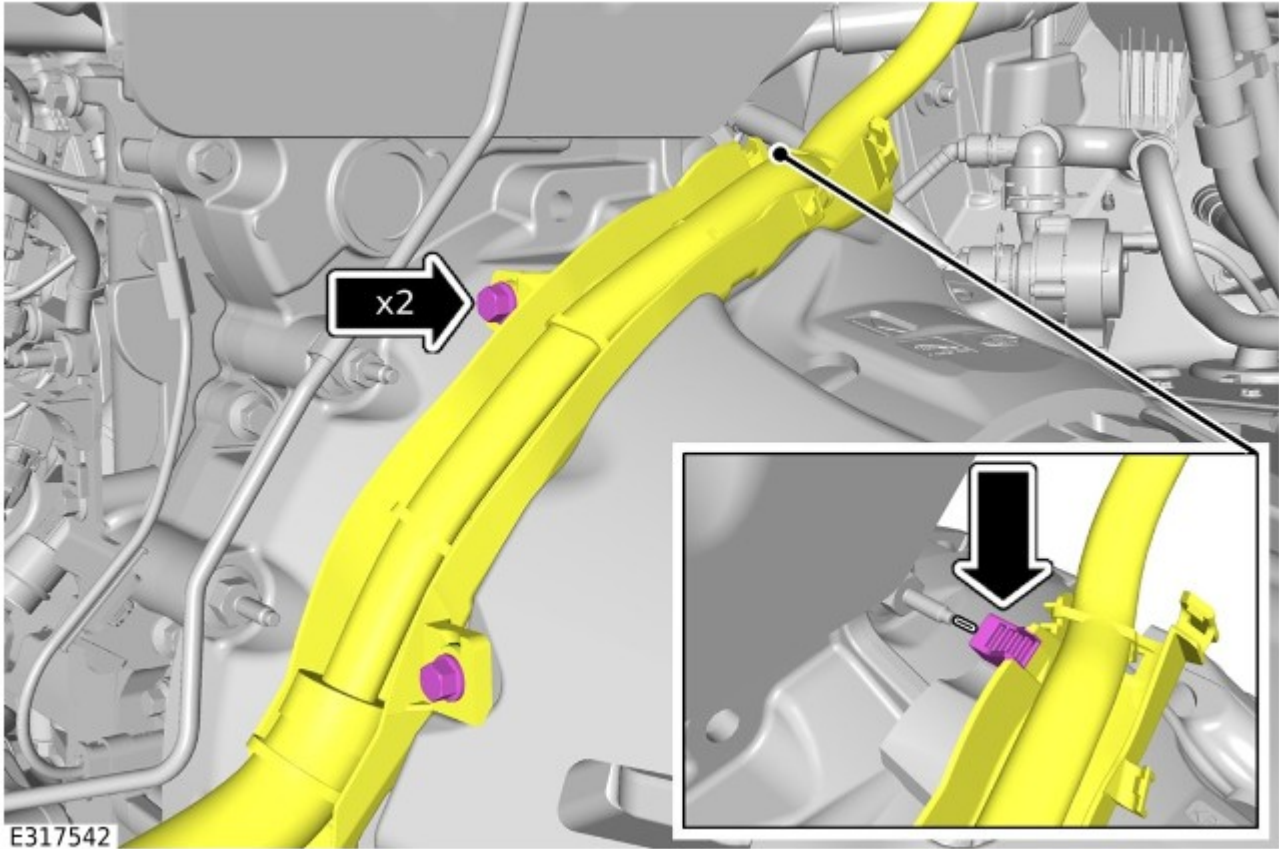
4. Reposition the [MHEV](#) cable to access the transmission bolts.

Remove the 2 bolts.

Release the clip from the transmission bell housing bolt.

Torque: **10 Nm**

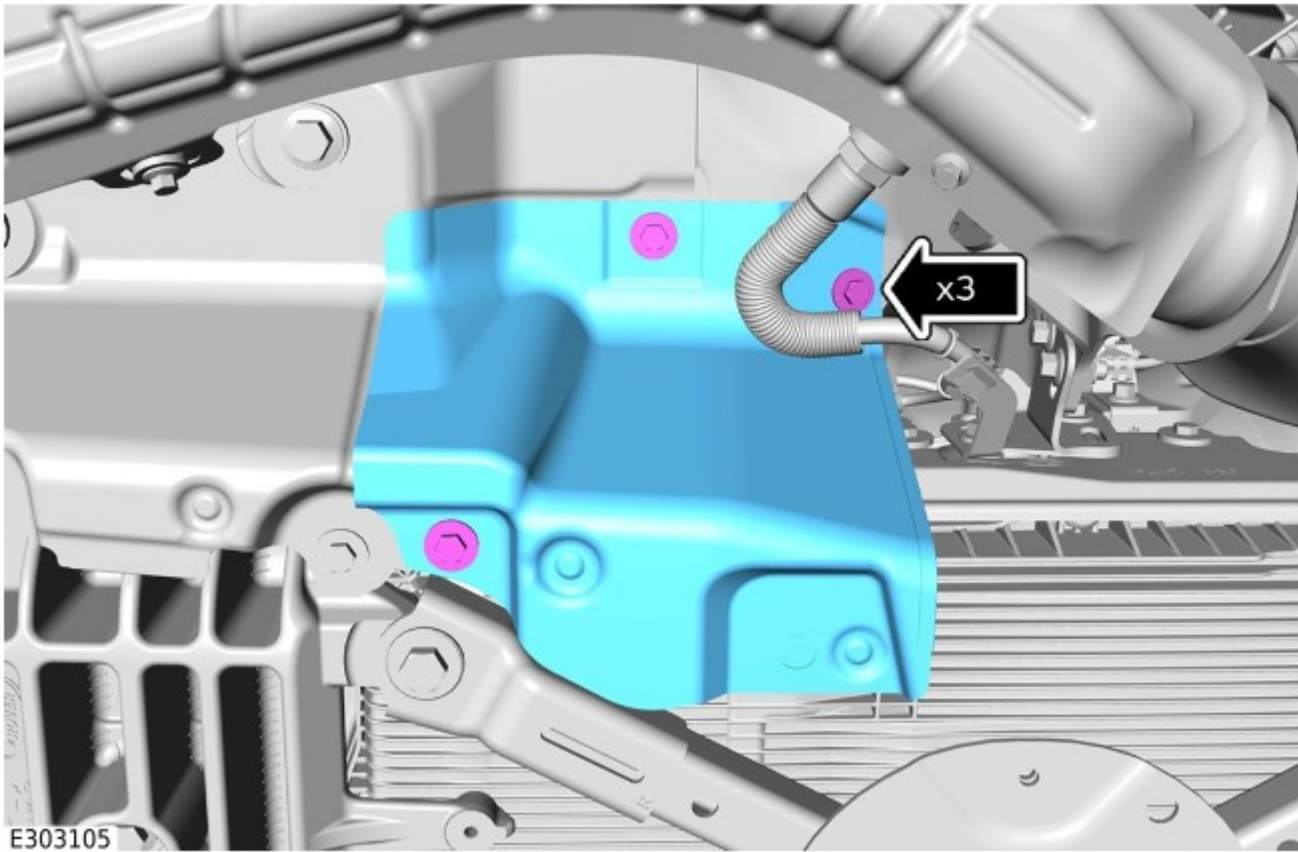
5. Remove the exhaust heatshield.

Remove the 3 bolts.

Torque: 5 Nm

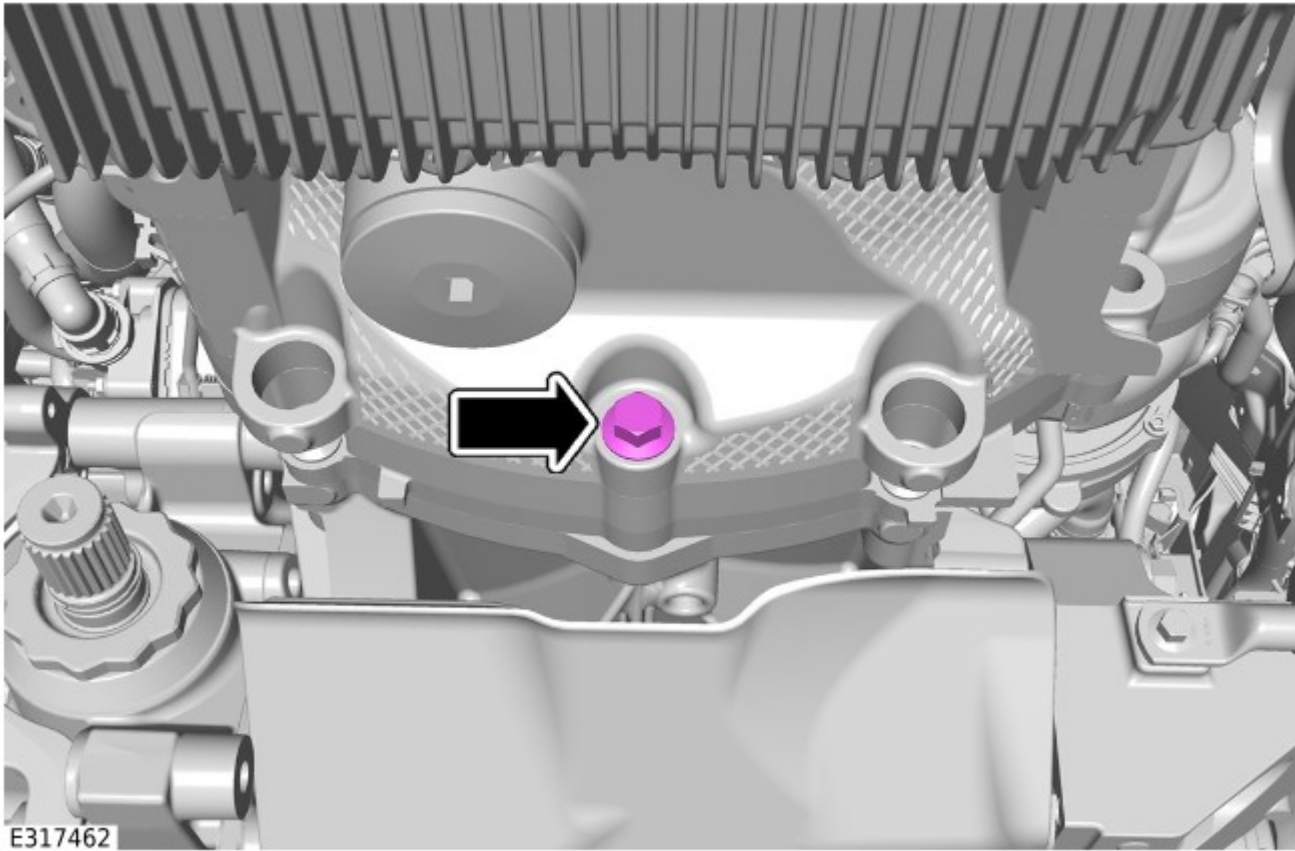
6. Tighten the transmission bell housing bolt.

Torque: **40 Nm**

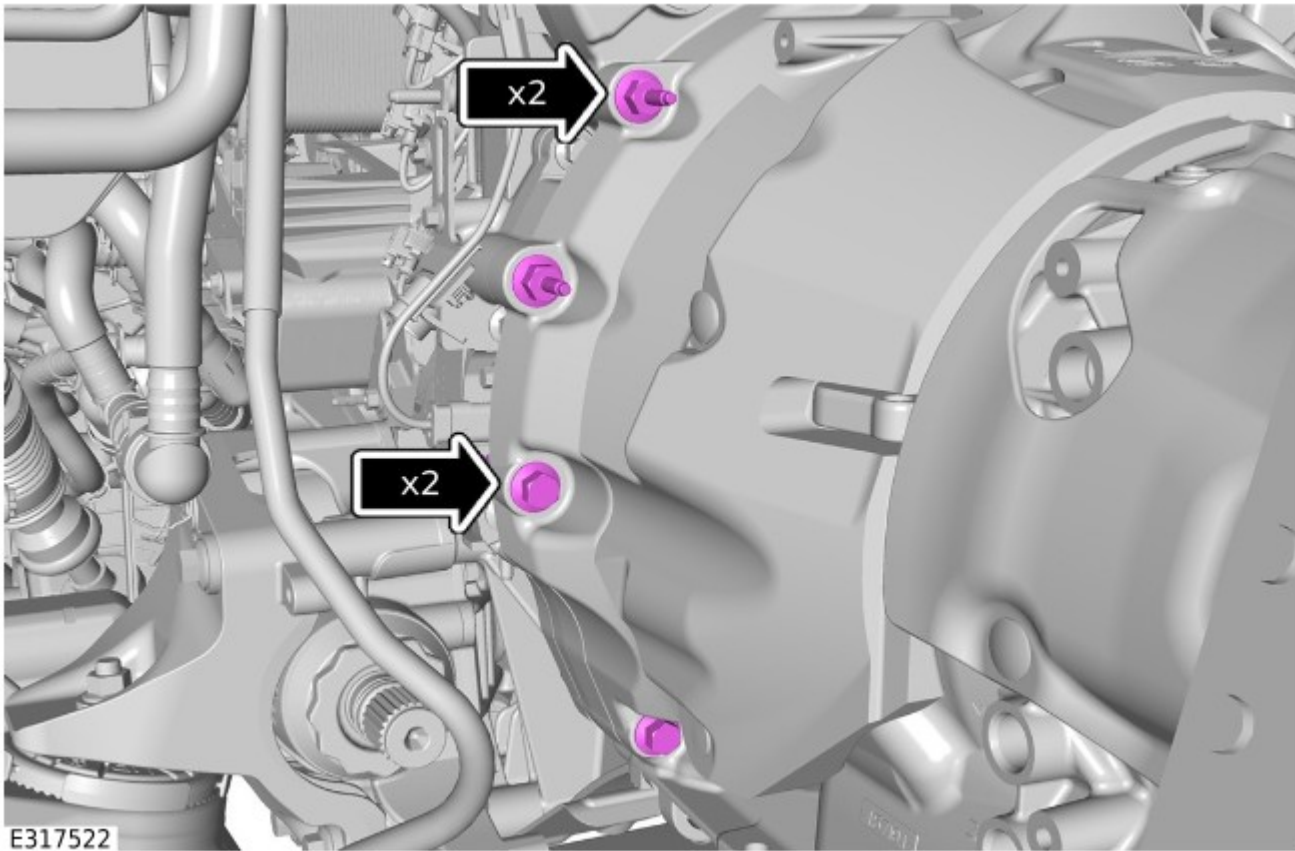
7. Using a suitable extension and universal joint, tighten the 4 transmission bell housing bolts.

Torque: **40 Nm**

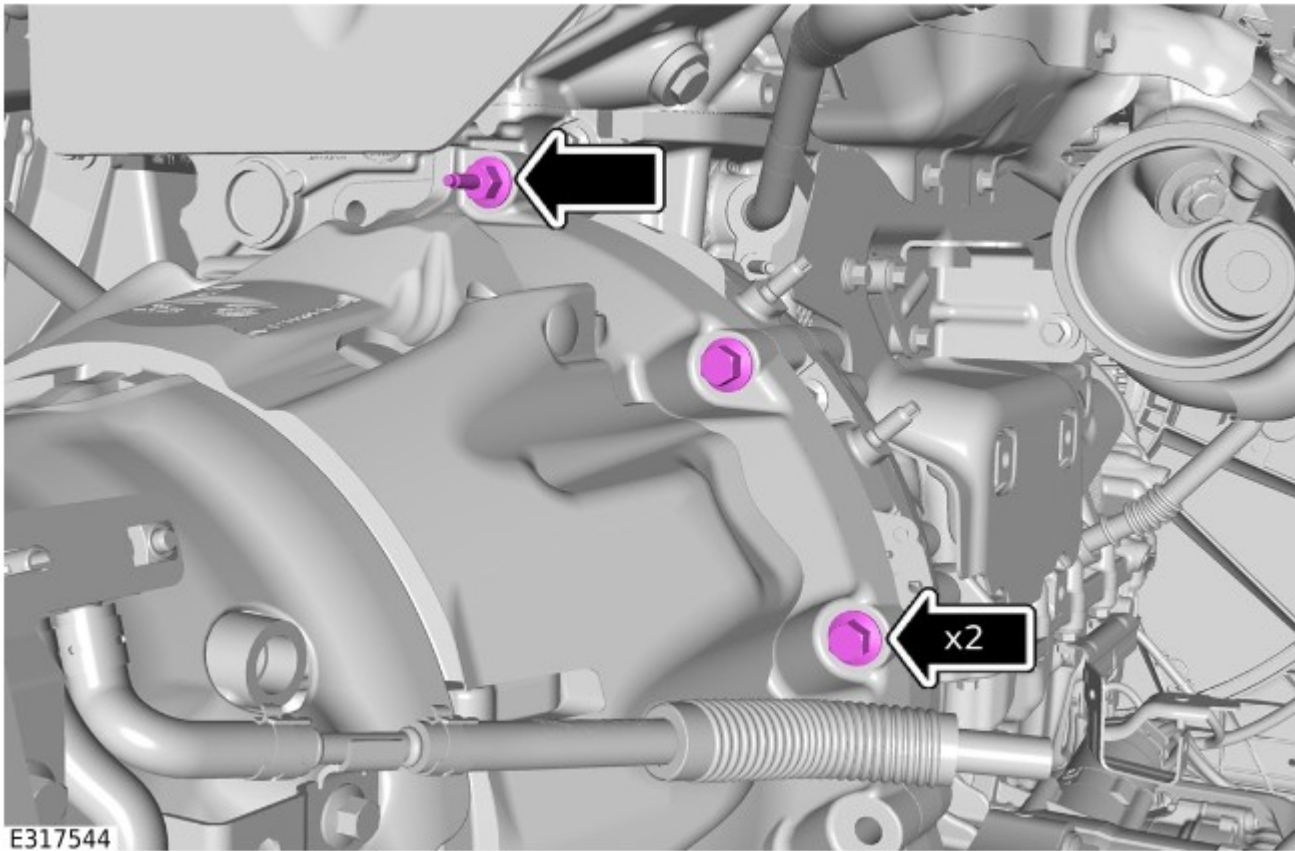
8. Using a suitable extension and universal joint, tighten the 3 transmission bell housing bolts.

Torque: **40 Nm**
