# Service Bulletin

Bulletin No.: 16-NA-130

**Subject: No Reverse, No Second After Upper Valve Body Replacement**

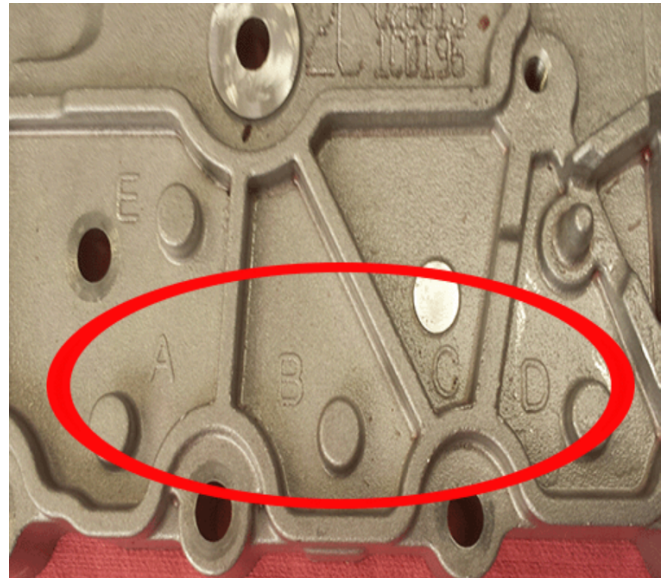
4498516

The post corresponding to the correct RPO will be milled off. In this case the "C" post is milled indicating that this is an MYC upper valve body. A milled "A" post indicates MYA, a milled "B" indicates MYB, a milled "C" indicates MYC and a milled "D" indicates MYD.

Upper valve bodies are unique by transmission RPO. Each upper valve body has four posts labeled A, B, C and D on the top side of the upper valve body. Inspect the upper valve body as shown below to determine the correct RPO usage.

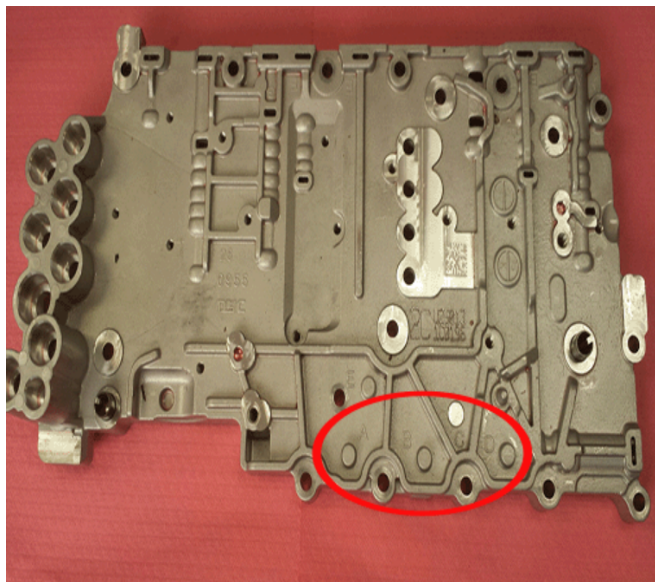
4498528

Location of the four post shown above.

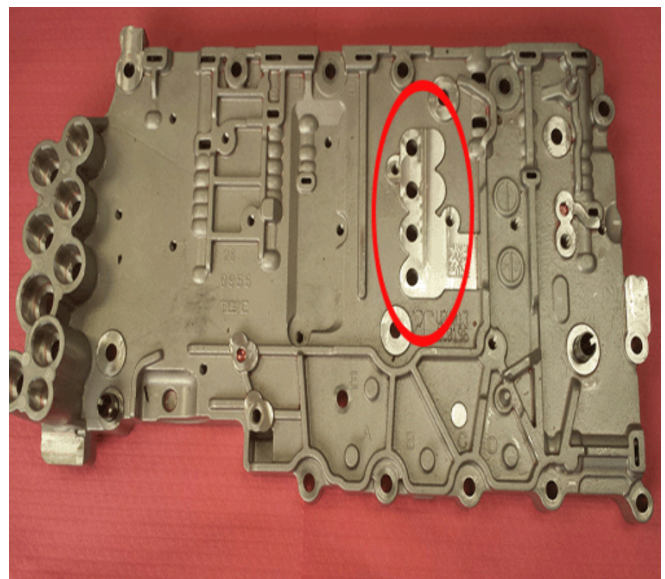
4498521

The oil passage holes that feed the center support and Low and Reverse Clutch and 2-6 Clutch contained within the center support vary location by transmission and corresponding upper valve body. The ISS and OSS mounting locations also vary by transmission. The incorrect valve body does not properly locate the oil feed holes and speed sensors.
