Service Bulletin

Bulletin No.: 21-NA-149

Date: March, 2023

Subject: Engine Wire Harness Chafing / IPC Gauges Sweep / IPC Warning Message / SES/Check Engine/MIL / No Start / No Crank / Runs Rough / Stalls / Reduced Engine Power / Various DTCs

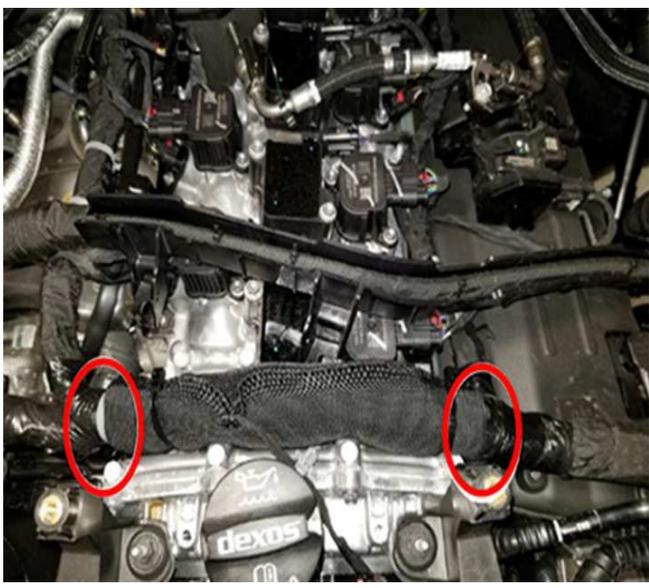
<p style="text-align: right;">5394681</p> <p>Example of engine wiring harness damage at Camshaft Carrier Cover shown below.</p>

<p>Cause 1</p>	<p>This Cause pertains to vehicles equipped with engine 2.7L, L3B only.</p> <p>These concerns may be caused by engine harness contact with under hood components.</p> <p>Caution: This Document Only Applies To VINs NOT Covered by Customer Satisfaction Program N192219370 Please Verify In VIS Before Proceeding</p> <p>Shown below are areas that should be inspected for this concern.</p> <p>Inspect the engine harness as it crosses over top of the Camshaft Carrier Cover.</p> <p>Harness damage can occur at any point across the Camshaft Carrier Cover.</p> <p>Typical inspection locations shown below.</p>

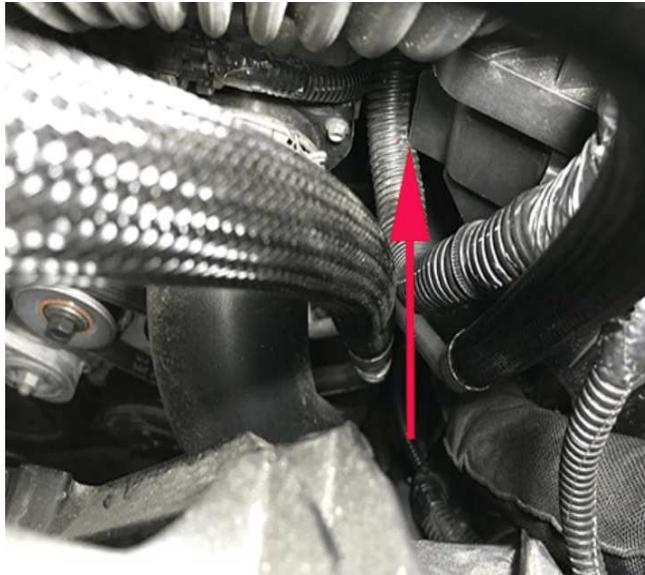
5394683

Inspect the engine harness at the Lower Air Cleaner Housing as shown below.

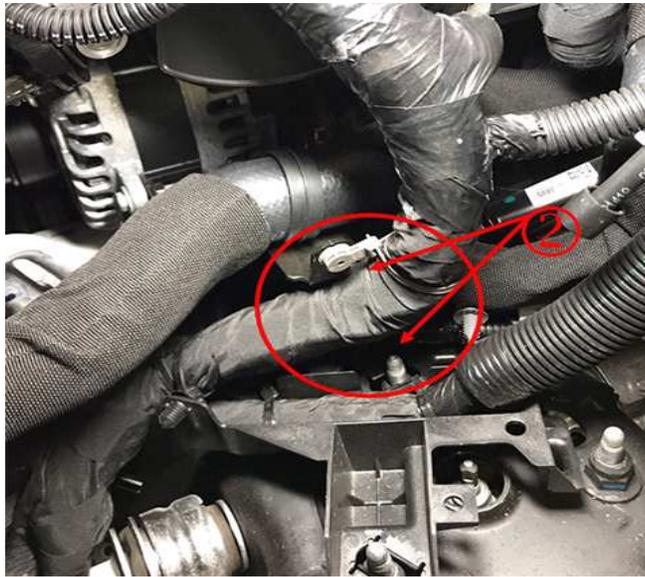
5324752

Example of engine harness damage, Lower Air Cleaner Housing removed shown below. Inspect the engine harness at the Generator Bracket and Left Front Coil Spring stud as shown below.

Note: Under normal driving conditions, the engine will rock back and forth in its mounts.

This may result in harness contact with this bracket that may not be present during engine off inspections.

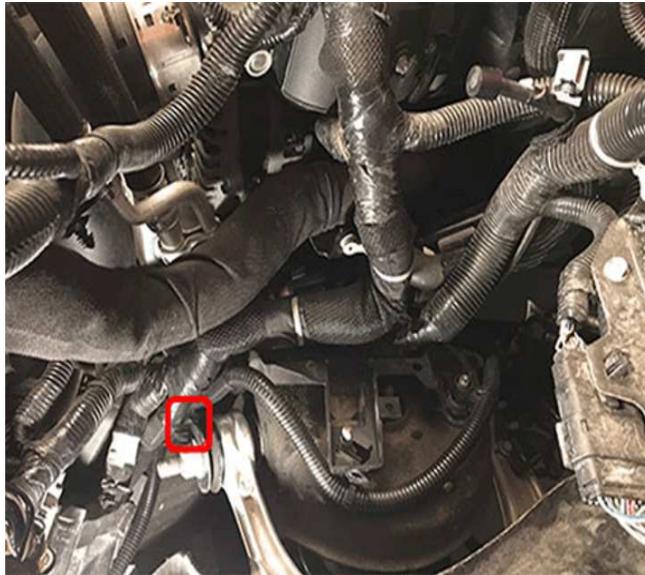
5394677

Inspect the engine harness at the Left Front Upper Control Arm Bushing as shown below.

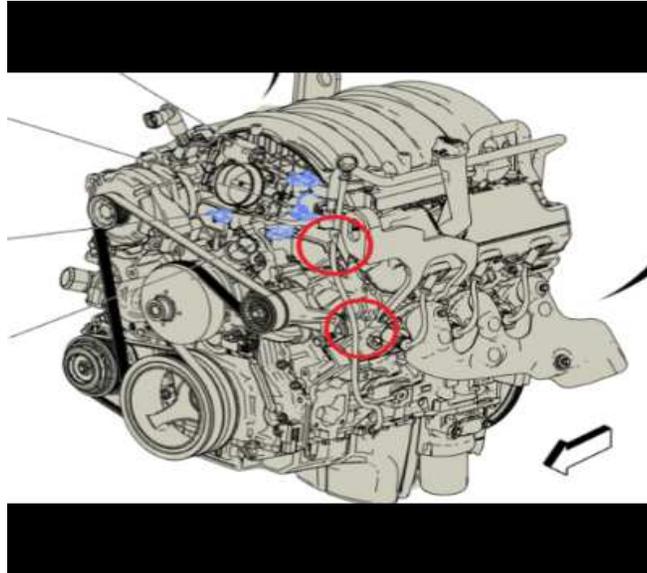
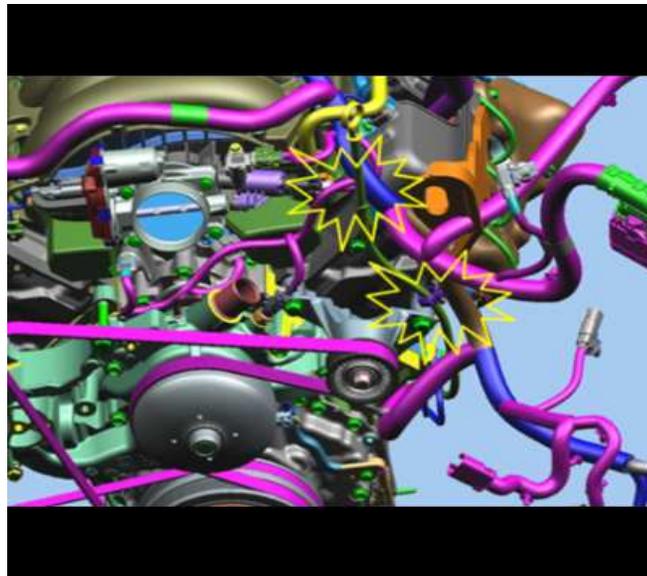
These concerns could be caused by engine wiring harness chafe on underhood components at various locations such as: Front corner of the left hand cylinder head, drive belt idler pulley bracket, or oil dipstick bracket; noted by the circled and starred areas in the graphics above.

This harness chaffing could cause shorting of any number of circuits to ground. Due to the number of circuits in the harness, there is a wide variety of different symptoms that could occur depending on which circuit(s) are damaged.

To correct this concern, repair the damaged wiring following the SI wire-to-wire repair procedures. Once repaired, protect and reposition the engine wiring harness to prevent future harness damage.

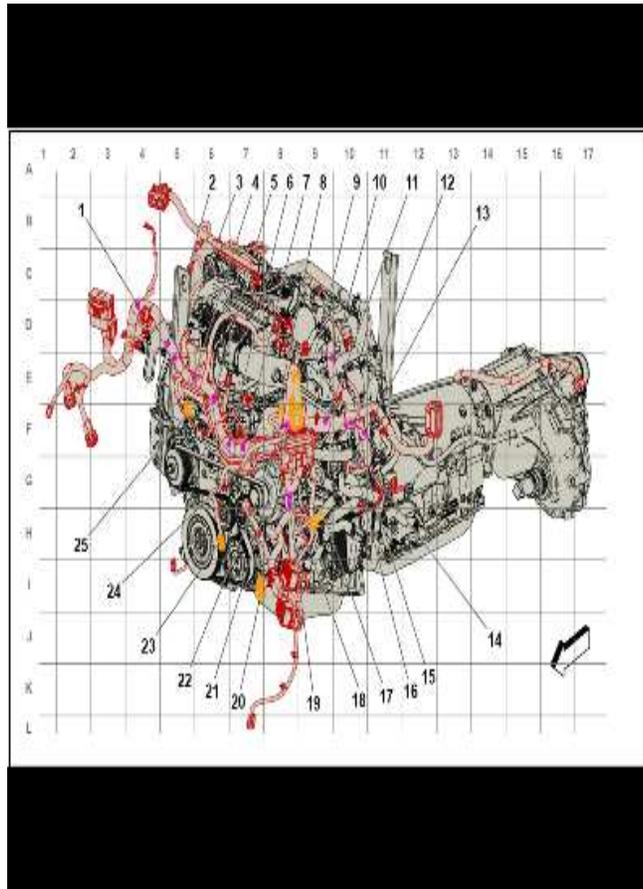
6163833

1. The engine harness pinched/shorted/chaffed at grid coordinates G-8, as shown above. This location is approximately 18 inches from the ECM connectors (1) and on top of the generator (2), as shown below. Due to the number of circuits in the harness, there is a wide variety of different symptoms that could occur, depending on which circuit(s) are damaged.

2. The engine harness shorted/chaffed at grid coordinates C-9, as shown above. The engine harness could be shorted out on the PVC hose clamp at the crankcase pressure regulator, as shown below (6). This is located approximately 4 inches from the crankcase sensor connector pigtail harness breakout.

In many cases, the ECM has been unnecessarily replaced for these concerns. Please thoroughly inspect the areas shown above and follow published SI diagnostics before any parts are replaced. If any concerns are found, then follow SI Wiring and Connector repair instructions to correct the concern.

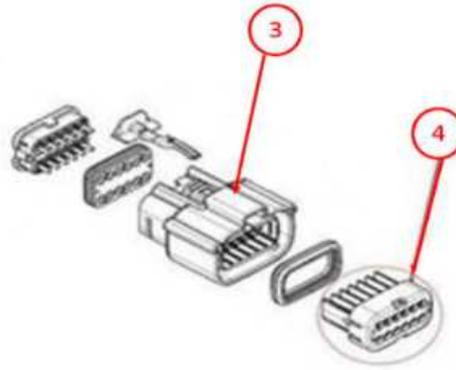
5643650

1. Inspect for poor terminal tension at connector X160, shown in the grid above, as callout 25. While inspecting X160 make sure the terminal locking feature (4), shown below, is not missing.

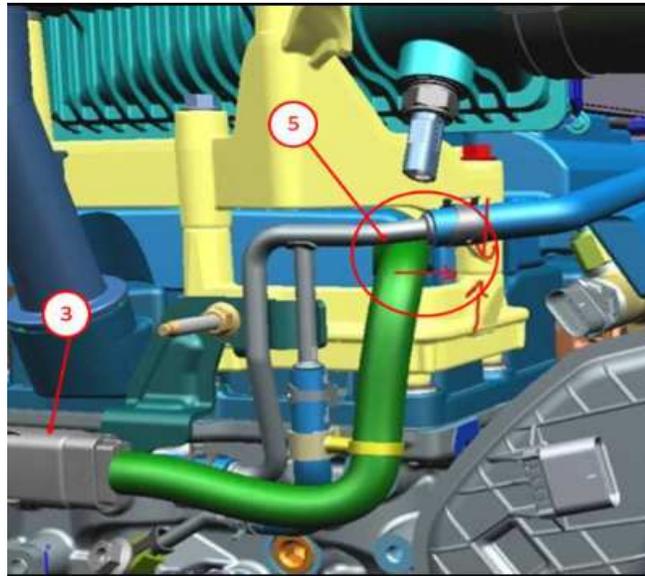
5643651

2. Inspect the fuel injector connectors to make sure they are fully connected/seated.
3. Inspect the fuel injector wiring harness near the X160 connector (3) for being pinched/shorted/chaffed, as shown below (5).

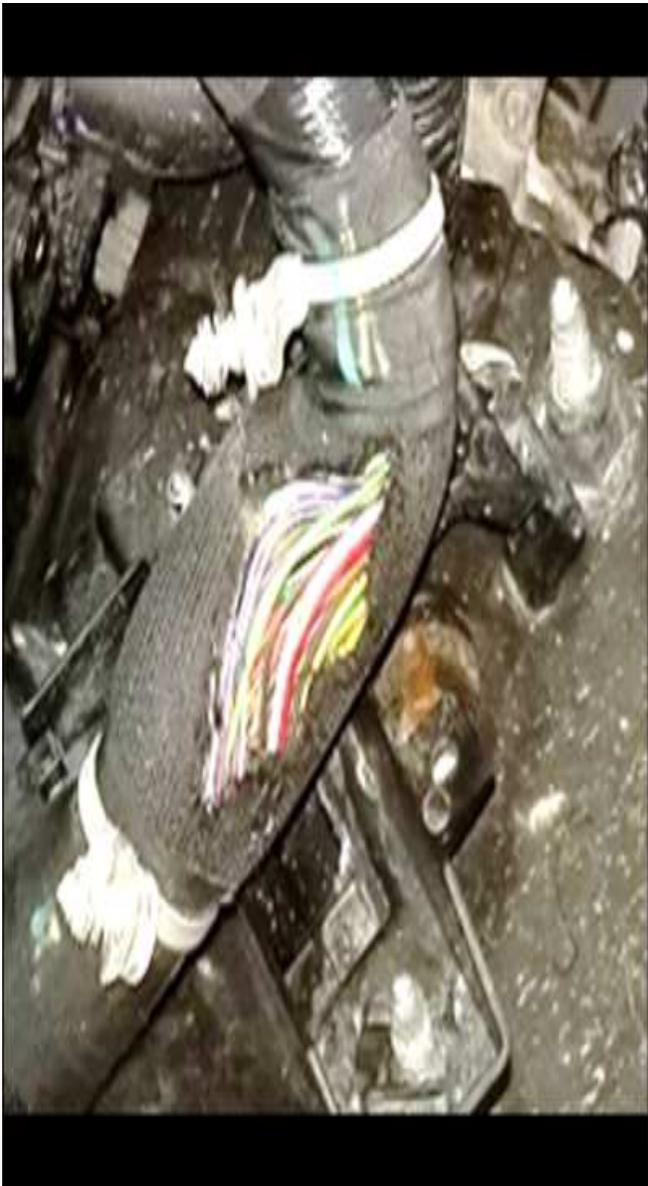
5868347

Examples of extreme wire chaffing.

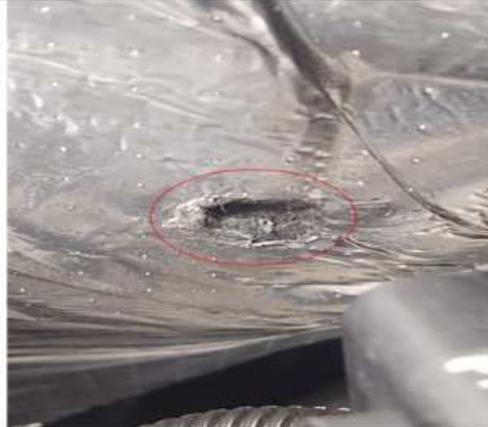
5949751

An example of firewall insulator chaffing

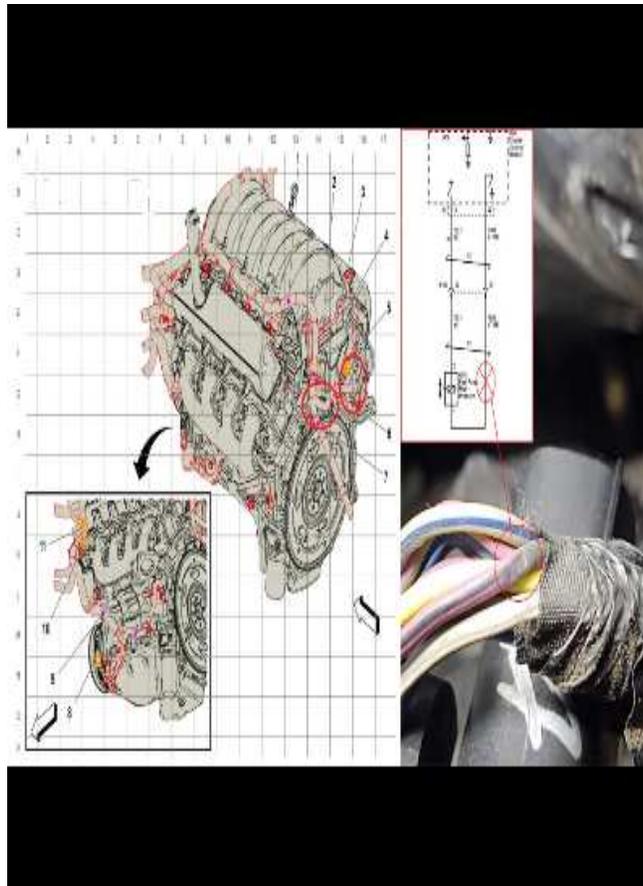
5949755

Other areas of concern.

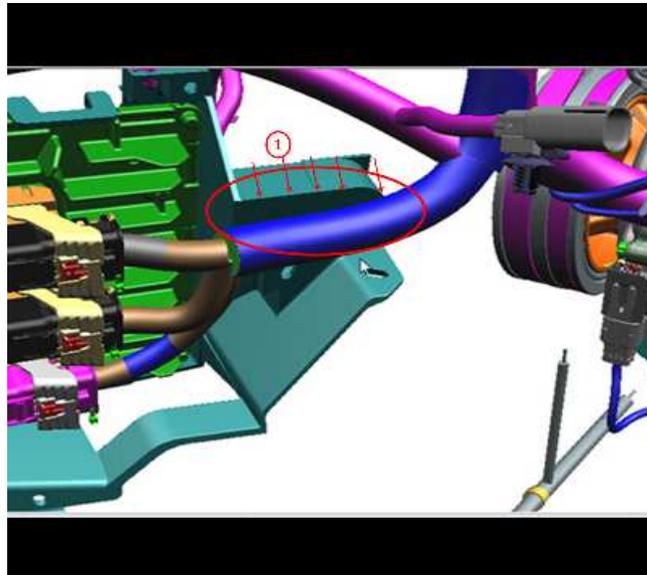
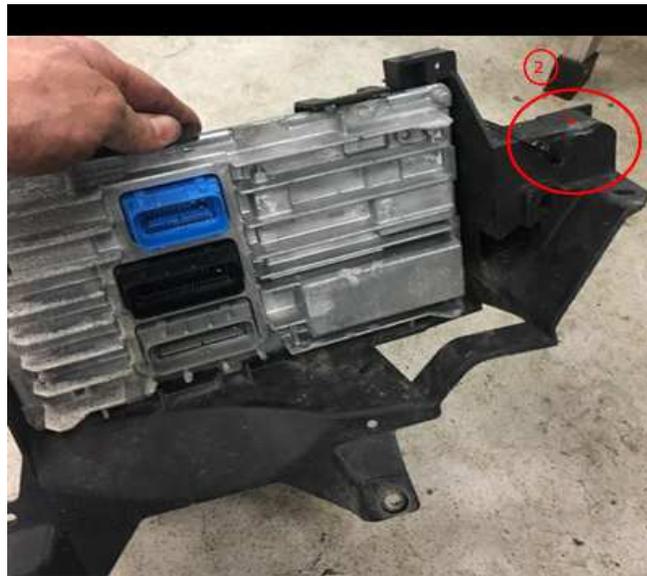
The cause of the condition may be an engine wire harness clip was removed during production due to ergonomic issues (hand clearance and branch stiffness). This led to an uncontrolled branch that came into contact with a sharp edge (1) & (2) on the ECM/TCM bracket, driver side upper control arm, and/or shock tower and caused chaffing during engine vibration and roll.

Utilizing Engine Harness sleeves, anti-abrasion tape, and zip-ties to secure the harness away from one or more of the chaffing points. Follow the Service Procedure steps below.

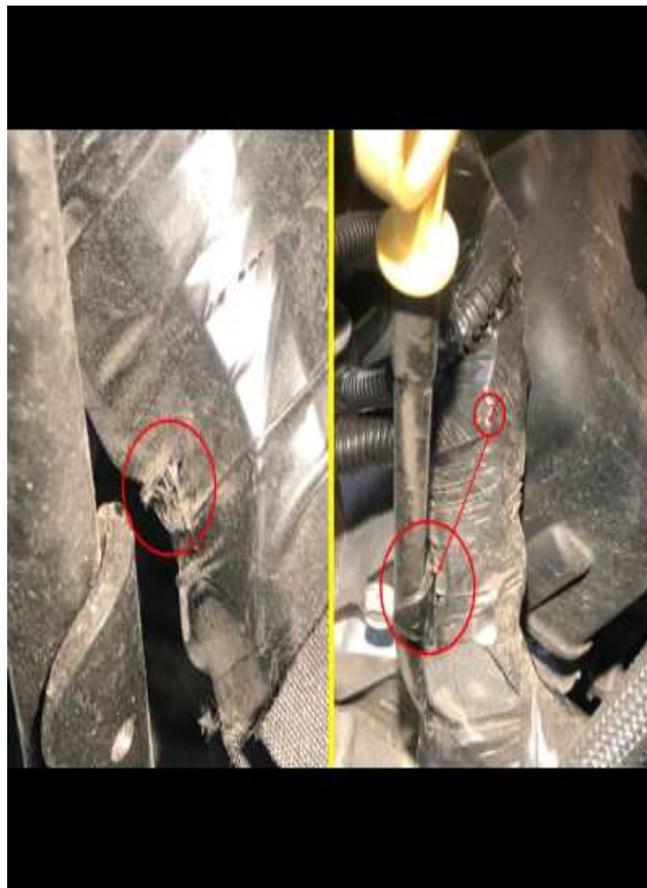
5911722

This Correction pertains to vehicles equipped with engine 4.3L, LV3 only.
Note: The first graphic below is a before, and after (2), repair example of harness chaffing at the Oil Dipstick bracket.

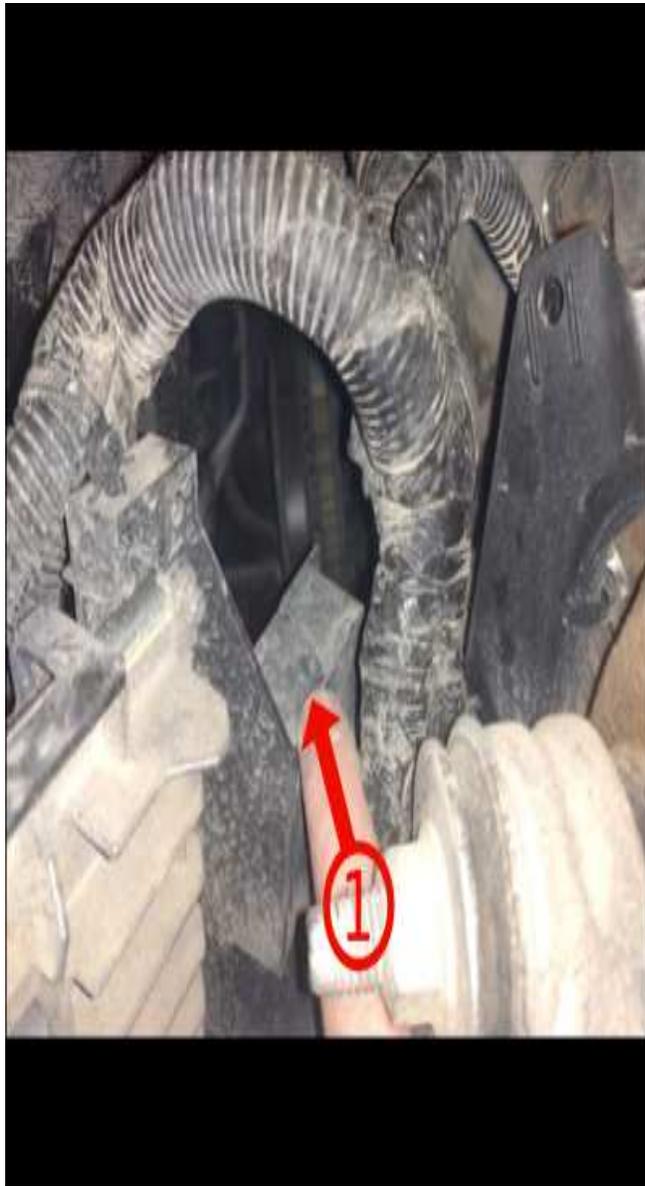
5868349

3. Locate the three contact points where the wire harness is chaffing, the ECM/TCM black bracket (1), the upper control arm (2), and the shock tower bolt (3).

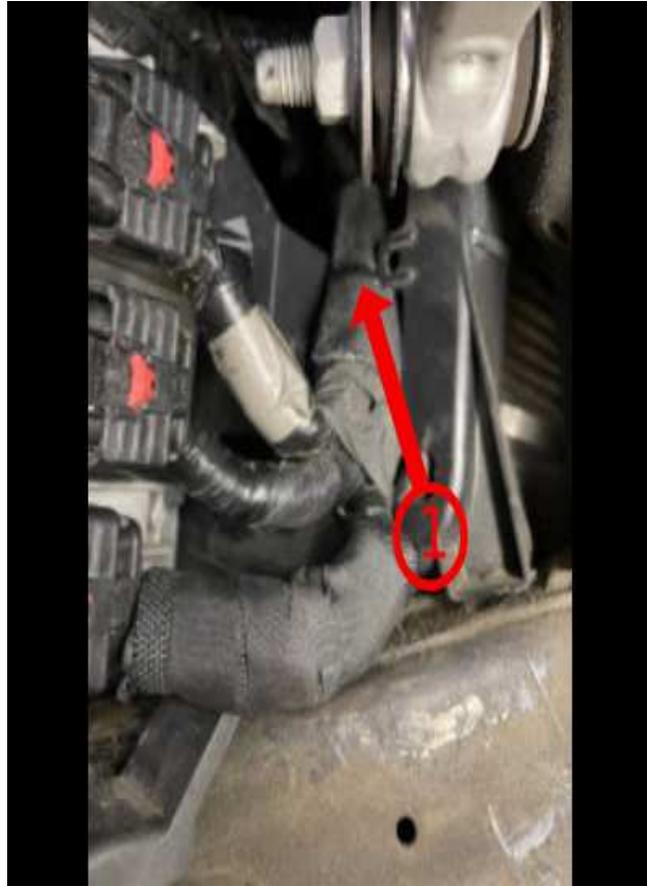
5868350

4. At the ECM/TCM bracket, locate the wire harness laying against the ledge (1).
