GLOBAL SAFETY FIELD INVESTIGATIONS
DCS6478
URGENT - DISTRIBUTE IMMEDIATELY

Subject: REVISION: N222375790-01 - Customer Satisfaction Program
Park Assist Retrofit
Population Update

Models: 2022 – 2023 Chevrolet Corvette
2022 – 2023 Cadillac CT4
2022 – 2023 Cadillac CT5

N222375790 Park Assist Retrofit

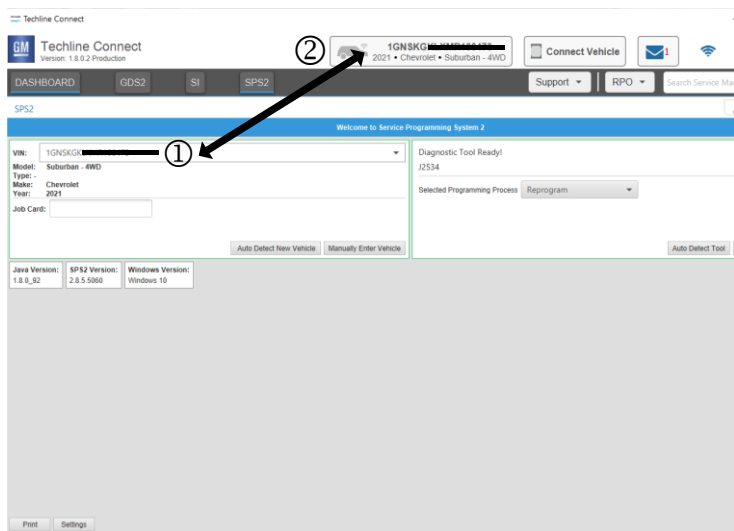
Caution: Be sure the VIN selected in the drop down menu (1) is the same as the vehicle connected (2) before beginning programming.

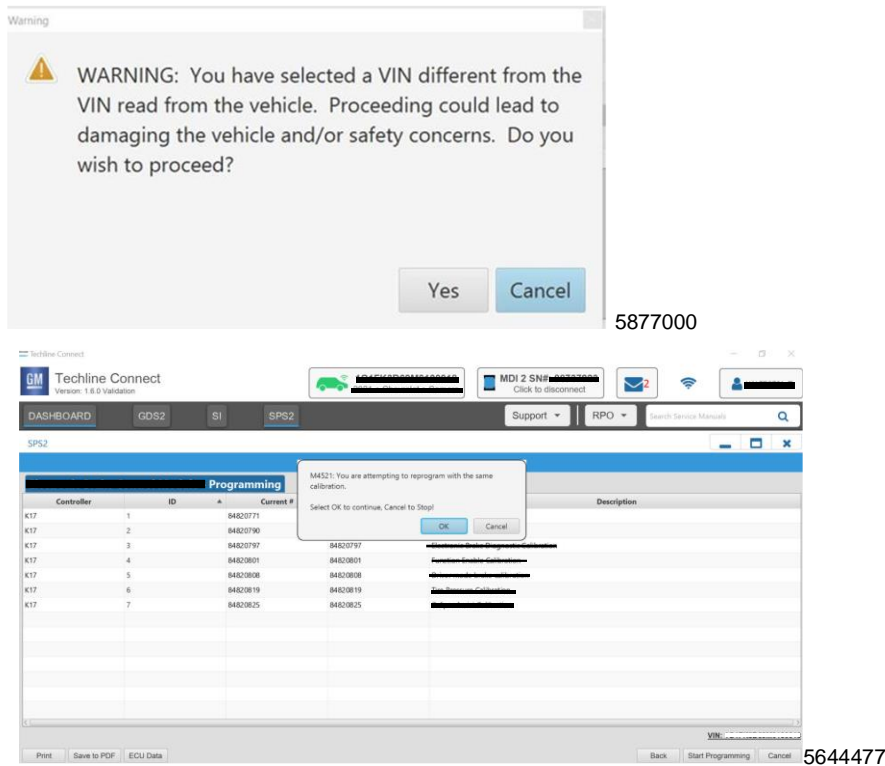
Important: If the vehicle VIN DOES NOT match, the message below will be shown.

Important: Techline Connect screens shown above.

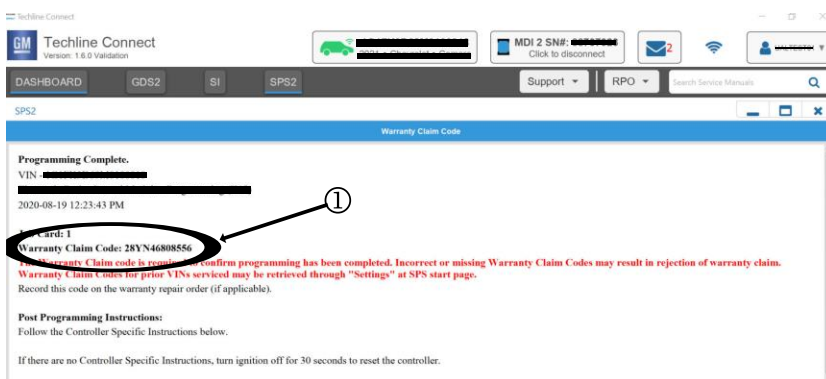
5644478

Note: The screenshot above is an example of module programming and may not be indicative of the specific module that is being programmed. Module selection and VIN information have been blacked out.

Important: To avoid warranty transaction rejections, you MUST record the warranty claim code provided on the Warranty Claim Code (WCC) screen shown above on the job card. Refer to callout 1 above for the location of the WCC on the screen.

6. Record SPS Warranty Claim Code on job card for warranty transaction submission.

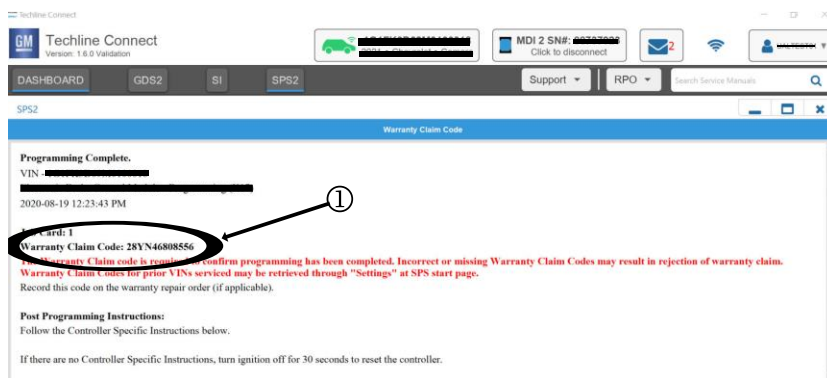
5644478

Note: The screenshot above is an example of module programming and may not be indicative of the specific module that is being programmed. Module selection and VIN information have been blacked out.

Important: To avoid warranty transaction rejections, you **MUST** record the warranty claim code provided on the Warranty Claim Code (WCC) screen shown above on the job card. Refer to callout 1 above for the location of the WCC on the screen.

6. Record SPS Warranty Claim Code on job card for warranty transaction submission.

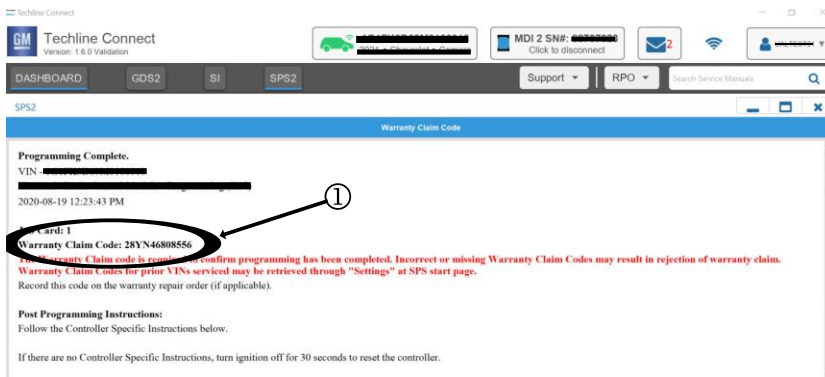
5644478

Note: The screenshot above is an example of module programming and may not be indicative of the specific module that is being programmed. Module selection and VIN information have been blacked out.

Important: To avoid warranty transaction rejections, you **MUST** record the warranty claim code provided on the Warranty Claim Code (WCC) screen shown above on the job card. Refer to callout 1 above for the location of the WCC on the screen.

7. Record SPS Warranty Claim Code on job card for warranty transaction submission.
