GLOBAL SAFETY FIELD INVESTIGATIONS
DCS6489
URGENT - DISTRIBUTE IMMEDIATELY

Subject: N222375791 - Customer Satisfaction Program
Park Assist Retrofit

Models: 2022 – 2023 Cadillac XT4
2022 – 2023 Cadillac XT5
2022 – 2023 Cadillac XT6
2022 – 2023 Chevrolet Camaro

N222375791 Park Assist Retrofit

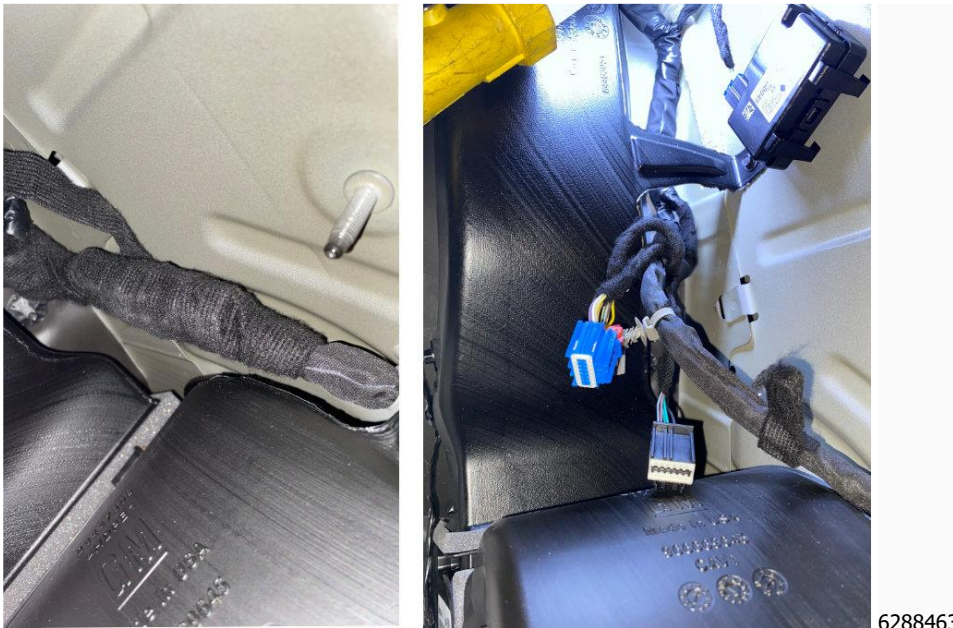
6288463

Note: The wiring harness for the Parking Assist Control Module may be wrapped around an adjacent wiring harness as shown above. Remove the attaching tape by unwrapping. Do NOT cut the tape as it could damage the wiring harness.

1. Install the new Parking Assist Control Module. Refer to *Parking Assist Control Module Replacement* in SI.

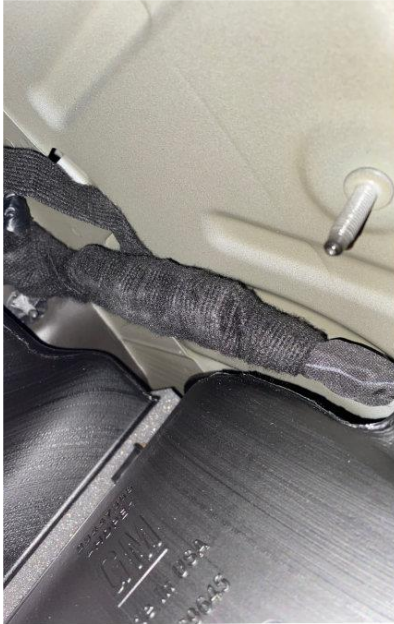
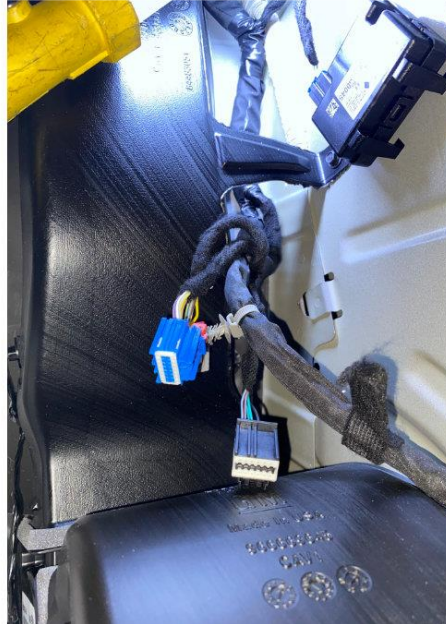
6288463

Note: The wiring harness for the Parking Assist Control Module may be wrapped around an adjacent wiring harness as shown above. Remove the attaching tape by unwrapping. Do NOT cut the tape as it could damage the wiring harness.

1. Install the new Parking Assist Control Module. Refer to *Parking Assist Control Module Replacement* in SI.

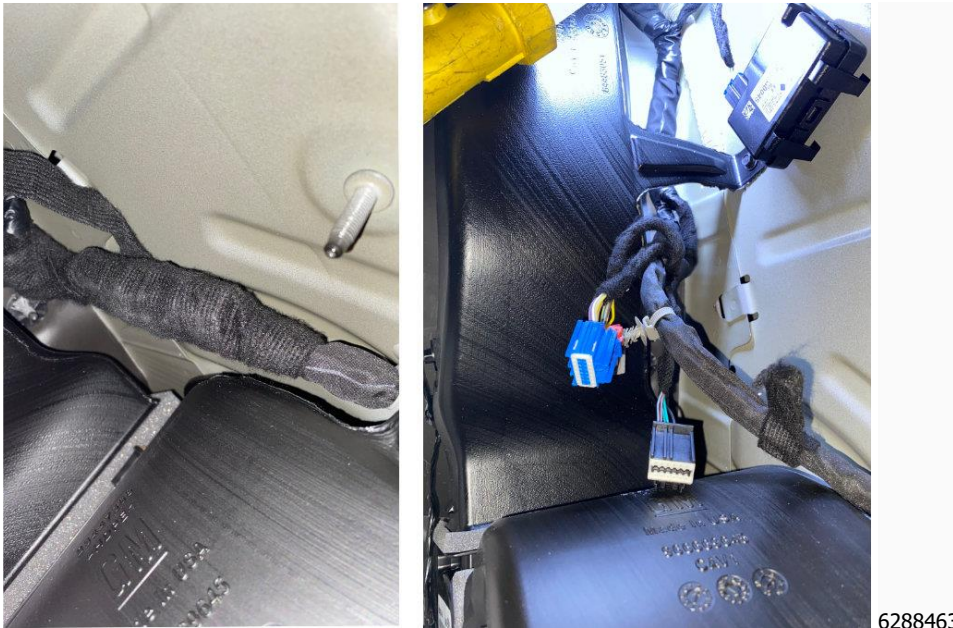
Note: The wiring harness for the Parking Assist Control Module may be wrapped around an adjacent wiring harness as shown above. Remove the attaching tape by unwrapping. Do NOT cut the tape as it could damage the wiring harness.

1. Install the new Parking Assist Control Module. Refer to *Parking Assist Control Module Replacement* in SI.

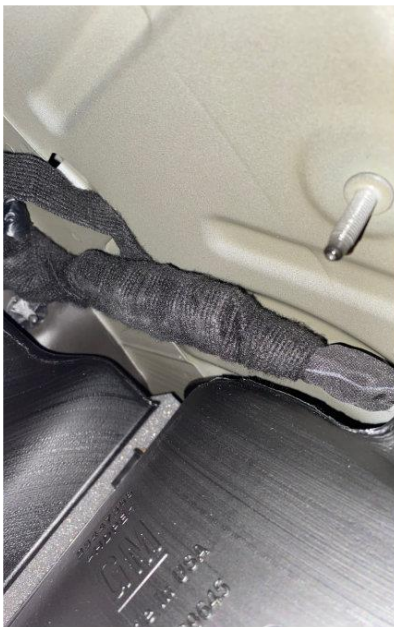
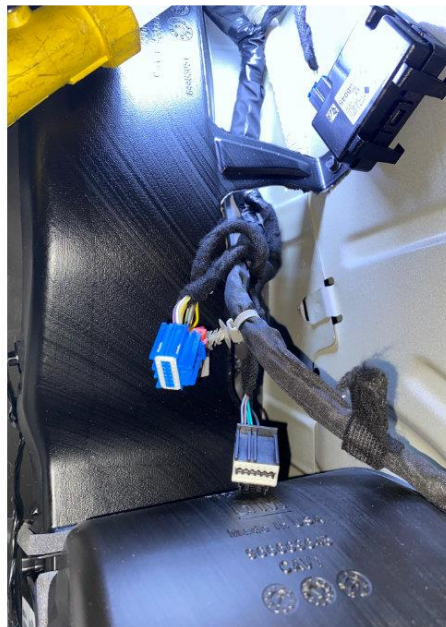
6288463

Note: The wiring harness for the Parking Assist Control Module may be wrapped around an adjacent wiring harness as shown above. Remove the attaching tape by unwrapping. Do NOT cut the tape as it could damage the wiring harness.

1. Install the new Parking Assist Control Module. Refer to *Parking Assist Control Module Replacement* in SI.

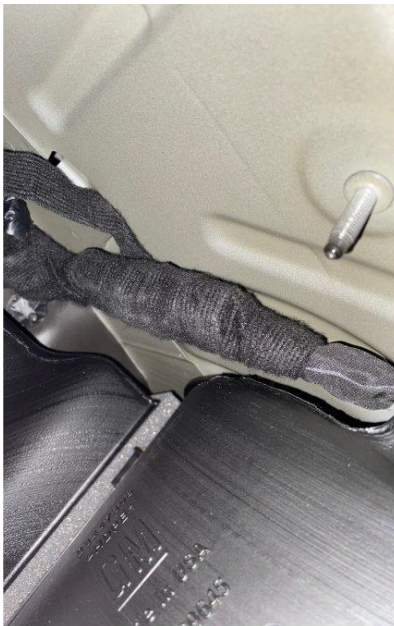
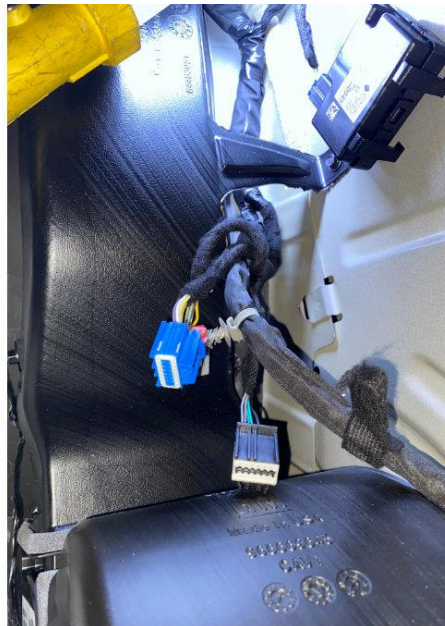
6288463

Note: The wiring harness for the Parking Assist Control Module may be wrapped around an adjacent wiring harness as shown above. Remove the attaching tape by unwrapping. Do **NOT** cut the tape as it could damage the wiring harness.

1. Install the new Parking Assist Control Module. Refer to *Parking Assist Control Module Replacement* in SI.

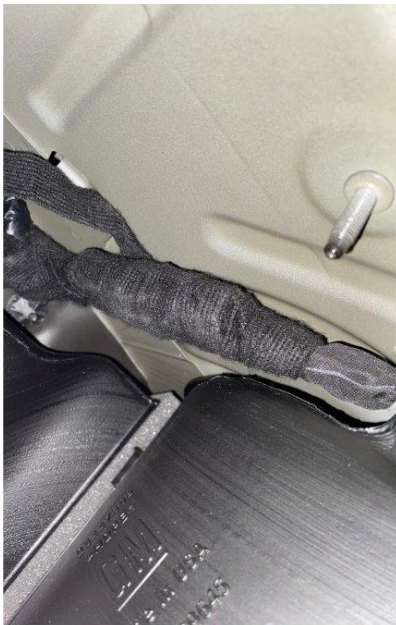
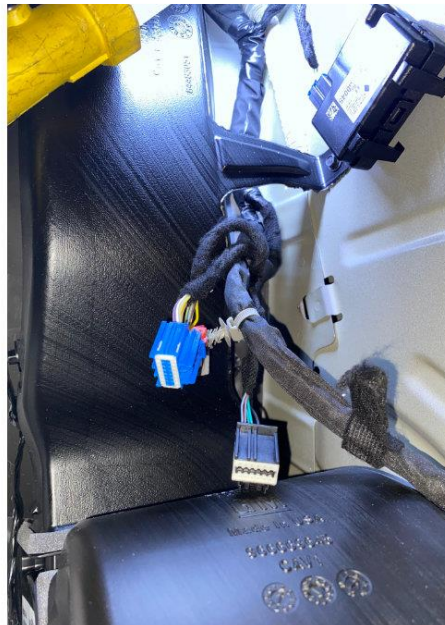
6288463

Note: The wiring harness for the Parking Assist Control Module may be wrapped around an adjacent wiring harness as shown above. Remove the attaching tape by unwrapping. Do NOT cut the tape as it could damage the wiring harness.

1. Install the new Parking Assist Control Module. Refer to *Parking Assist Control Module Replacement* in SI.
