# Technical Service Bulletin

## 53 Creaking or knocking noises from rear of vehicle

53 23 07 2068978/2 March 7, 2023. Supersedes Technical Service Bulletin Group 53 number 22-06 dated December 21, 2022, for reasons listed below.

| Model(s) | Year | VIN Range | Vehicle-Specific Equipment |
|---|---|---|---|
| Q4 Sportback e-tron | 2022 – 2023 | All | Not Applicable |

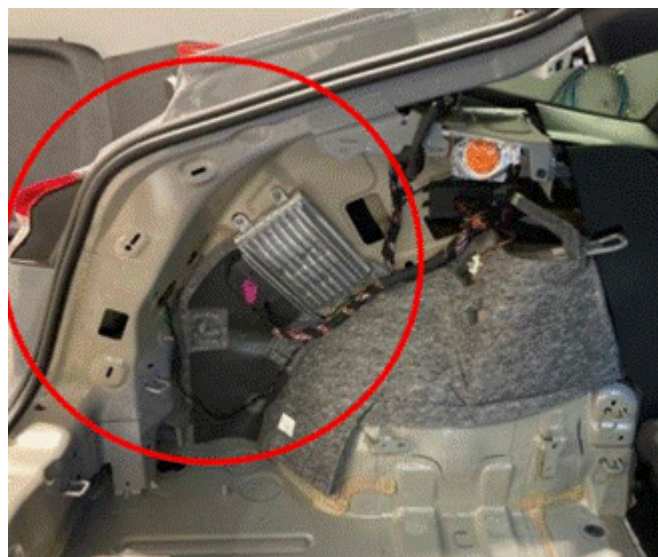
**Workshop findings:** The noises can be replicated in these driving conditions. The noises are diagnosed as originating specifically in the rear cargo area from the sheet metal overlap of the left rear side panel and the left rear cross panel.

**Figure 1.** Area of cargo area where noises are generated.

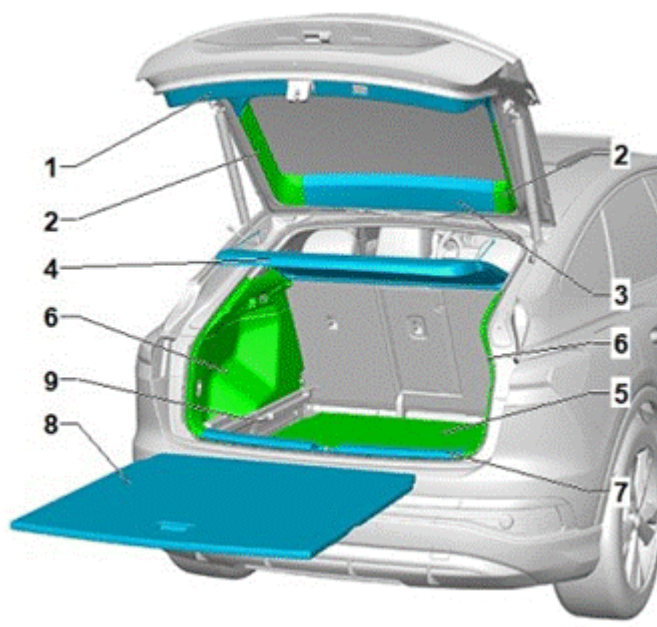
**Figure 2.** Luggage compartment trim.

1. Detach the left rear luggage compartment side trim panel according to the work procedure in Elsa: *Repair manual>>Body>>Body Interior>>70 Interior Trim>>Luggage Compartment Trim Panels>>Luggage Compartment Side Trim Panel, Removing and Installing.*

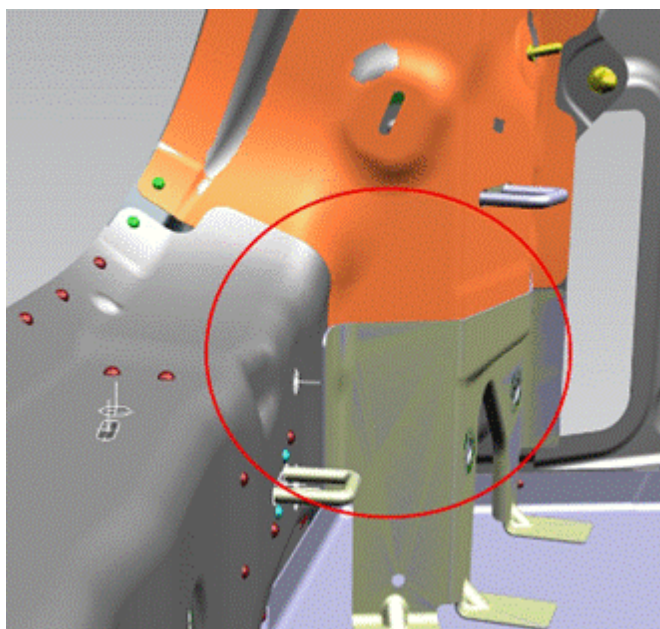
**Figure 3.** Area of left rear panel overlap to be repaired.

2. Figure 3 shows the exposed area where the work is to be performed.

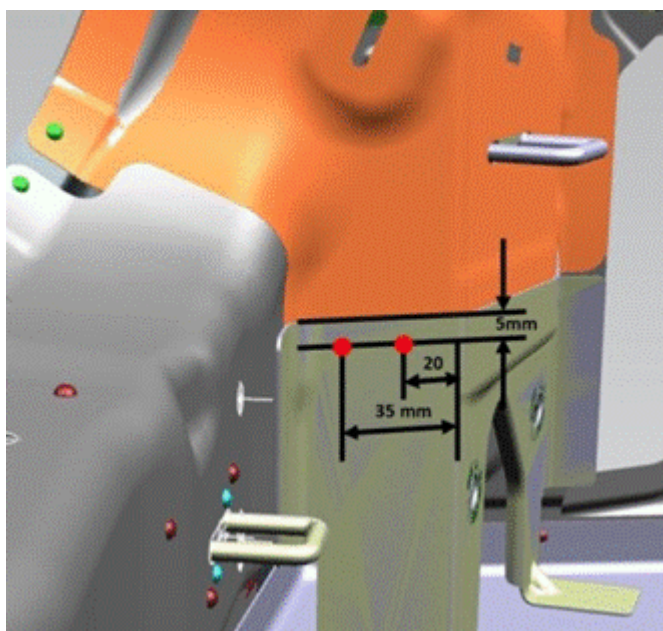
**Figure 4.** Location of 6.5 mm holes to be drilled in the outer support.

- Using the forward fold and the upper edge of the lower support bracket as a guide measure and mark 20 mm and 35 mm rearward from the fold and 5 mm downward from the upper edge of the lower support bracket on the left corner. In these two spots shown in the measuring schematic in Figure 4 drill two 6.5 mm holes through both panels as located by the red dots. Make sure to completely de-burr these drill holes.

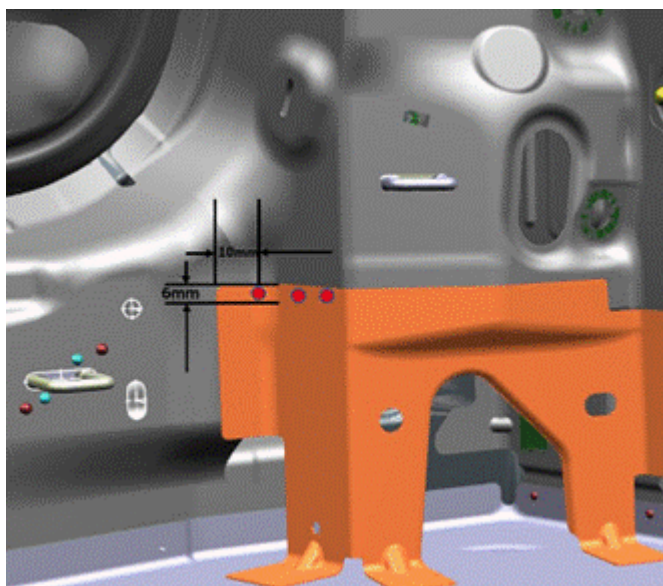
**Figure 5.** Location of 6.5 mm hole to be drilled in the cross panel section.

- On the rear cross panel section of the left lower support bracket measure and mark 10 mm horizontally from the inner edge of the support bracket and 6 mm downward from the upper edge of the lower support bracket. In this spot shown in the measuring schematic in Figure 5 drill one 6.5 mm hole through all 3 of the panels joined in this area as located by the red dots. Make sure to completely de-burr this drill hole as well.

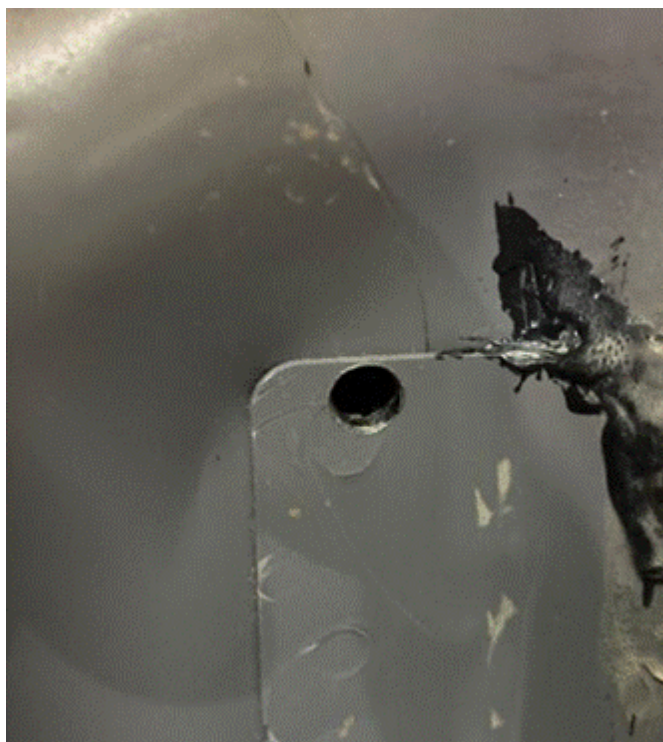
**Figure 6.** Completed drilled 6.5 mm hole in the cross panel section.

5. Figure 6 shows the finished drilled hole location in the rear cross panel section. Using a plastic wedge separate the two mating panels of the cross panel and lower support slightly and inject D 180004M2 two-part body adhesive between the mating panels and around all three of the drilled openings.

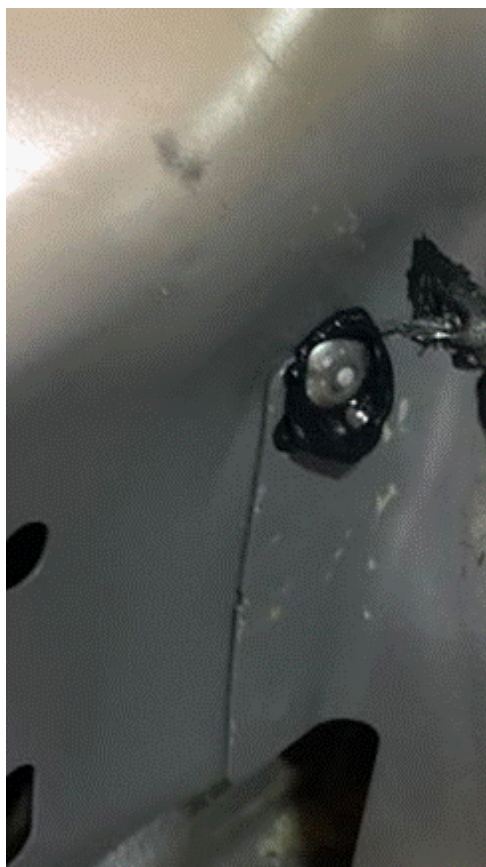
*Figure 7. Rivet installed in innermost cross panel hole.*

6. Insert and install one WHT009075 pop rivet in the innermost cross panel hole.

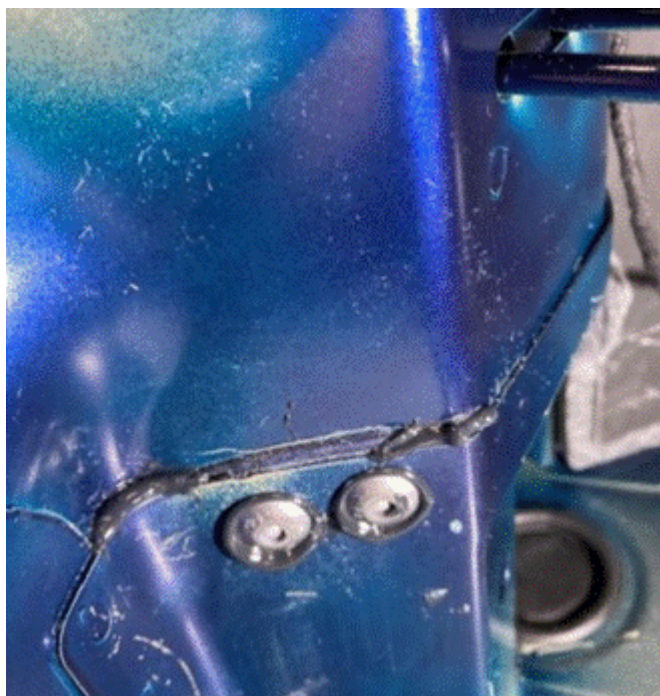
**Figure 8.** Panels with two-part body adhesive and rivets installed.

7. Insert and install two WHT005413A pop rivets into the two outermost drilled holes. Observe the appropriate curing time for the adhesive.

8. After the curing time is complete, seal the entire work area with cavity wax (D 308SP5M1 or equivalent e.g. 3M™ 08852). Test drive the vehicle to confirm resolution of the noises. Reinstall the luggage compartment trim.
