60 Water sloshing noises in roof area when cornering

60 23 63 2069594/1 March 6, 2023.

Model(s)	Year	VIN Range	Vehicle-Specific Equipment
A6 allroad	2020 – 2023	All	Not Applicable
RS 6 Avant	2021 - 2023

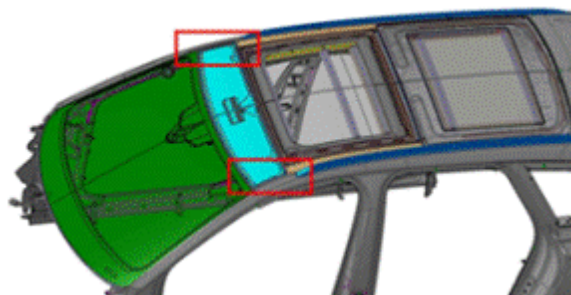
Figure 1. Area of roof to be serviced.

1. Figure 1 shows the area of the roof that will be serviced.

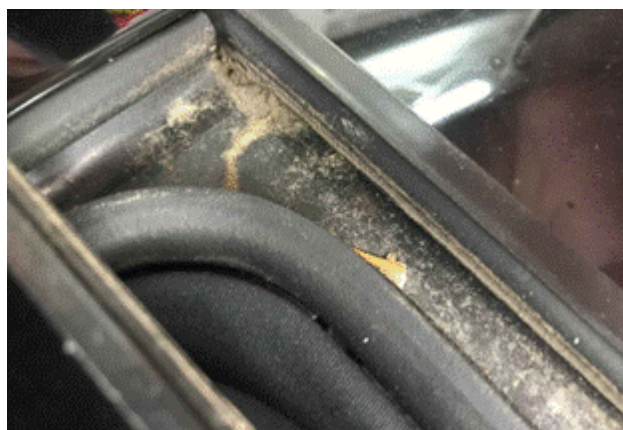
Figure 2. Sunroof frame drainage with the presence of fine dirt and debris.

2. With the front glass panel open, Figure 2 shows the dirt that accumulates in the front sunroof frame channel. Carefully remove all of the accumulated dirt and/or debris.

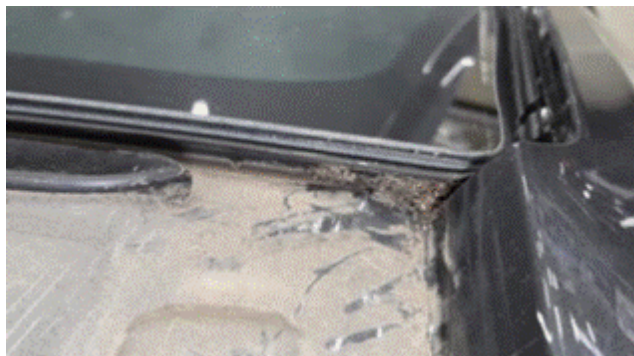
Due to an accumulation of fine dirt and debris in the water drain channels, water is not correctly guided away from the panoramic sunroof through the water drain hoses. Instead, it drains out of the sunroof frame under the bonded front trim and down along the outer A-pillar.

3. Figures 3 and 4 show the water drainage obstruction that can occur when fine dirt and debris accumulate in this area.

Figure 3. Water passage obstructed preventing drainage.

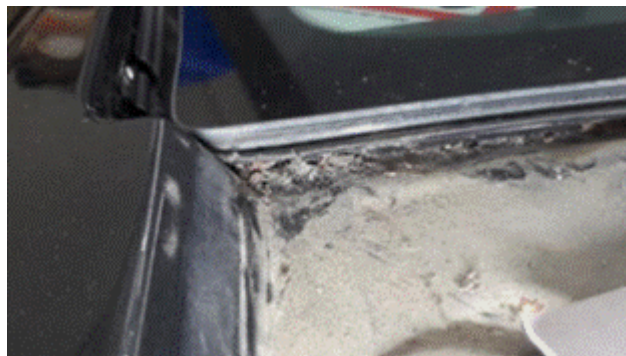
Figure 4. Drainage path obstructed.

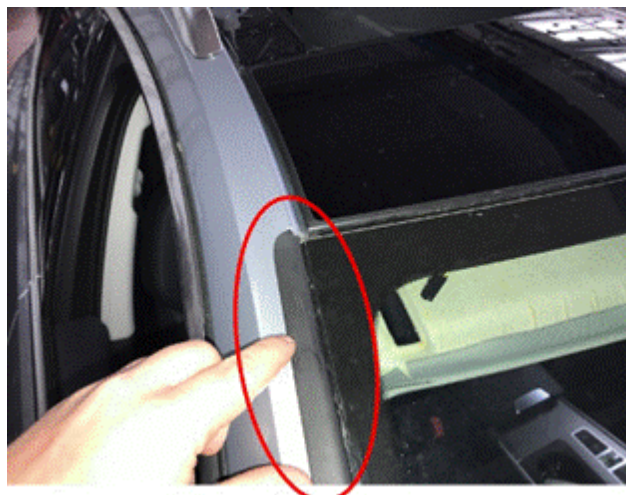
Figure 5. Drip rails to be removed.

4. This condition can occur on both the right and left drainage channels.
5. Begin the cleaning process by removing the drip rails on both the right and left sides of the windshield (Figure 5).

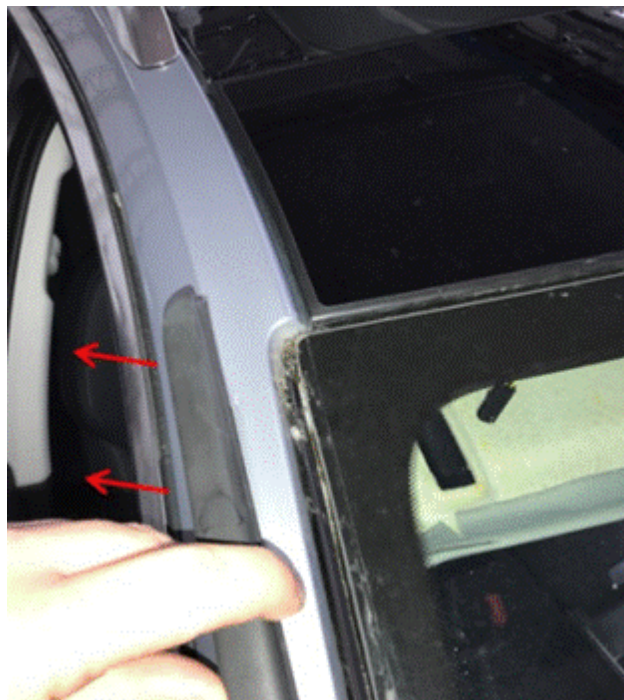
Figure 6. Drip rail removed.

6. Follow the disassembly instructions in ElsaPro Repair manual>>Body>>66 Exterior Equipment>>Moldings, Trims, Extensions and Trim Panels>>Side Sill Trim Panel Decorative Trim, Removing and Installing>>Drip Rail, Removing and Installing (Figure 6).

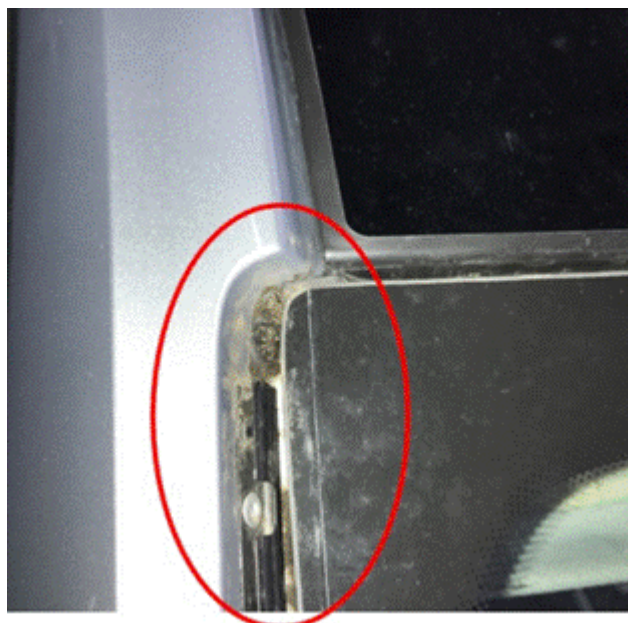
7. Figure 7 shows the accumulation of dirt and debris under the now removed drip rail trim.

Figure 7. Drip rail trim removed exposing the accumulation of dirt and debris.

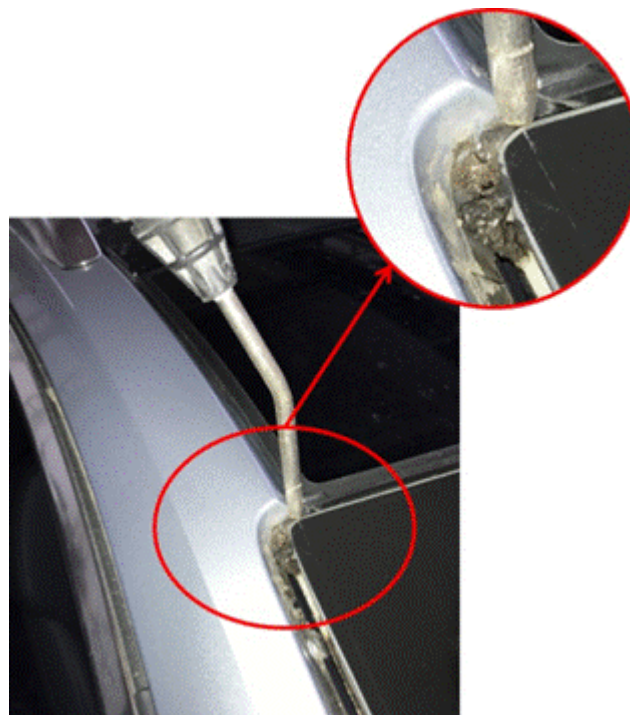
Figure 8. Removal of dirt and debris in the drainage channels using a blow gun with compressed air.

8. Using an air gun and compressed air loosen and remove any dirt and debris thoroughly (Figure 8).

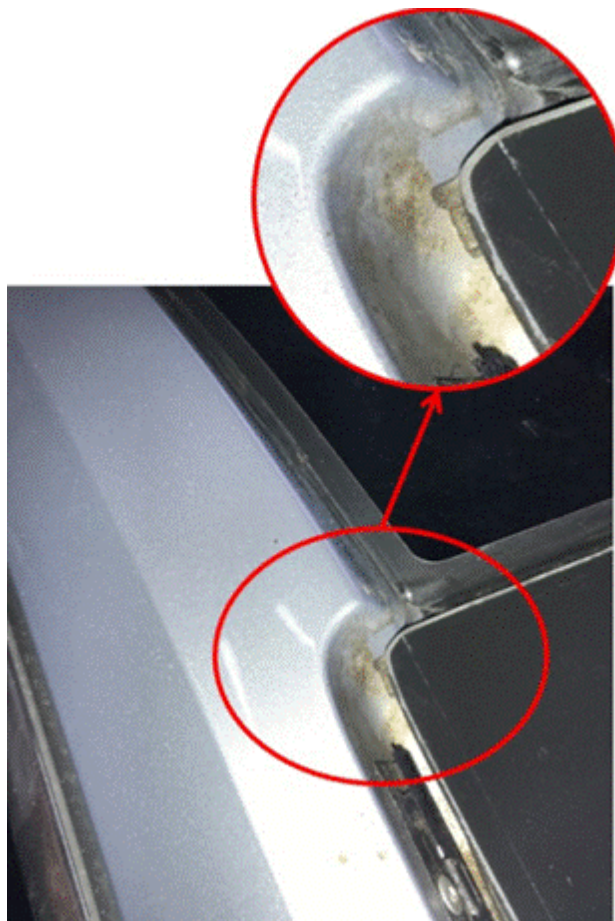
9. Figure 9 shows the drainage channel cleared after application of compressed air and a blow gun.

Figure 9. Drainage channel cleared.

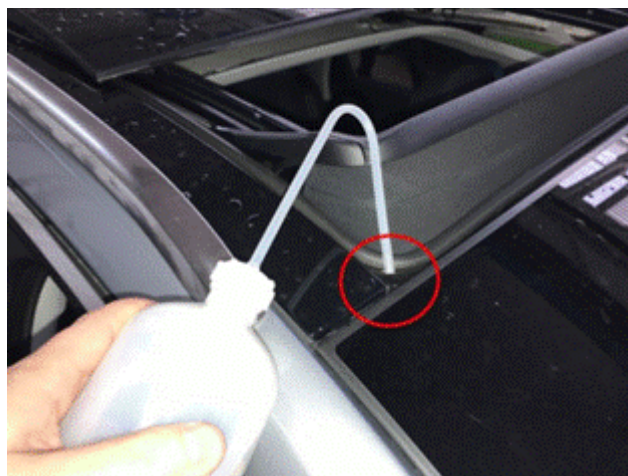
Figure 10. Rinsing the drainage channels.

- 10 Using a mixture of mild detergent and water rinse the drainage channels clean (Figure 10).

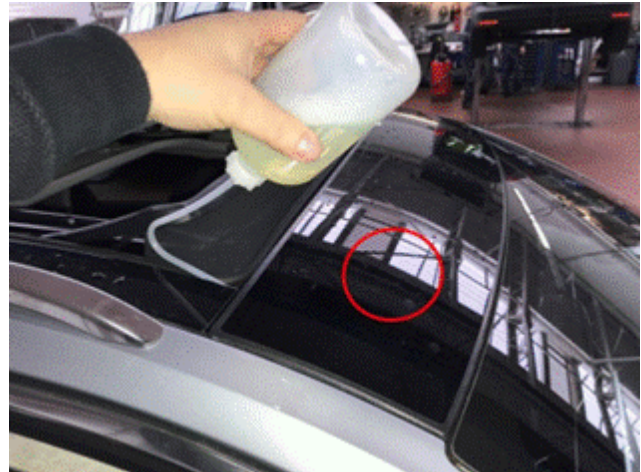
Figure 11. Mild detergent and water solution application.

- 11 Apply the solution at every angle to ensure thorough rinsing of the drainage channels (Figure 11).

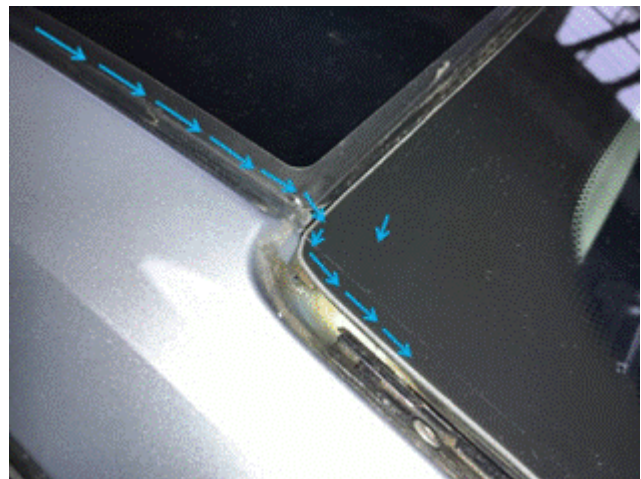
Figure 12. Correct water drainage path.

- 12 Figure 12 shows the typical water drainage path that must be clear for correct operation. If necessary, repeat the cleaning procedure multiple times until no more dirt particles are visible.

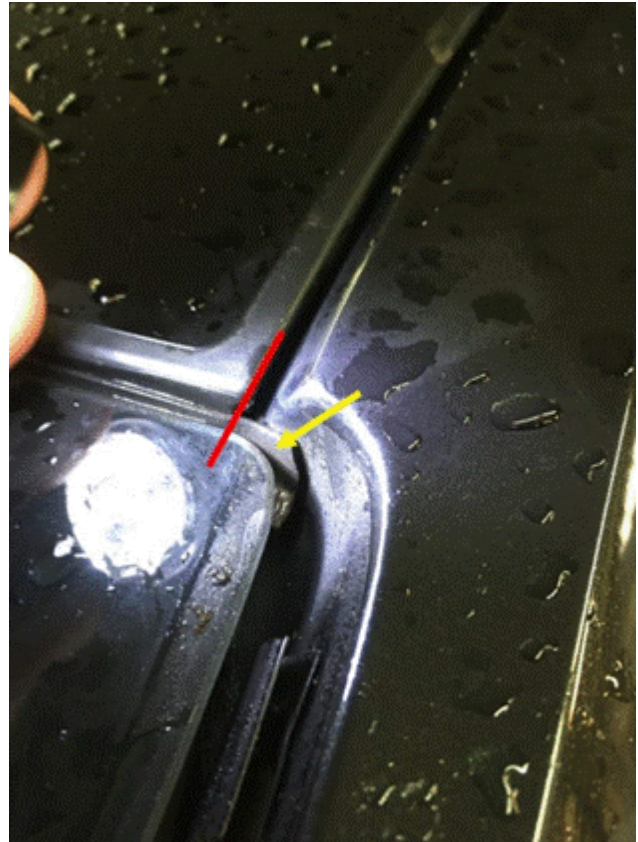
Figure 13. Section of windshield profile lip seal section to be cut away and removed.

The lip seal of the windscreen cover profile will be cut back at the edges to enlarge the passage to the water drain channel allowing a constant flush of fine dirt particles.

- 13 Now, modify the lip seal of the windshield cover profile. The sealing lip must be cut back as far as possible from the red line to the right yellow arrow. The cut away piece of the lip seal must be removed (Figure 13).

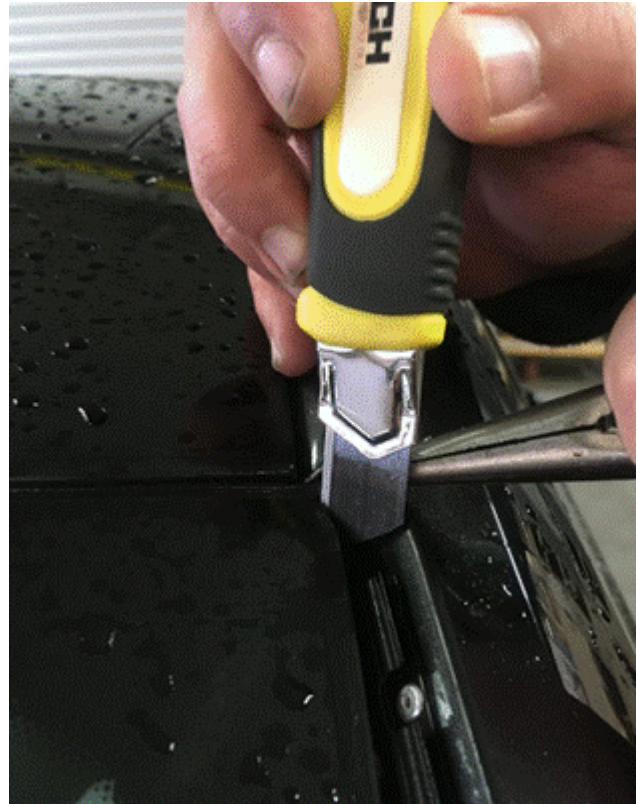
Figure 14. Use of a wide utility type knife will not allow the correct cuts due to the limited space.

- 14 Using an X-Acto ® or equivalent precision cutting instrument cut the lip seal away. A precision cutting instrument is crucial as a wide utility type cutter is too wide to gain access to the precise cuts required. Exercise extreme caution so as not to damage the painted surfaces or the windshield glass. Mask off the cutting area with masking tape if necessary (Figure 14).

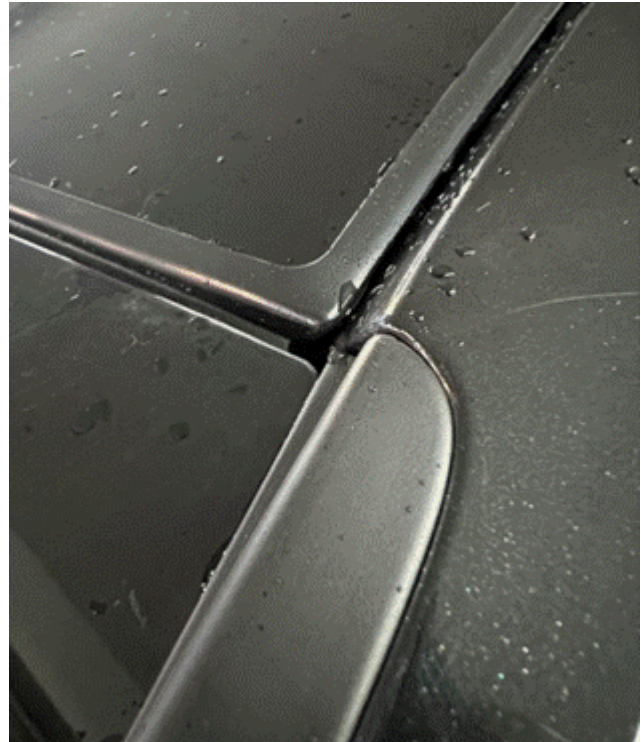
Figure 15. Drip rail trim reinstalled showing the desired opening for proper water drainage.

15 Reinstall the drip rail trim (Figure 15).
