Technical Service Bulletin

63 Paint peeling from the rear bumper cover

63 23 10 2064279/3 March 3, 2023. Supersedes Technical Service Bulletin Group 69 number 21-74 dated November 22, 2021, for reasons listed below.

Model(s)	Year	VIN Range	Vehicle-Specific Equipment
Q5, and SQ5	2020 – 2022	All	Not Applicable
Q5 e quattro, Q5 Sportback, SQ5, and SQ5 Sportback	2022

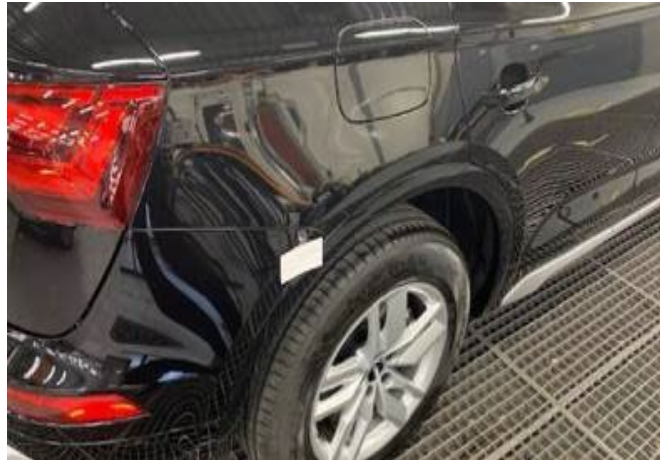
An inconsistency in the production process of the rear bumper cover specifically at the edges that meet the rear side panel caused a weakness making the painted surfaces on these edges prone to paint peel over time. Either the right side, left side, or both sides of the bumper cover are affected.

1. Figure 1 shows the area of the bumper cover affected.

Figure 1. Bumper cover edge affected.

Should the condition described in this TSB occur the rear bumper cover is to be replaced. Do not attempt to refinish the original bumper cover. Due to the technical nature of the root cause refinishing the original bumper cover will only reintroduce a subsequent paint peel in these areas of the rear bumper cover over time.

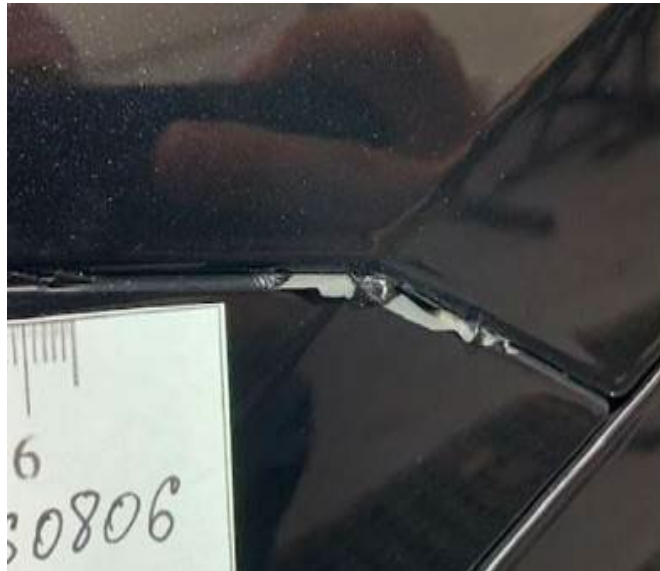
2. Figure 2 shows a close-up view of the paint peel.

Figure 2. Paint peel on the bumper cover edge.

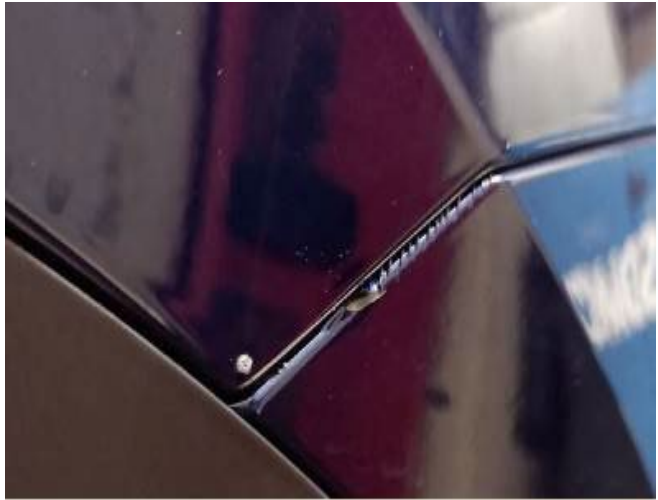
3. Figure 3 shows the condition in its early stages that may evade notice.

Figure 3. Early stages of the peel.

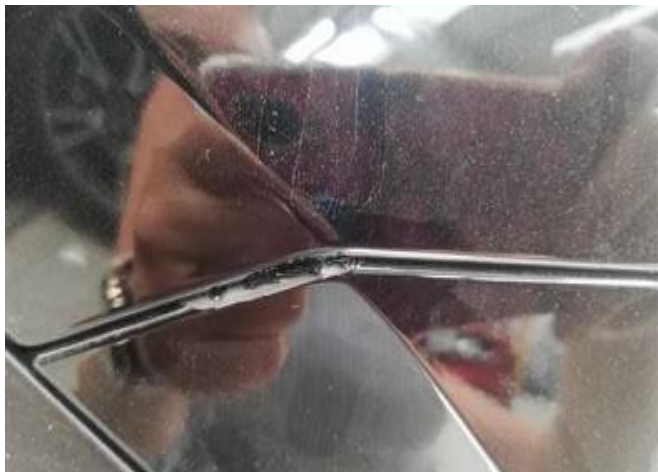
4. Figure 4 shows an intermediate loss of paint in this area.

Figure 4. Moderate loss of adhesion.

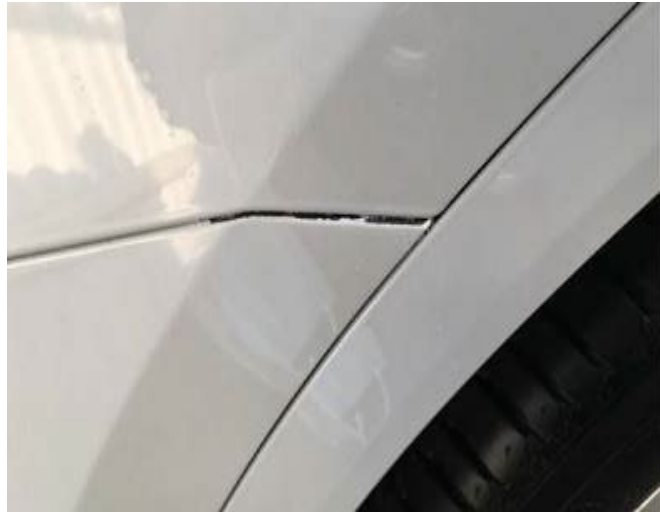
5. Figure 5 shows severe advancement of paint loss on the rear bumper cover.

Figure 5. Advanced paint peel.
