Bulletin No.: PIT5978
Published date: 02/3/2023

PIT5978 No Apple CarPlay While Phone Is Hardwired

Brand:	Model:	Model Years:	VIN:		Engine:	Transmissions:
			from	to		
Cadillac	Escalade	2023	01/12/2023	01/27/2023	All	All

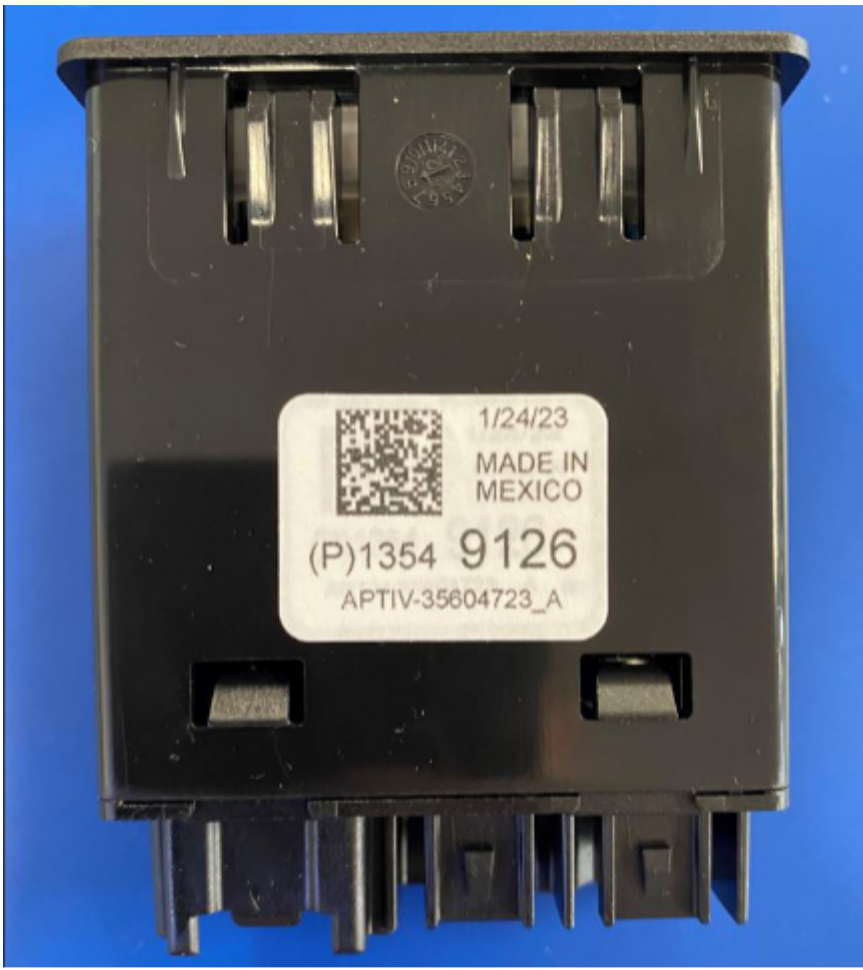
Involved Region or Country	GME, GMIO, GMNA, and Holden.
Additional Options (RPO)	IOV
Condition	Customers may notice that when they hardwire connect their phone through USB, that Apple Carplay is inop. Wireless Apple Carplay will work, it is only hardwired that is inoperative.
Cause	A hardware anomaly in the USB port.

Dealers are to check the part number of the USB. If part number is: 13549126, then dealers are to replace USB with part number 13529873. If it is not 13549126, this PI does not apply and dealers will need to follow SI directions in further root causing issue. PN is not customer visible but is on the 2D label on the back of the part. Easy to pop out with a trim stick to review. This is the one in the front of the cup holder without the SD Card slot.
