Preliminary Information

PIP5874B 3.0L LZ0 Diesel Exhaust Backpressure Valve Part Restriction

Models

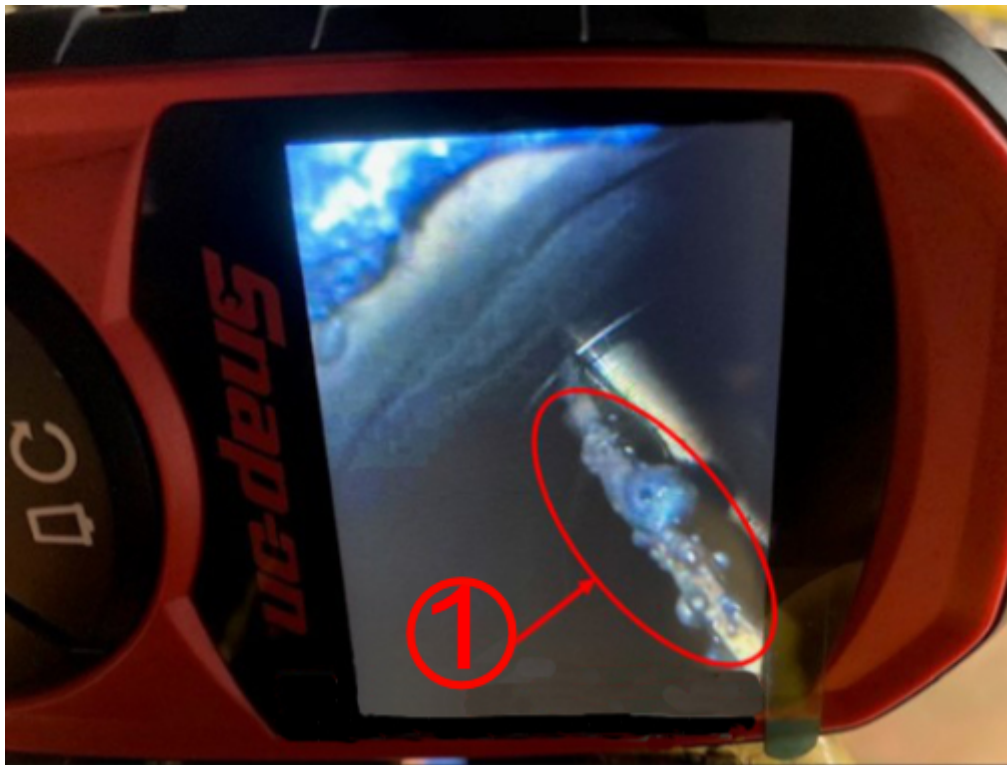
3) Note whether the valve moves smoothly through its entire travel and look for welding slag on the valve's flap as seen in the picture below.

4) If welding slag is found capture the image or take a picture of the bore scope's screen as well as the exhaust pipe's identification label (Illustration below) and submit the pictures in a field product report per bulletin 02-00-89-002 (Canadian dealers refer to bulletin 10-00-89-006). Replace the rear exhaust assembly from the clamp back. There is no need to continue with the remainder of the PQC template **(only if welding slag is present)**.
