## Preliminary Information

### PIT5832F Diagnostic Tip: Unable to complete the Serial Data Authentication Configuration/ No Start Or Unable To Perform Theft Relearn After Replacing Or Programming A Module / DTC U1962

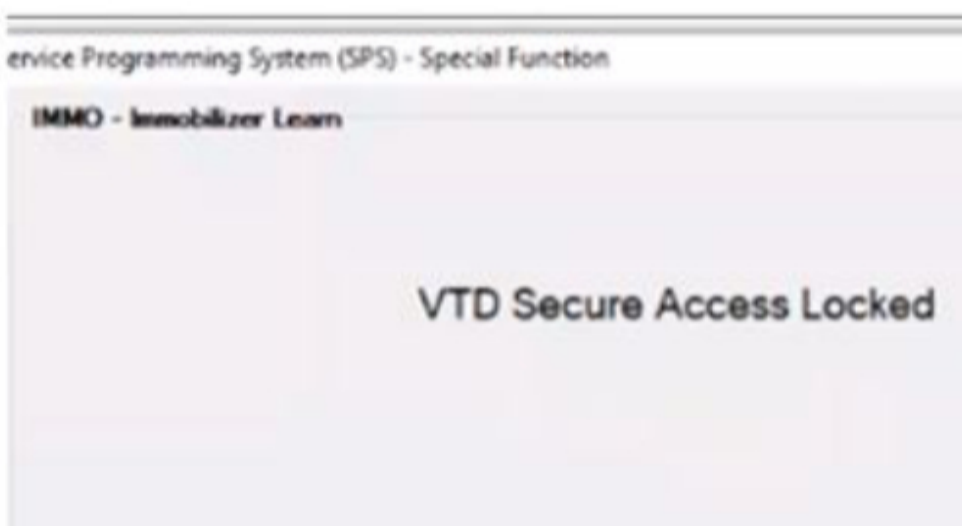
1. If a module was replaced, make sure the new module was SPS programmed correctly or the SDAC will fail and not complete correctly.
2. If a module such as the BCM is replaced, and the immobilizer learn needs to be completed after replacement, the tech needs to make sure that the SDAC completes correctly, or a pop-up message like the one below will be displayed:

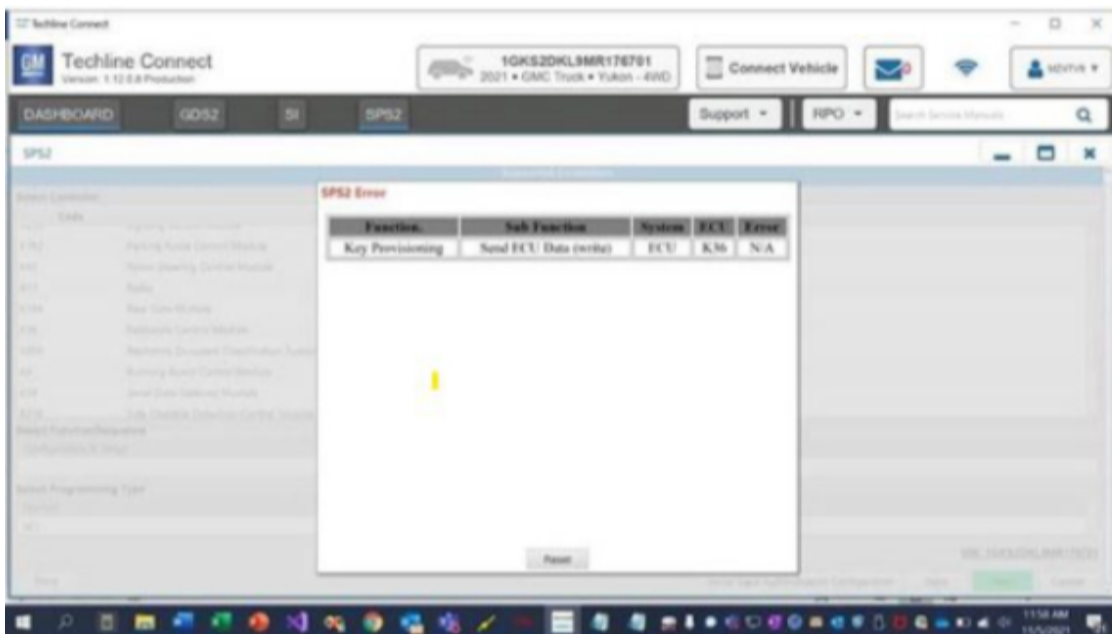
4. The SDAC will run up to 3 times before it fails. When it fails, there should be a pop box that shows up on the screen like the one below. Check and record the items listed under System and ECU. If the system box reads "Server" then the issue is related to the SPS system server or internet connection and not related to the vehicle. Attempt the SDAC again at a later time or the next day early in the morning. ( If the box doesn't read "Server" continue to step 5 )

5. If the system box reads "ECU", then the Global ID of the module that is causing the concern should be able to be obtained. In the example below, the Global ID is listed as K36, which is for the SDM. The module's name can be found by looking at the global codes listed under "Control Module References" document in SI for the vehicle that is being working on.

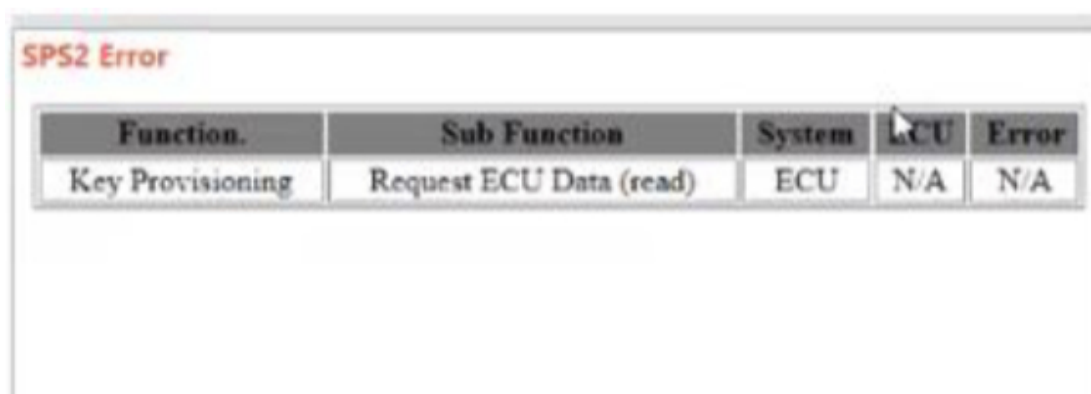
6. Sometimes the pop-up box will read "ECU" but it will not give you a Module ID in the ECU box. In this case, the servicing dealer will have to contact Techline support and they will have to assist by getting a SPS log file from the dealership's system. If this is the case, they must be contacted right after the SDAC failure. If any other programming is attempted before contacting Techline, then the SPS log will be erased.
