Preliminary Information

PIT5912G Lane Keep Assist Unavailable / Adaptive Cruise Control Inop / Service Driver Assist Systems / Amber Front Collision Icon On / Dead Battery / No Crank / Front View Camera / Auto Start Stop Inop / Unable To Complete Camera Learn Stops At 94% /DTC U3000 44 49 54 and/or 57

Models

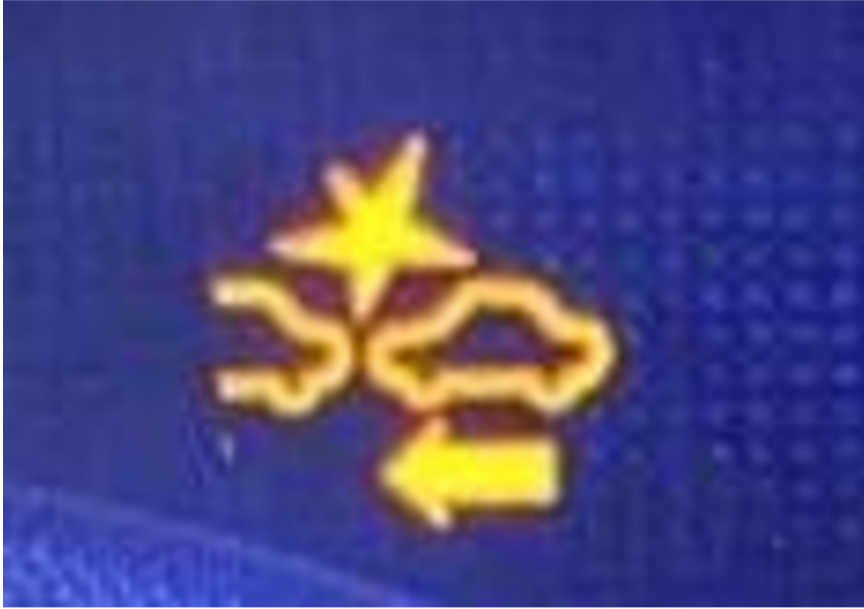
Involved Region or Country	North America
Additional Options (RPO)	With RPO UHY Without RPO UGN
Condition	<p>Some customers may comment on an amber Forward Collision icon displayed in the IPC, as shown below. Also, DTC U3000 symptom 44, 49, 54, and/or 57 may or may not be set current in the Front View Camera Module. In some cases, there could be a low or dead battery condition. Customers may also notice certain features related to the Front View Camera are unavailable, such as:</p> <ul style="list-style-type: none"> - Forward Collision Alert (RPO: UEU) - Following Distance Indicator (RPO: UE4) - Low Speed Collision Mitigation Braking (RPO: UHY) - Pedestrian Collision Mitigation Braking (RPO: UKJ) - Lane Keep Assist (RPO: UHX) - Automatic High Beam Assist (RPO: TQ5) - Adaptive Cruise Control (RPO: KSG) <p>Note: Because this condition could cause a low/dead battery, it can cause the Auto Stop/Start feature to be disabled due to the battery start of charge. The front view camera module issue should be corrected first before diagnosing an auto stop/start complaint.</p>

Cause	The cause of this concern could be Onstar performing a task, which causes the B174W Front View Camera to set the DTC and disable during the next vehicle start up.

1. Turn the ignition off.
2. Remove the F11DR fuse for the B174W Front View Camera, located in the X51R Right Instrument Panel Fuse block.
3. Leave the fuse removed for 1 minute, then reinstall the fuse.
4. Clear any DTCs and check camera operation.
5.
 - If the camera operation has returned, then no further action is required.
 - If the camera operation has NOT returned, then perform a camera relearn using GDS2.
6.
 - If the camera operation has returned after the camera relearn, then no further action is required.
 - If the camera operation has NOT returned after the camera relearn then perform normal SI diagnostics and repair as necessary.
 - If the camera will not complete the Front View Camera relearn procedure, then see "Extended Camera Relearn Procedure", shown below.

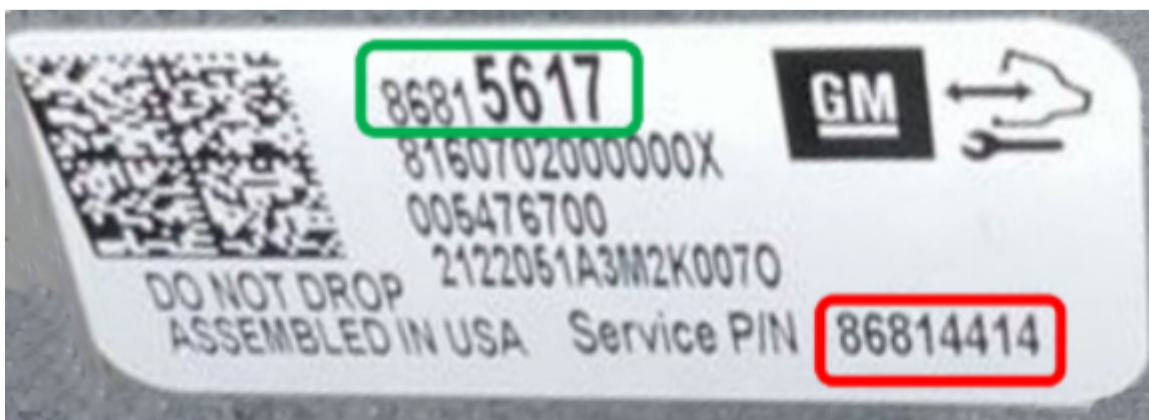
Note: If it is necessary to replace the Front View Camera, be sure to use the correct Part Number listed in the Electronics Parts Catalog. The Original Front View Camera may have "Service P/N 86814414" printed on the label (circled in red below) and that is the incorrect Part Number for this vehicle. Correct Part Number to use is in location circled in green below. If the part was ordered incorrectly it can be returned to the PDC using the correct MR return code. The part number shown below in green is ONLY an example to show location of which part number to use, it may not be the part number for your particular vehicle.
