Technical product information

| Topic | Touch Screen Remote (TSR) is not operating (No display or functionality) |

Bentayga Series and New Flying Spur

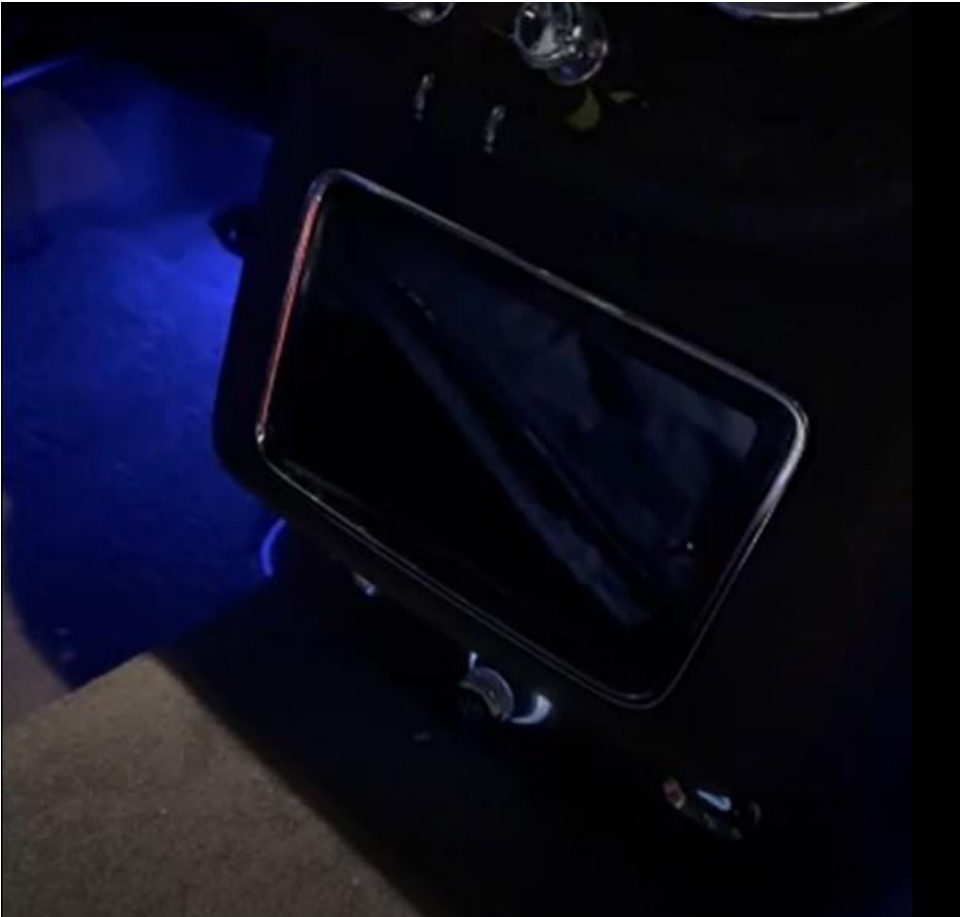
- Referring to Figure 1 - The Touch Screen Remote (TSR) is not operating (No display or functionality)

The issue described is evident regardless if the screen is located within the TSR cradle or not
