Technical product information

Topic	Creaking noise from the rear seat cushion edge/rear seat side valance
Market area	Russische Föderation (5RU),Australia E04 Bentley rest Asia and Australia (6E04),China 796 VW Import Comp. Ltd (Vico), Beijing (6796),Germany E02 Bentley rest Europe (6E02),Japan E03 Bentley Japan (6E03),Korea, (South) E08 Bentley South Korea (6E08),United Arab Emirates E06 Bentley Middle East and Africa (6E06),United Kingdom E01 Bentley UK (6E01),United States E05 Bentley USA and rest America (6E05)
Brand	Bentley
Transaction No.	2069561/1
Level	EH
Status	Approval
Release date

Bentayga Series - 4 seat configuration only

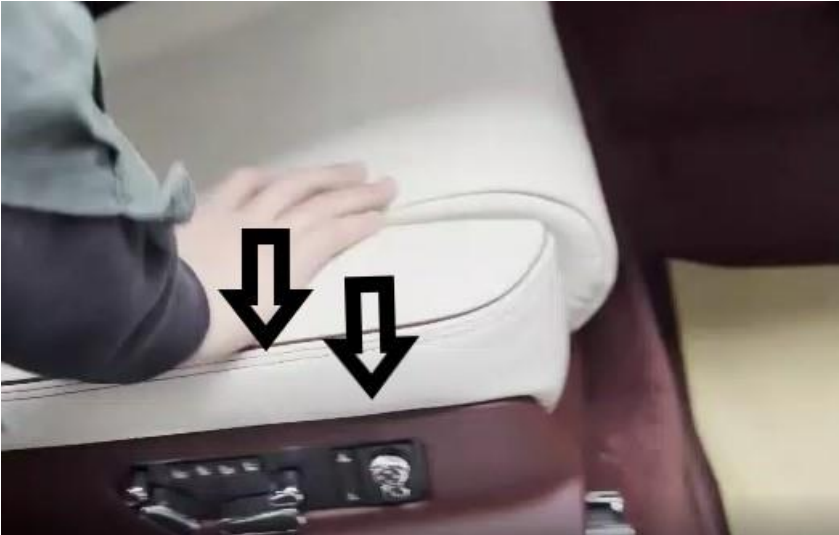
Referring to Figure 1 - When pressure is applied to the points shown, a creaking noise can be heard from the rear seat cushion edge/rear seat side valance

The creaking noise is caused by contact between the side valance pins and the seat frame
