## Technical product information

<b>Topic</b>	Rear doors do not fully open (Left and/or Right)
<b>Market area</b>	Russische Föderation (5RU),Australia E04 Bentley rest Asia and Australia (6E04),China 796 VW Import Comp. Ltd (Vico), Beijing (6796),Germany E02 Bentley rest Europe (6E02),Japan E03 Bentley Japan (6E03),Korea, (South) E08 Bentley South Korea (6E08),United Arab Emirates E06 Bentley Middle East and Africa (6E06),United Kingdom E01 Bentley UK (6E01),United States E05 Bentley USA and rest America (6E05)
<b>Brand</b>	Bentley
<b>Transaction No.</b>	2068866/1
<b>Level</b>	EH
<b>Status</b>	Approval
<b>Release date</b>

### Bentayga EWB

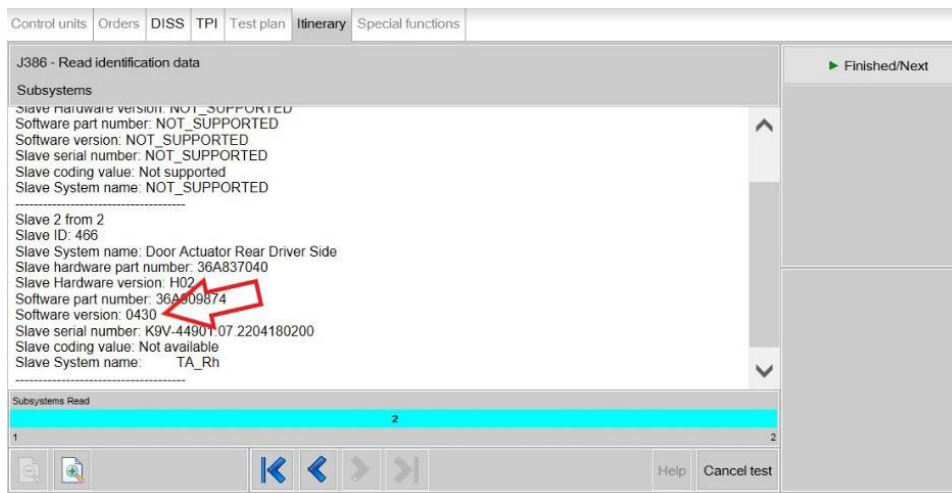
Figure 1

In the event the Software version is 0430 (Figure 1) the operative MUST raise a Technical DISS query stating the following:

- The Software version of J386 and J387 (Left and right) is 0430

**In the event the Software version is 0440 - The software is up to date, no further action is required from a Software perspective**

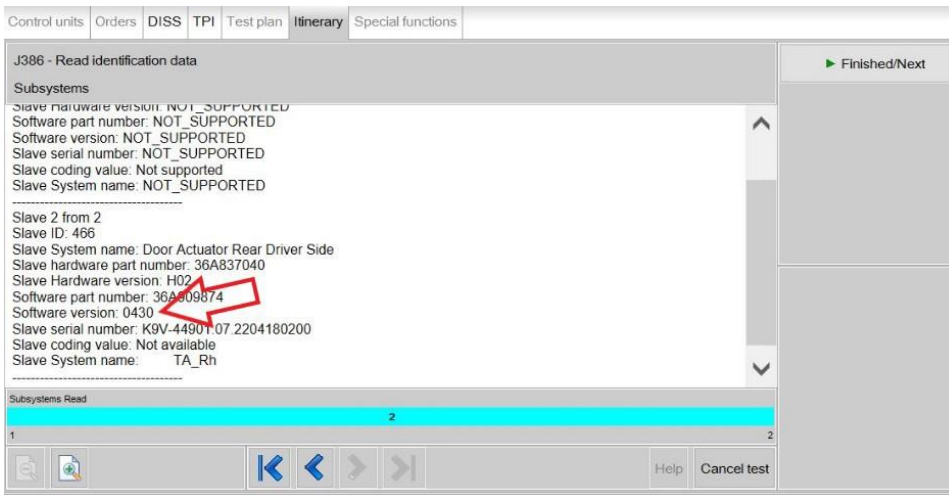
Figure 1

**In the event the Software version is 0440 - The software is up to date no further action is required from a Software perspective**
