Technical product information

Topic	Bentayga V8 Kovomo - DTC P310B00 with Symptom Code 2638 - Check Engine Lamp - Fuel Pressure Regulation
Market area	Bentley: worldwide (2WBE)
Brand	Bentley
Transaction No.	2058484/11
Level	EH
Status	Approval
Release date

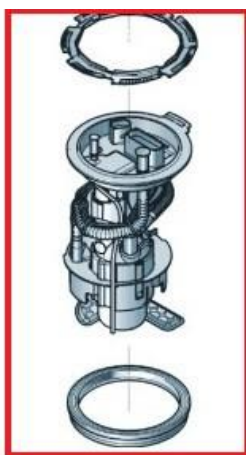
- 1) Referring to the example shown in Figure 1 - Check the actual pressure value

1) Referring to the example shown in Figure 1 - Check the actual pressure value

- Extended ambient conditions:		
Engine rpm	639.5	1/min
Normed load value	13.725490449999999	%
Vehicle speed	0	km/h
Coolant temperature	82	°C
Intake air temperature	42	°C
Ambient air pressure	1000	mbar
Voltage terminal 30	12.4	V
Dynamic environmental data	20 96 28 11 CE 11 94 11 C8 12 80 11 C9 F8 41 11 A4 26 66 12 8AAA 15 9F 66 60 15 A0 66 64	
Unlearning counter according OBD	40	
Low fuel pressure, specified value	450.0	kPa
Fuel low pressure, actual value	501.3	kPa
Fuel pump adaptation	-198.3	kPa
Fuel pump, specified value	14.99939	%
Fuel temperature	79.5	°C
Fuel high-pressure, actual value	13.104	MPa
Fuel pressure rail 2	13.106	MPa

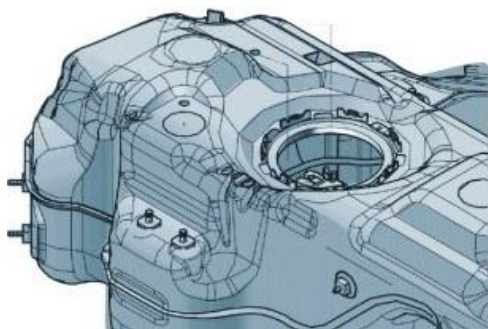
Figure 2

- In the event the fuel pressure actual value is above 450kPa the Fuel Delivery Module within the fuel tank (Figure 2) should be replaced

- In the event the fuel pressure actual value is above 475kPa (2023MY) the Fuel Delivery Module within the fuel tank (Figure 2) should be replaced

The fuel tank flange seal and securing ring should also be replaced

- Refer to Repair Group 20 Fuel supply, gas operation / 4.0L V8 TSI/ Fuel pump, fuel level sensors, and jet pump (RH) - To remove and fit

- Refer to Repair Group 20 Fuel supply, gas operation / 4.0L V8 TSI/ Fuel pump, fuel level sensors, and jet pump (RH) - To remove and fit.

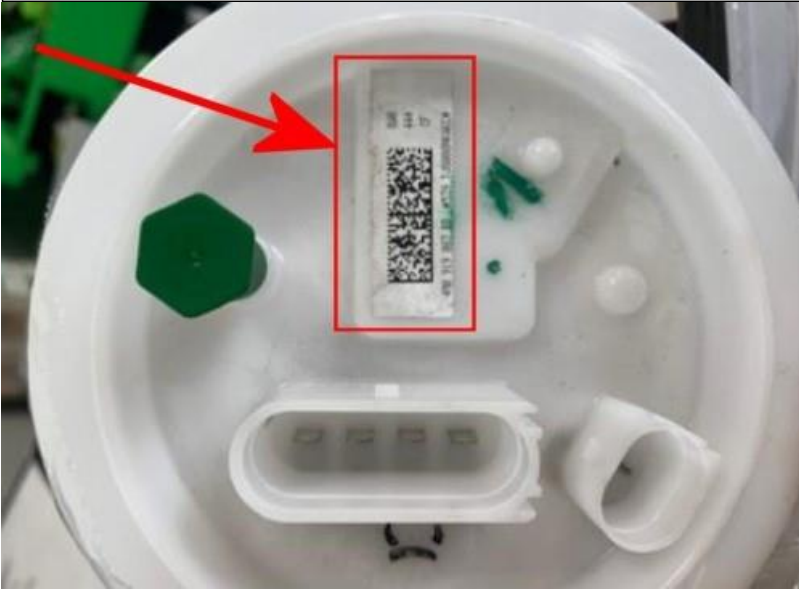
IMPORTANT: Once the fuel delivery module has been replaced, the operative should attach a clear photograph of the manufacture information label as shown in Figure 3
