### **SERVICE ADVISORY 23-438**

## SERVICE ADVISORY # 23-438

### Hideout 186SS and Springdale 1860SS Slide Floor

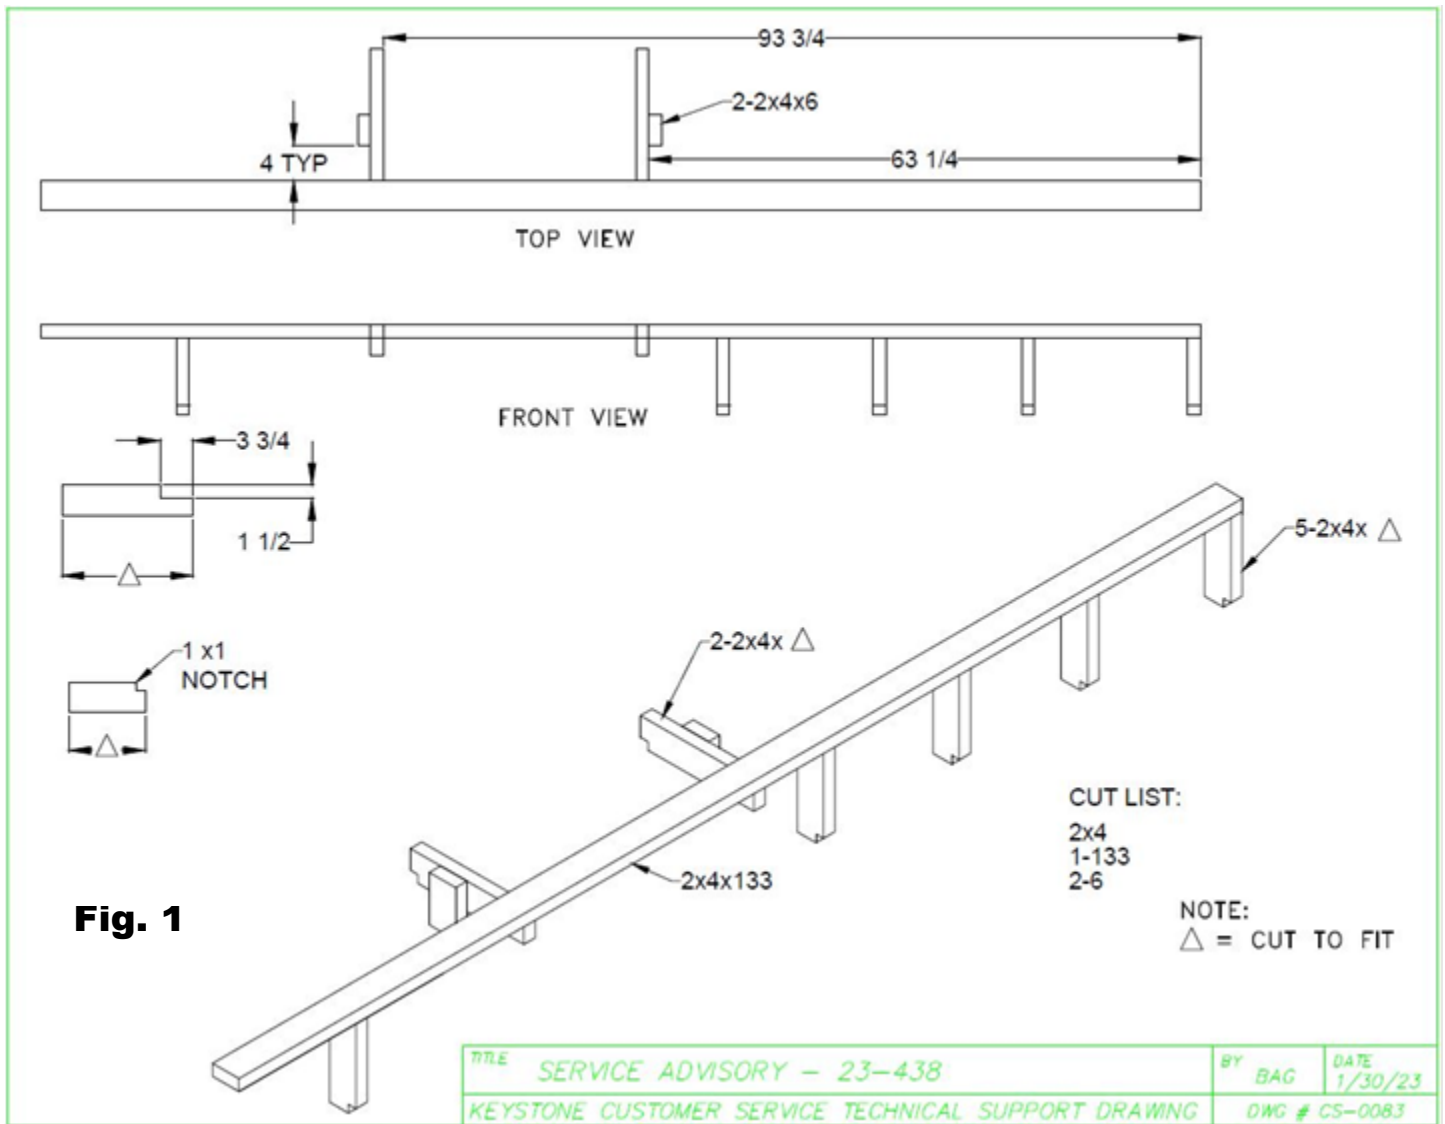
It has been determined that the slide floor in the Hideout 186SS and Springdale 1860SS may be improperly supported. The following procedure describes how to install support into the cabinet below the slide room floor.

Remove the wood cleat from the top of the cabinet front and discard it. Assemble the 2"x 4" wood support frame as shown in the print. See Figure 1. Once assembled the wood support frame work should be flush with or slightly above the cabinet face. Set the wood support frame in place over the wheel well. Attach the wood support frame to the wheel well using a piece of 2"x 4" that is cut to approximately 6 inches on each end of the wheel well.
