GROUP	MODEL
ELE	2023MY Carnival (KA4)
NUMBER	DATE
289	March 2023

## TECHNICAL SERVICE BULLETIN

### SERVICE ACTION: TIGHTENING OF IGNITION GROUND BOLTS (SA531)

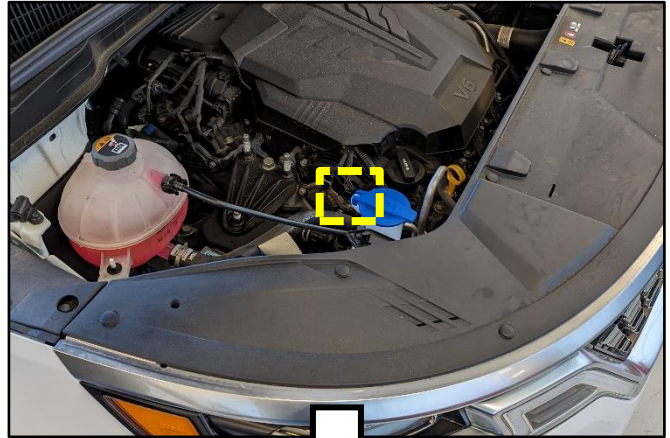
1. Open hood and locate the two (2) ignition grounds in the area shown.

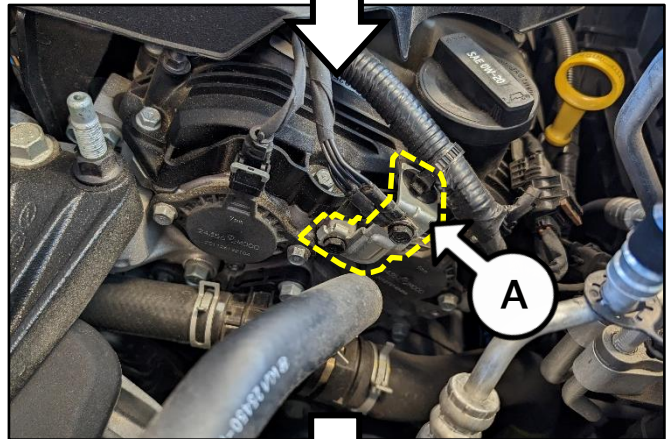
**Note:** The ignition ground bracket (A) bolts (GC02) are located between the intake and exhaust Oil Control Valve (OCV) on Bank 2.
