Subject: REVISION: N222375790-02 - Customer Satisfaction Program
Park Assist Retrofit
Revised Service Procedure

Models: 2022 – 2023 Chevrolet Corvette
2022 – 2023 Cadillac CT4
2022 – 2023 Cadillac CT5

N222375790 Park Assist Retrofit

Revision: 02

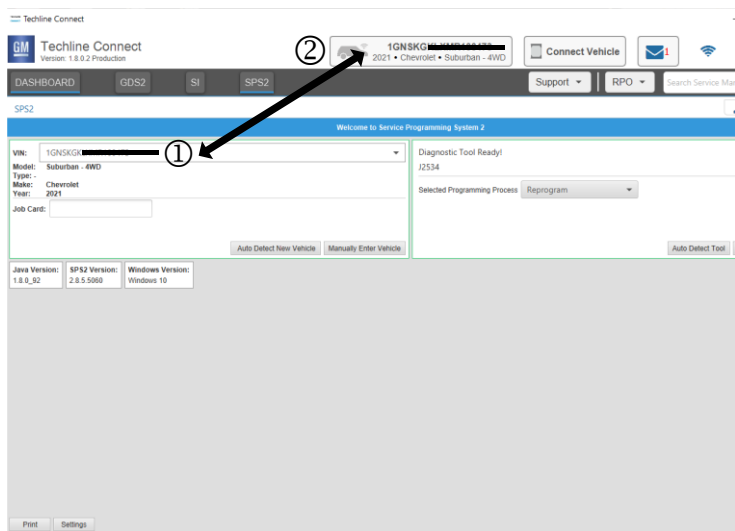
Caution: Be sure the VIN selected in the drop down menu (1) is the same as the vehicle connected (2) before beginning programming.

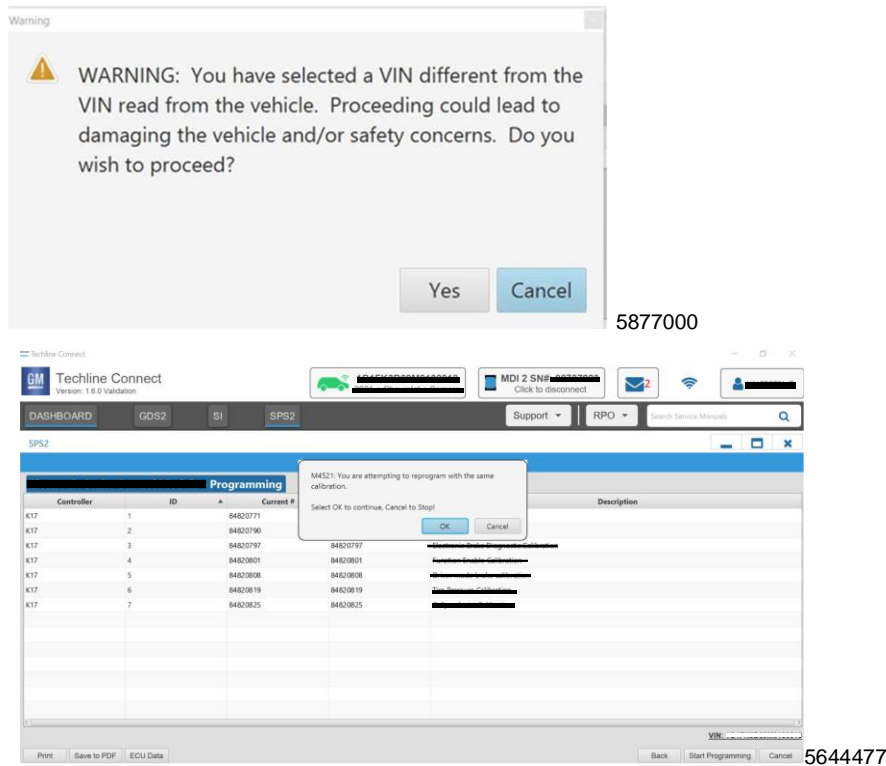
Important: If the vehicle VIN DOES NOT match, the message below will be shown.

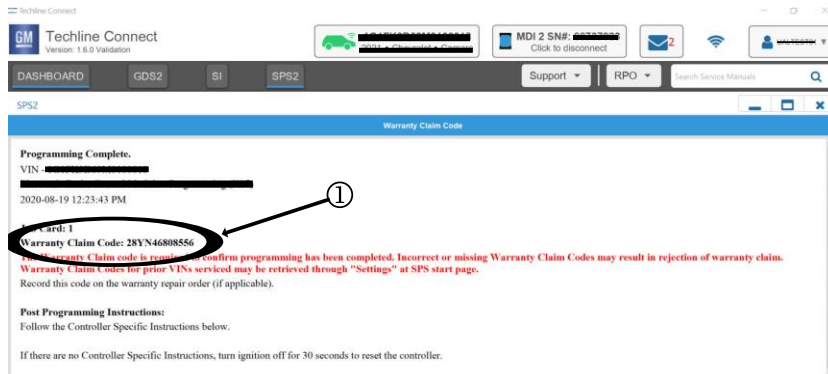
5644478

Important: To avoid warranty transaction rejections, you **MUST** record the warranty claim code provided on the Warranty Claim Code (WCC) screen shown above on the job card. Refer to callout 1 above for the location of the WCC on the screen.

5. Record SPS Warranty Claim Code on job card for warranty transaction submission.
6. Clear all DTCs.

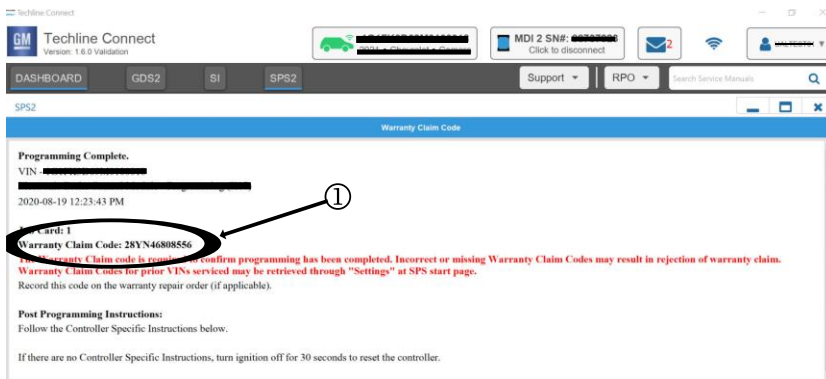
5644478

Important: To avoid warranty transaction rejections, you **MUST** record the warranty claim code provided on the Warranty Claim Code (WCC) screen shown above on the job card. Refer to callout 1 above for the location of the WCC on the screen.

6. Record SPS Warranty Claim Code on job card for warranty transaction submission.
7. Clear All DTCs

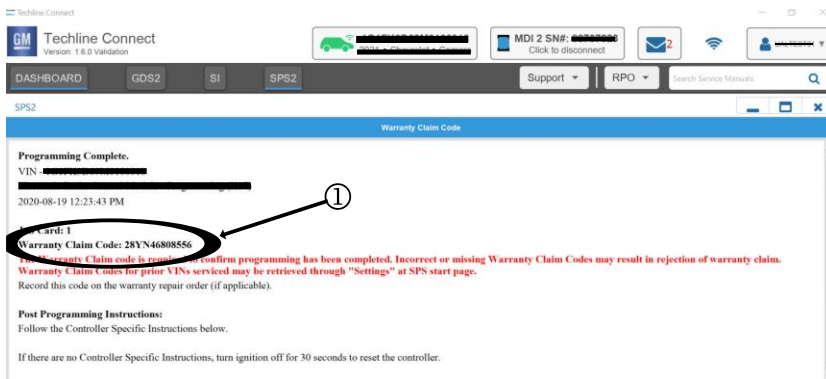
5644478

Important: To avoid warranty transaction rejections, you **MUST** record the warranty claim code provided on the Warranty Claim Code (WCC) screen shown above on the job card. Refer to callout 1 above for the location of the WCC on the screen.

6. Record SPS Warranty Claim Code on job card for warranty transaction submission.
7. Clear all DTCs.

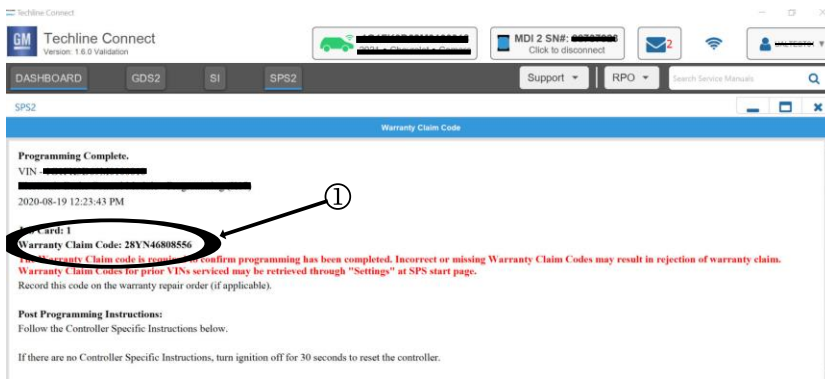
5644478

Important: To avoid warranty transaction rejections, you **MUST** record the warranty claim code provided on the Warranty Claim Code (WCC) screen shown above on the job card. Refer to callout 1 above for the location of the WCC on the screen.

7. Record SPS Warranty Claim Code on job card for warranty transaction submission.
8. Clear DTCs.
