Subject: REVISION: N222359240-01 – Customer Satisfaction Program
Outside Rear View Mirror Not Dimming
Revised Parts Table

Models: 2021 – 2022 Chevrolet Blazer

N222359240 Outside Rear View Mirror Not Dimming

Revision: 01

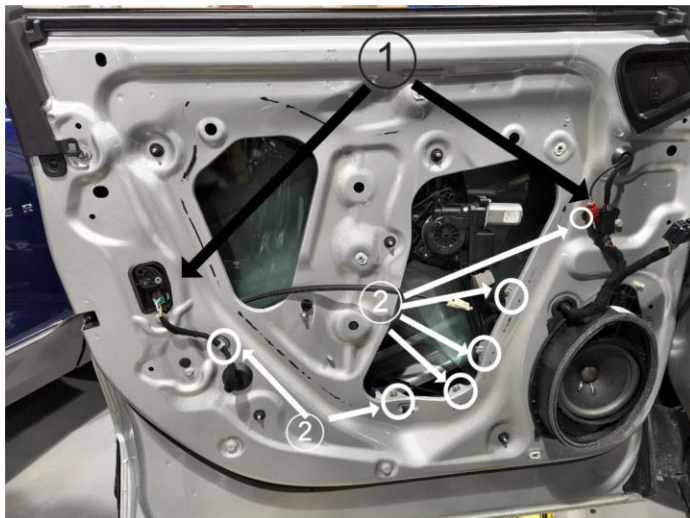
6051664

Condition	Certain 2021 - 2022 model year Chevrolet Blazer vehicles, may have a condition in which the driver side mirror does not auto dim.
Correction	Dealers are to replace the front door wiring harness.

4. Disconnect electrical connectors (1). Be sure to disconnect the wire harness connector to the front side door outside handle.
5. Disengage wire harness retaining clips (2).
6. Push the harness rubber retainers through the door panel.
7. Carefully remove the front side door wiring harness.
8. Install new front side door wiring harness.
9. Install harness rubber retainers.
10. Insert wire harness retaining clips.
11. Connect electrical connectors.
12. Install front side door speaker.
13. Install front side door water reflector. Refer to *Front Side Door Water Deflector* in SI.
