# Rapid Update 599

## Grecale Premium Alarm System (LSA) OPT – Volumetric Alarm Deactivation

DATE: FEBRUARY 21 2023

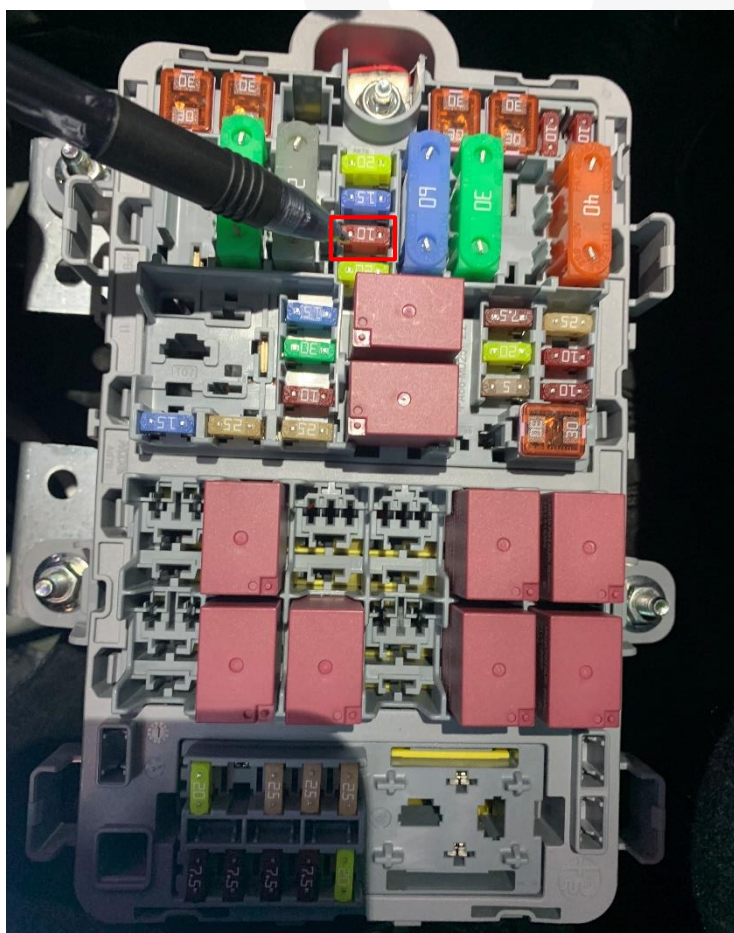
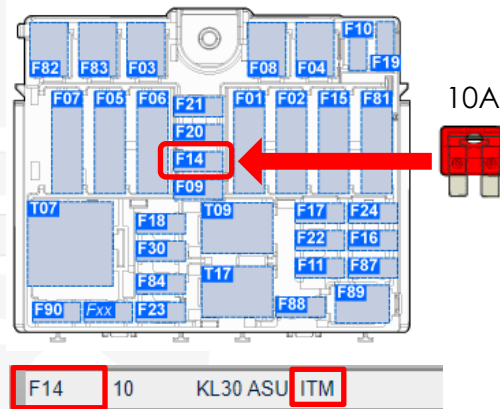
Due to a regression via the new ITM SW 2.05, an improper behavior of the Volumetric Alarm could affect the Premium Alarm System (LSA opt) which could cause an abnormal power draw and potentially drain the 12V battery.

1. Always check ModisCS+ to see if the vehicle is involved in this action and if it has not been previously performed.
2. Write the new "**Vehicle Configuration**" (VC) through the MD-EVO.
3. Accessing the Rear Distribution Unit (**RDU**), remove the F14 10A fuse, indicated in the picture below.

**NOTE:** Please keep the fuse removed until a new Service action has been released to reactivate the volumetric feature.
