# Rapid Update 591

## Grecale – Air suspension system leak check

DATE: FEBRUARY 21 2023

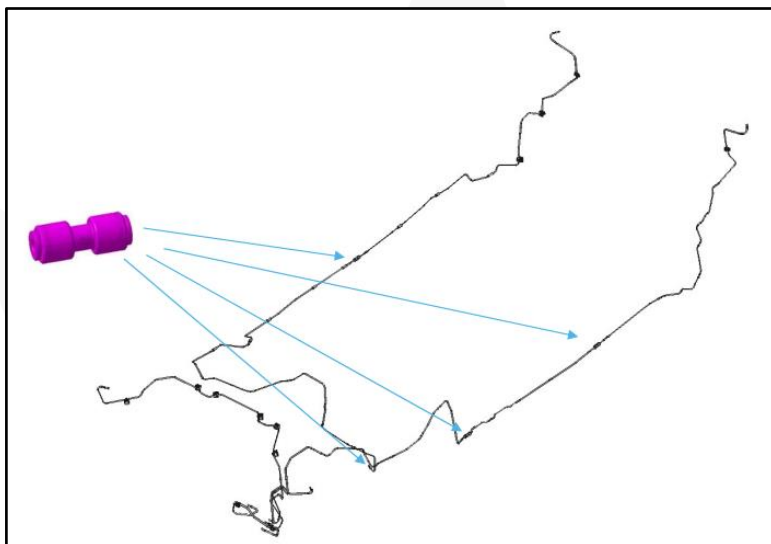
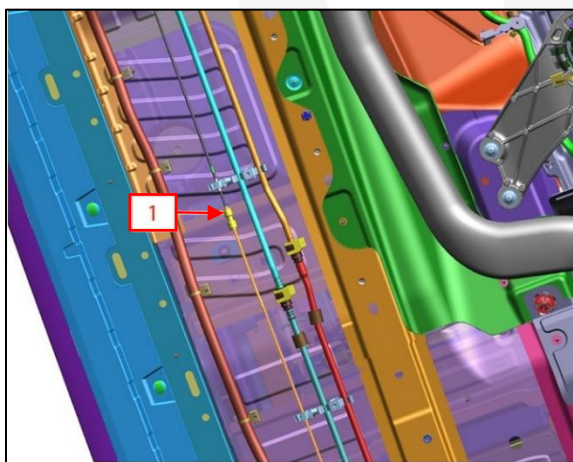
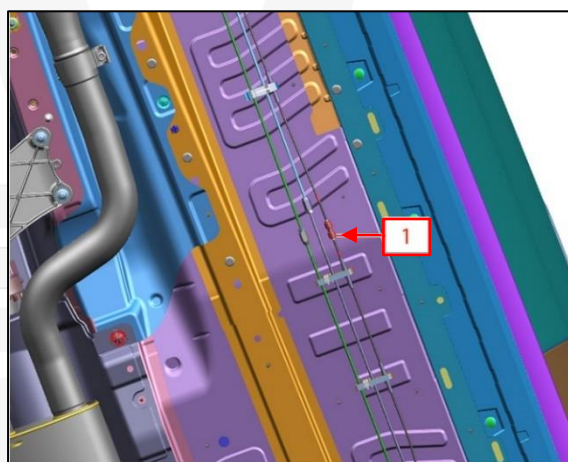
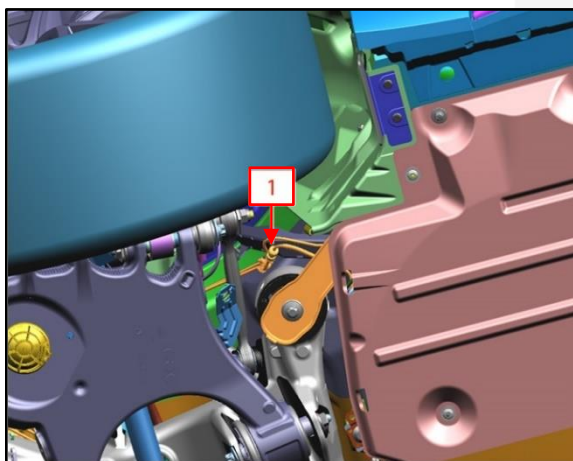
If any anomaly is detected in the procedure for operating the air springs, it is necessary to check all 4 air pipe couplings in which the circuit is divided and the connections on the air springs.

- Remove the underbody guards according to the procedures in the workshop manual:
  - **9.14.044.0**      **CENTRAL LH UNDERBODY GUARD**      **00**
  - **9.14.043.0**      **CENTRAL RH UNDERBODY GUARD**      **00**
  - **9.14.097.0**      **REAR CENTRAL RH UNDERBODY COVER**      **00**
- Check for air leaks using a gas leak detector liquid (e.g., Snoop Leak Detector) or equivalent at the following points (1) as illustrated below.

**NOTE:** If an air leak is evident from any of the areas of the air pipe couplings, it is necessary to replace the two components of the sections (male end and female ends) following the workshop procedure.

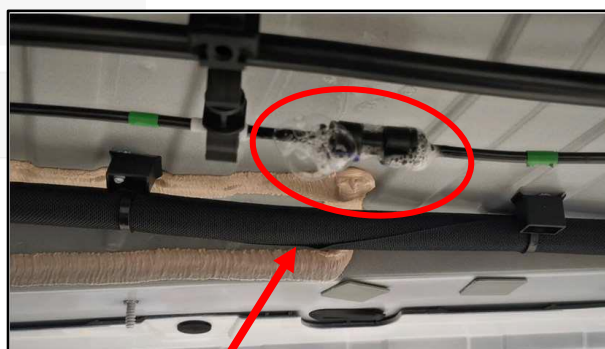
**Example:** of air leak at air pipe indicated by bubbles using a gas leak detector or equivalent
